Assessment of Climate Change Vulnerability with Options for Adaptation

Year 1 Report

AGRG. 2019. A Multi-Dimensional Analysis of Topo-bathymetric Lidar Data of Paqtnkek Mi'kmaw First Nation Lands and Waters: Assessment of Climate Change Vulnerability with Options for Adaptation. Technical report, Applied Geomatics Research Group, NSCC Middleton, NS.

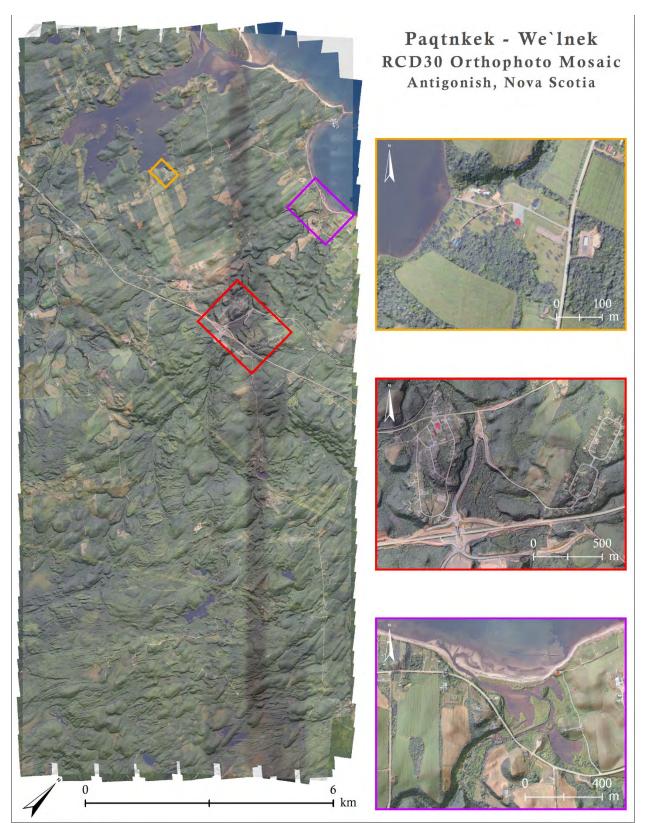
Figure 3.6: High-resolution true colour imagery of Paqtnkek and surrounding area collected simultaneously with the lidar draped on the DEM; insets match to larger imagery by frame colour. Insets show the We`lnek shoreline, the new highway 104 interchange, and the mouth of the Afton River.

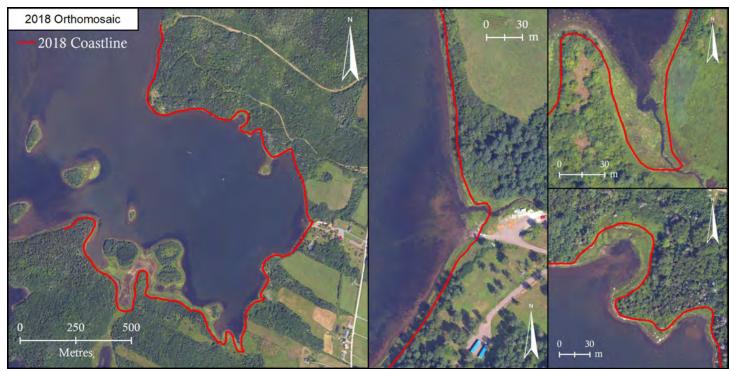
Figure 4.4: The 15 cm resolution 2018 RCD30 imagery of Church Cove, Pomquet Harbour, 2018. The left shows the extent of the digitized coastline in red. The zoomed in panels on the right show how the coastline was defined differently depending on the type of coastline (steep bank, marshy area, etc.).

The coastline in each georeferenced image from 1945 to 2018 was digitized in ArcMap using "the most landward evidence of tidal inundation" as the definition for coastline. The coastline was digitized for all of Church Cove, the small bay where the We`lnek reserve is located (Figure 4.4). In some areas the coastline appeared at the bottom of a steep bank, and in other areas the extent of tidal inundation was indicated by a wrack line visible in the imagery.

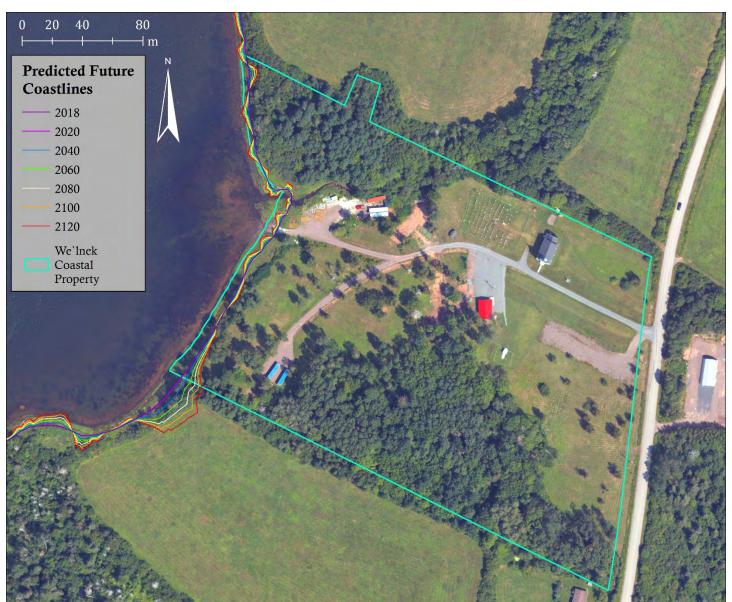
Figure 4.10: Predicted future coastlines (various colours) along the Paqtnkek First Nation's coastal property (in aqua) shows accumulation over time near the river mouth, and erosion over time on the west end of the parcel.

have seen accretion in the past will continue to advance seaward (Figure 4.9). Frequently, sections of eroding coastline were adjacent to sections of advancing coastline, often with a zone of no change between or nearby. These segments of coastline with zero rate of past change were projected to remain constant in the future. Small bays and inlets around Church Cove presently cutting landward continue to erode (Figure 4.9B) while other areas show slight accumulation over time, such as coastline adjacent to the mouth of the small river which runs behind the church on Paqtnkek's coastal land parcel. If the rate of coastline change continues at the same pace it has for the last fifteen years, most of the coastline directly along Paqtnkek's coastal property should see moderate accumulation, except for a section of coastline along the western edge of the property (Figure 4.10).

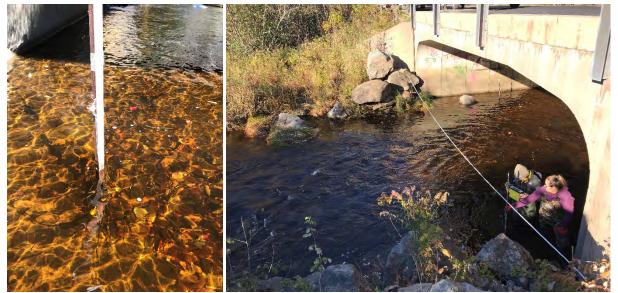
Figure 5.1: Pressure sensor deployed in the Afton River (left); Project GIS technician Kara Pictou and AGRG Research Associate Sam Lewis taking cross section measurements on Oct 23 (right).
