Using Topo-Bathymetric Lidar to Map Eelgrass in Malpeque, PEI

September 24, 2021

Webster, T., McGuigan, K., Crowell, N., Douglas, L. 2021. Using Topo-Bathymetric Lidar to Map Eelgrass in Malpeque, PEI. Technical report, Applied Geomatics Research Group, NSCC Middleton, NS.

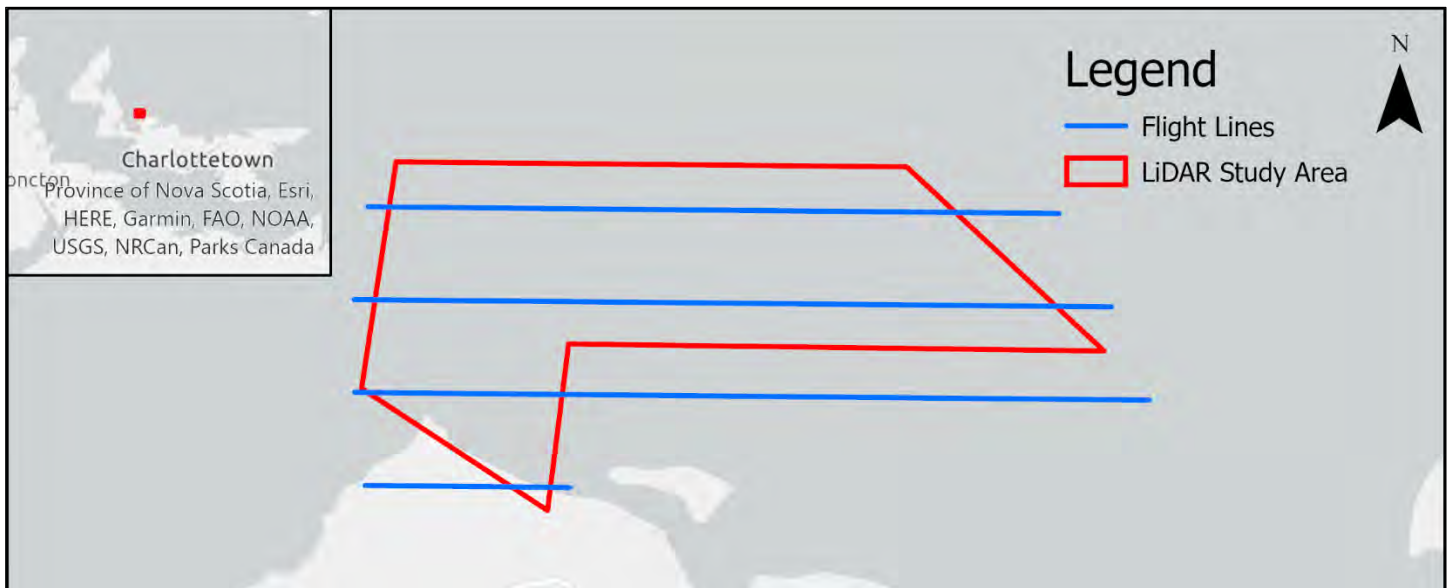
Figure 1. Englobe study area and planned flight lines over Malpeque Bay, PEI.

Survey lines were planned using Leica Mission Pro at 400 m altitude at a speed of 65 m/s with 30% lateral overlap to ensure that no data gaps were present within the 0.6 km² area of interest (Figure 1). Data collection parameters supported a topo point density of >10 ppm, a bathy density of >5 ppm and aerial imagery with a ground pixel resolution of better than 5 cm. The Malpeque lidar survey was successfully completed on July 29, 2021, from 1300 to 1330 UTC. In-situ weather and GNSS constellation conditions were deemed suitable to support optimal data collection. Control for the survey was established by flying flat and level over two active control points proximal to the AOI in Ellerslie, PEI (PEEL 3533) and Gulf Shore, PEI (PEGS 3534). (Figure 2).

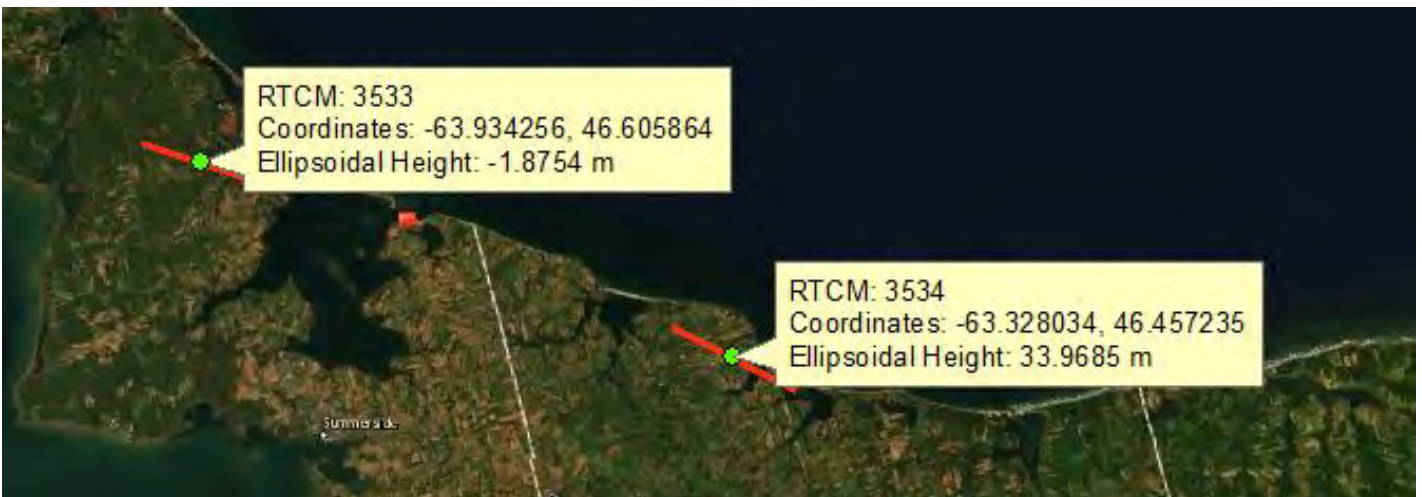
Figure 2. Locations of the RTCM reference stations used during calibration flights for the LiDAR survey in Malpeque, PEI.

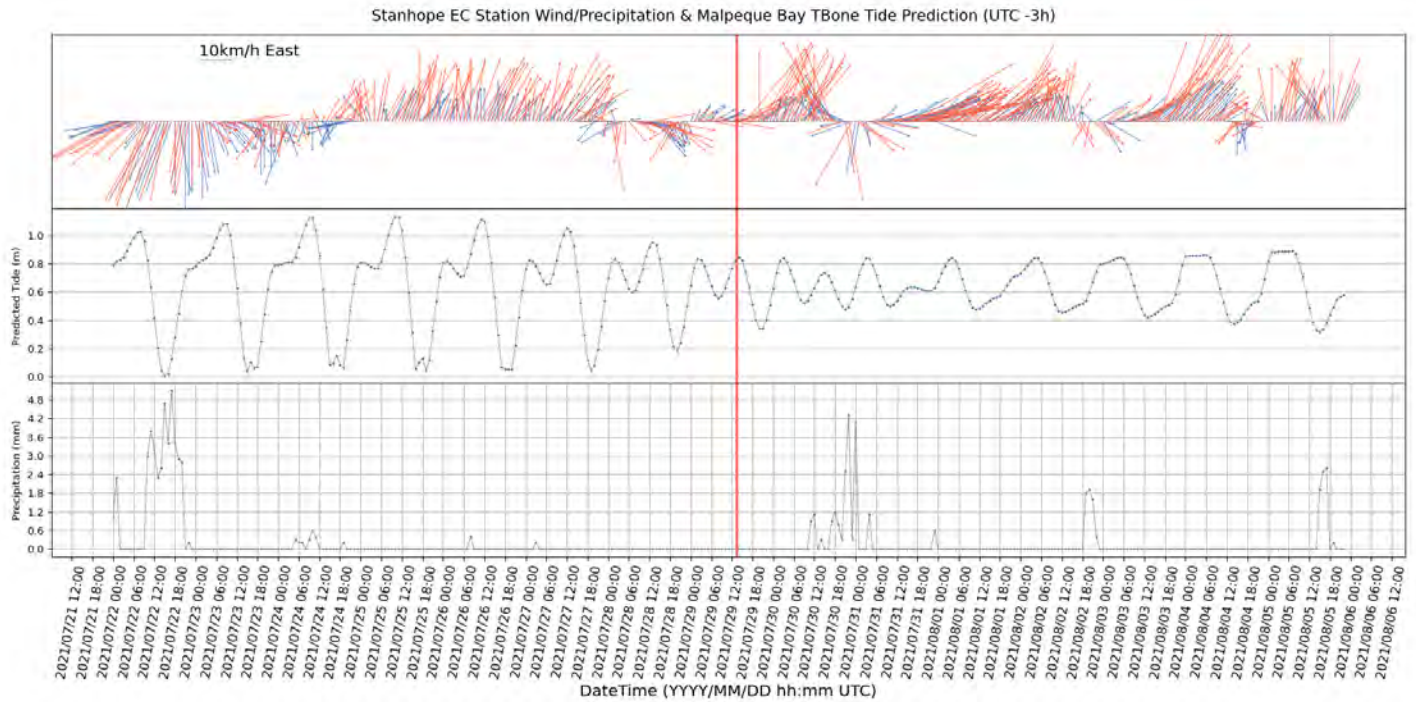
Figure 3. Wind speed (km/h), precipitation (mm) and predicted tide (m) for the Malpeque Bay area. Wind data from the Stanhope EC weather station is plotted in blue, and the Summerside EC weather station is plotted in orange. Flight times are highlighted in red.

Meteorological conditions during and prior to topo-bathy lidar data collection are an important factor in successful data quality because the bathy lidar sensor is limited by water clarity. Windy weather has the potential to stir up any fine sediment in the water and prevent good laser penetration, rain is not suitable for lidar collection, and sun angle can produce problematic glint in aerial imagery. Forecasted, current, and past weather conditions were monitored prior to data collection using the Summerside and Stanhope weather stations operated by Environment and Climate Change Canada (Figure 3). Conditions were deemed suitable to support optimal data collection at the time of survey.

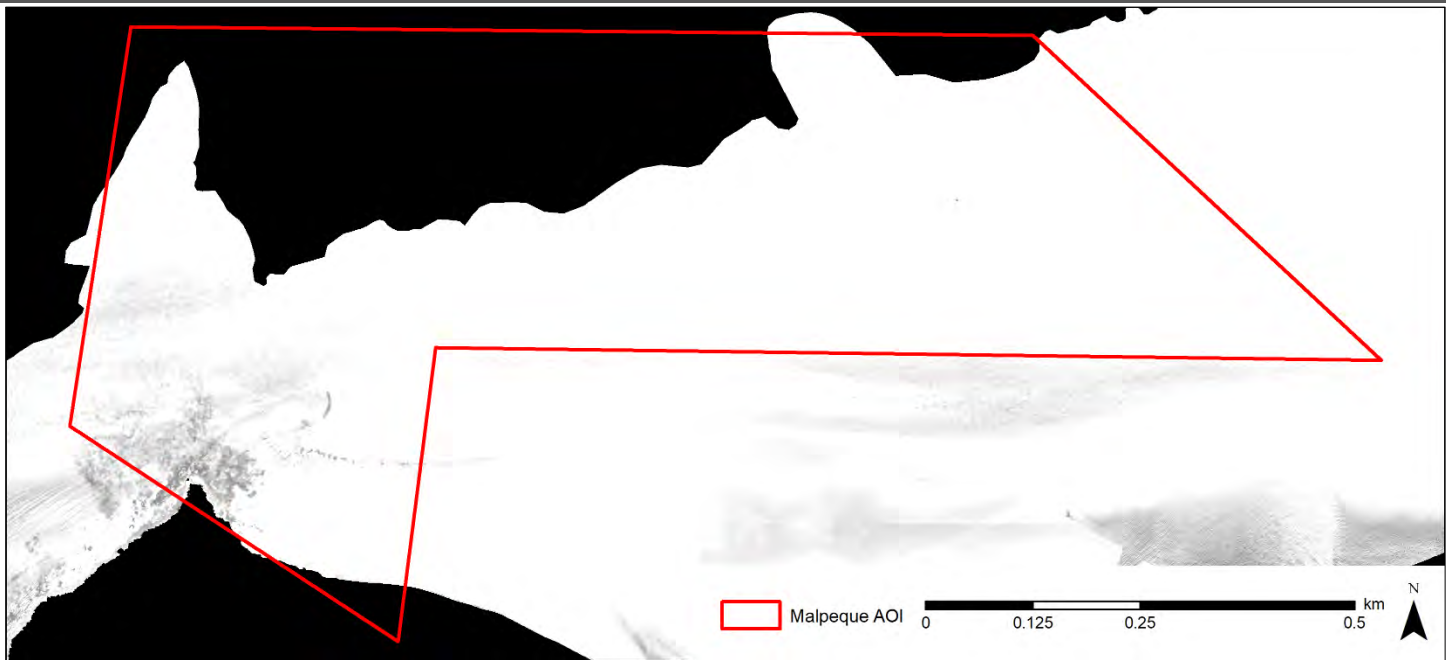
Figure 7. Eelgrass confidence map generated using the image based SAV map, the lidar based SAV map, and depth. Eelgrass appears darker than surrounding bottom materials with little inconsistency.

A principal reason for building SAV indexes for each sensor is that they each have various benefits and limitations. The SAV model derived from the camera sensor performed better in very shallow waters, less than 1 m depth, where the lidar reflectance is susceptible to peaking and exhibiting noise due to complex water surface interactions. The lidar shows a stronger sea floor reflectance up to a much greater depth (>7 m) compared to the camera. Both sensors have various technical artifacts which can diminish the result of their individual SAV products including sea surface glint, sediment plumes, water characteristics, signal loss due to incident angle, and changing light conditions. These problems are inconsistent between the sensors and a fusion of their SAV products helps to produce a superior model. Various approaches have been experimented with to amalgamate these models and based on the extent of the various technical aspects which affect each sensor the maximum returning value from both models was used to map SAV in the Malpeque AOI (Figure 7):

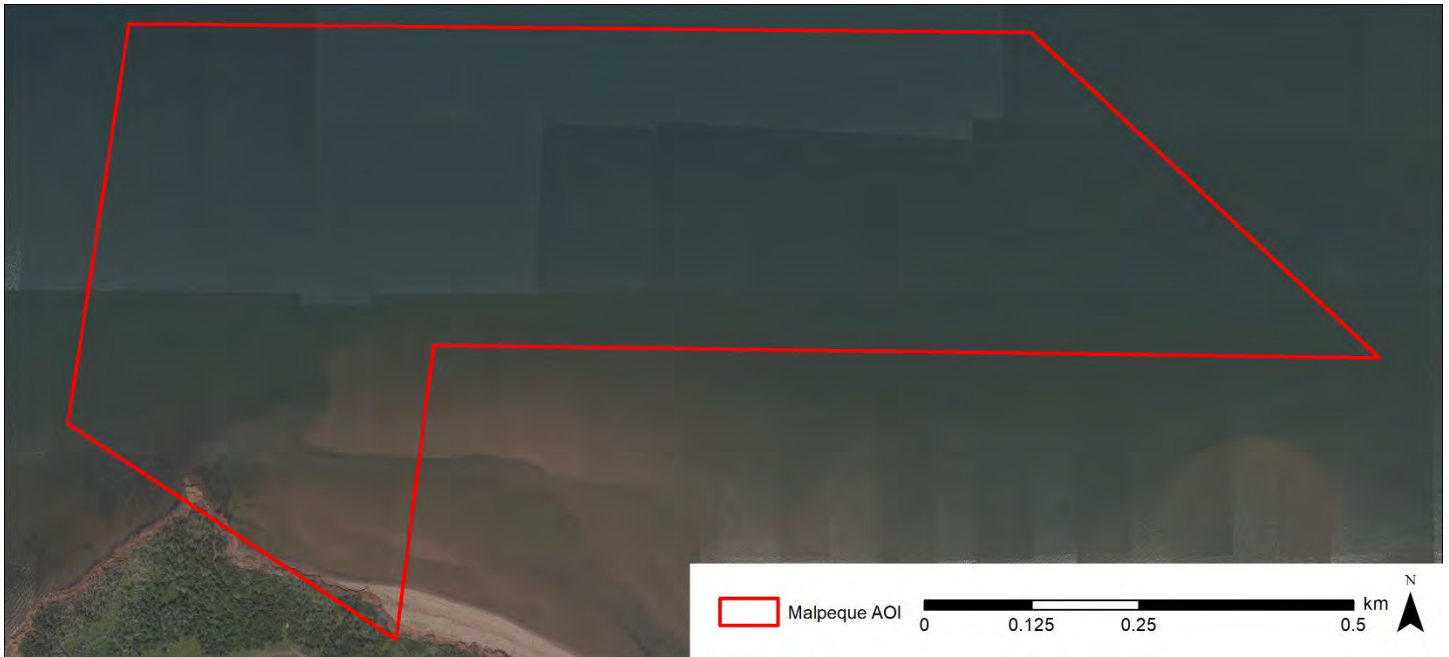
Figure 8. True colour orthomosaic of Malpeque Bay, PEI created using Agisoft Metashape Professional 1.7.2.

The orthophoto mosaic product was generated at a resolution of 0.05 m resolution with pixel perfect alignment between frames and covered the entire extent of the AOI (Figure 8). The quality of the imagery was suitable for assisting with the interpretation of the DEM and eelgrass coverage though context-based contrast and brightness enhancements (Figure 9).

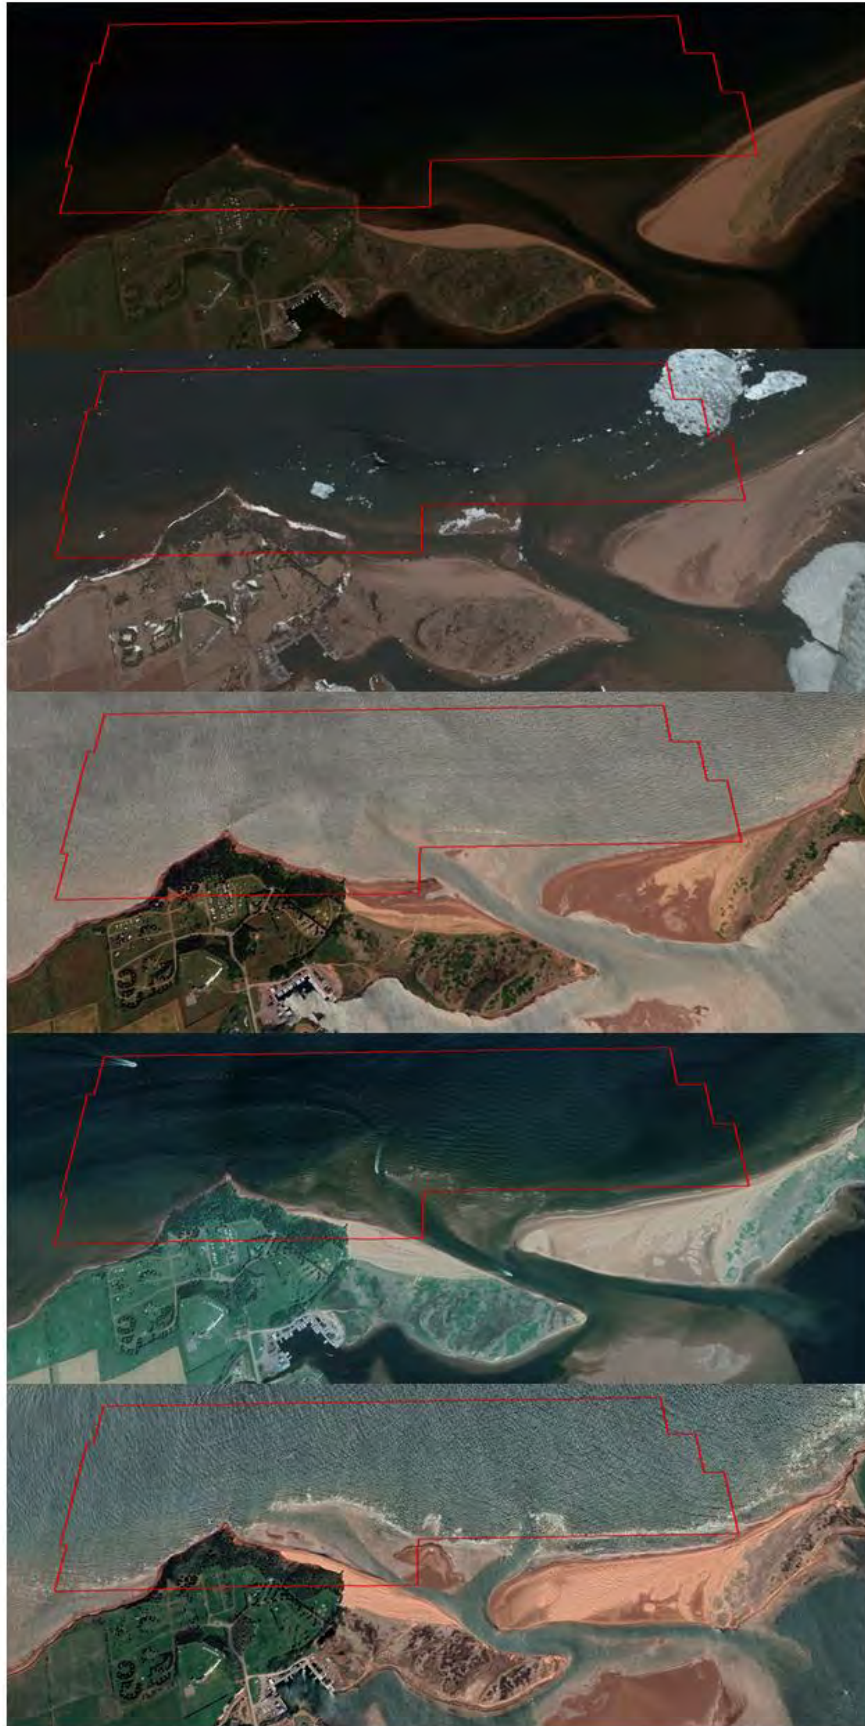
Figure 15. (From top to bottom) Google Earth images of Malpeque Bay, PEI show a shifting sand from August 6, 2012, April 17, 2014, July 22, 2017, July 10, 2019, and May 30, 2021, with the AOI study area outlined in red.

Malpeque Bay is a high energy area that has constantly changing bottom features which invalidate the use of historical imagery to validate data. In such high energy areas, storms can cause significant seagrass loss (Côté-Laurin et al. 2017, Oprandi et al. 2020). Eelgrass distribution and abundance may have changed between the most recent satellite imagery and the lidar survey for this project. Seagrasses can take years to recover from disturbance (O'Brien et al. 2018) and multiple disturbances over many years could cause significant decline in eelgrass in this area. It will be important to create up to date eelgrass maps for the Malpeque Bay area if continued dredging is being considered. Large areas of shifting sand can appear similar in reflectance to vegetation resulting in an overestimation of eelgrass presence. This is specifically an issue in the Malpeque area, recent aerial photography indicates the sand bar within this area of interest has continued to shift significantly (Figure 15). Dark patches were mapped within sand ripples in the central portion of the study area around 6 m depth. While this depth could theoretically support eelgrass, DFO advised that even if eelgrass was present, it would be ephemeral and disturbed by natural causes in the depressions within the sand ripples.
