Analysis of Lidar Data for Improved Flood Risk Mapping:

Enhanced Lidar Point Cloud Classification and Product Development

Nova Scotia Community College
Applied Geomatics Research Group
NSCC, Middleton, NS
Tel. 902 825 5475
Email: timothy.webster@nsc.ca

Colin MacDonald
Director, Geographic Information Services
ICT Services, Internal Services Department
Government of Nova Scotia
5161 George St.
Halifax, NS B3J 2Y1
March 31st, 2022

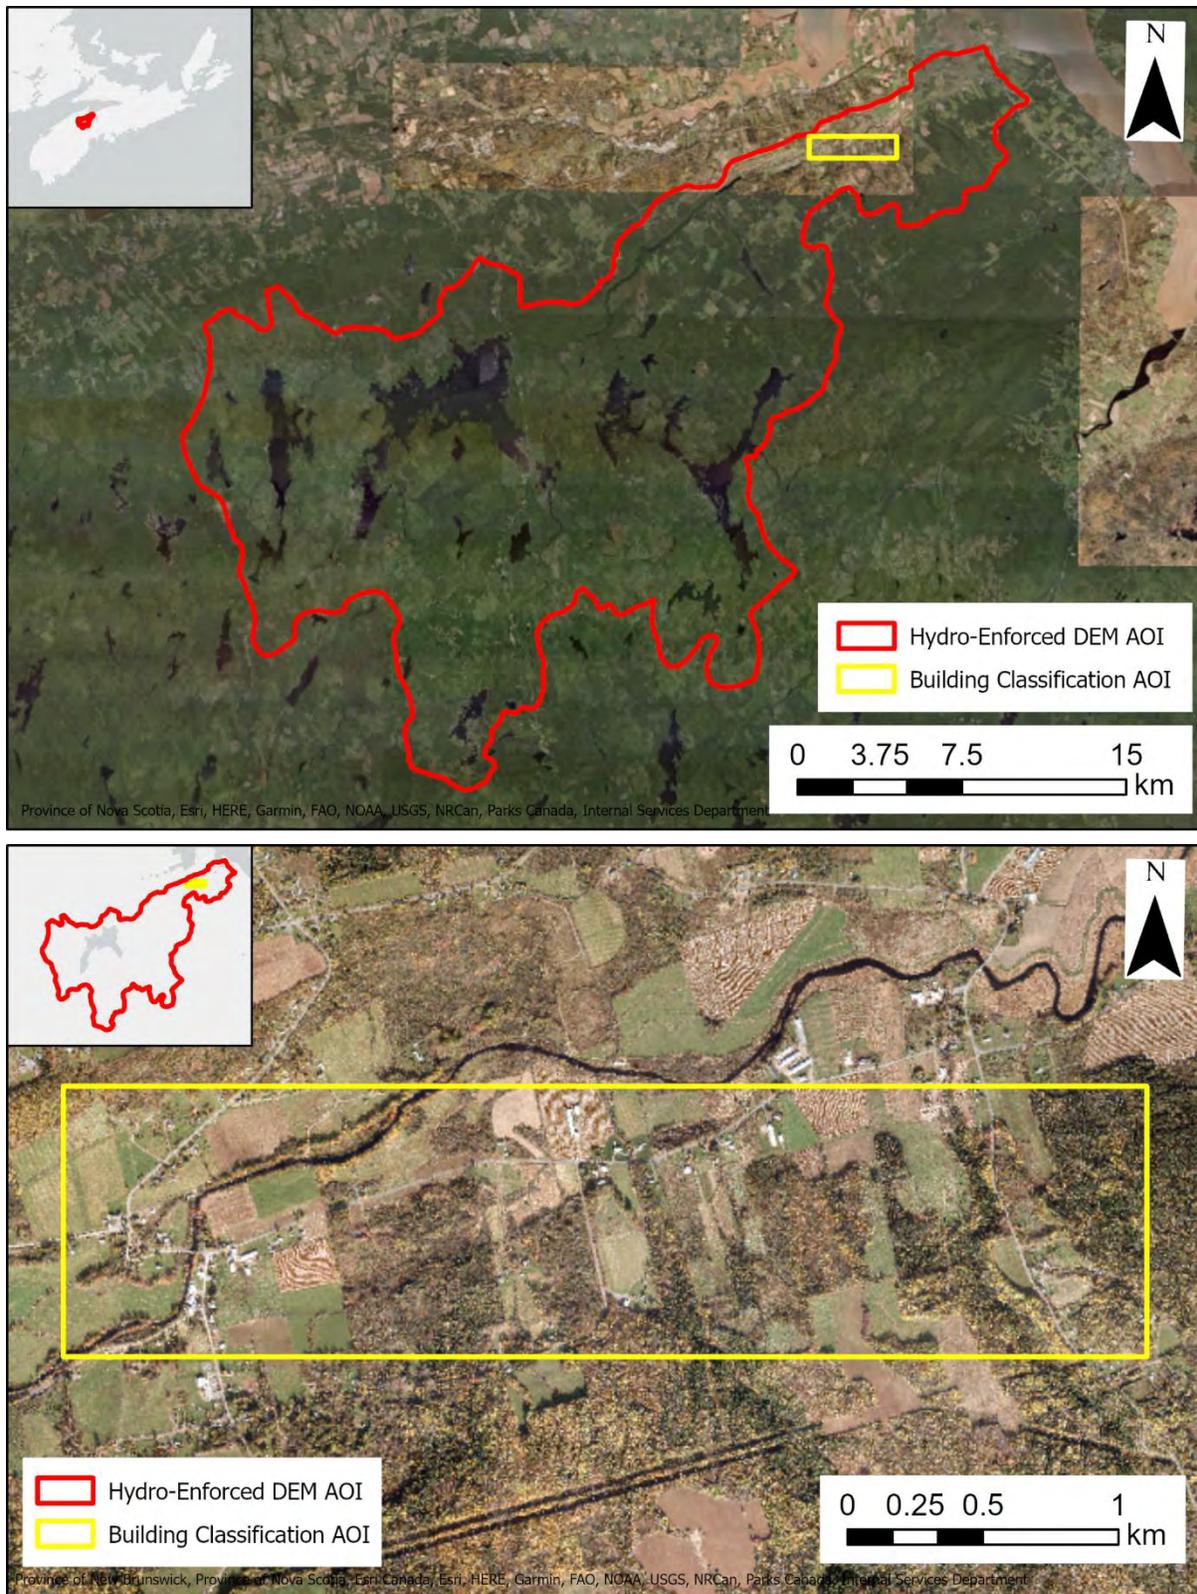
Figure 1. Maps of the study area used for the generation of hydro-enforced DEMs (top) and lidar classification updates for buildings and other land cover classes (bottom).

The study area was a 4 km² region within the Gaspereau River – Black River watershed (Figure 1). The Gaspereau River stretches approximately 24 km from its source at Gaspereau Lake to its mouth near Hortonville. There are several dammed sections in the upper reaches of the river that form deep, narrow channels. The lower reaches of the river are characterized by tidal marshes. A major tributary of the river is the Black River which connects to the Gaspereau River at White Rock (Millward, Ouellette, & Ricketts, 1985).

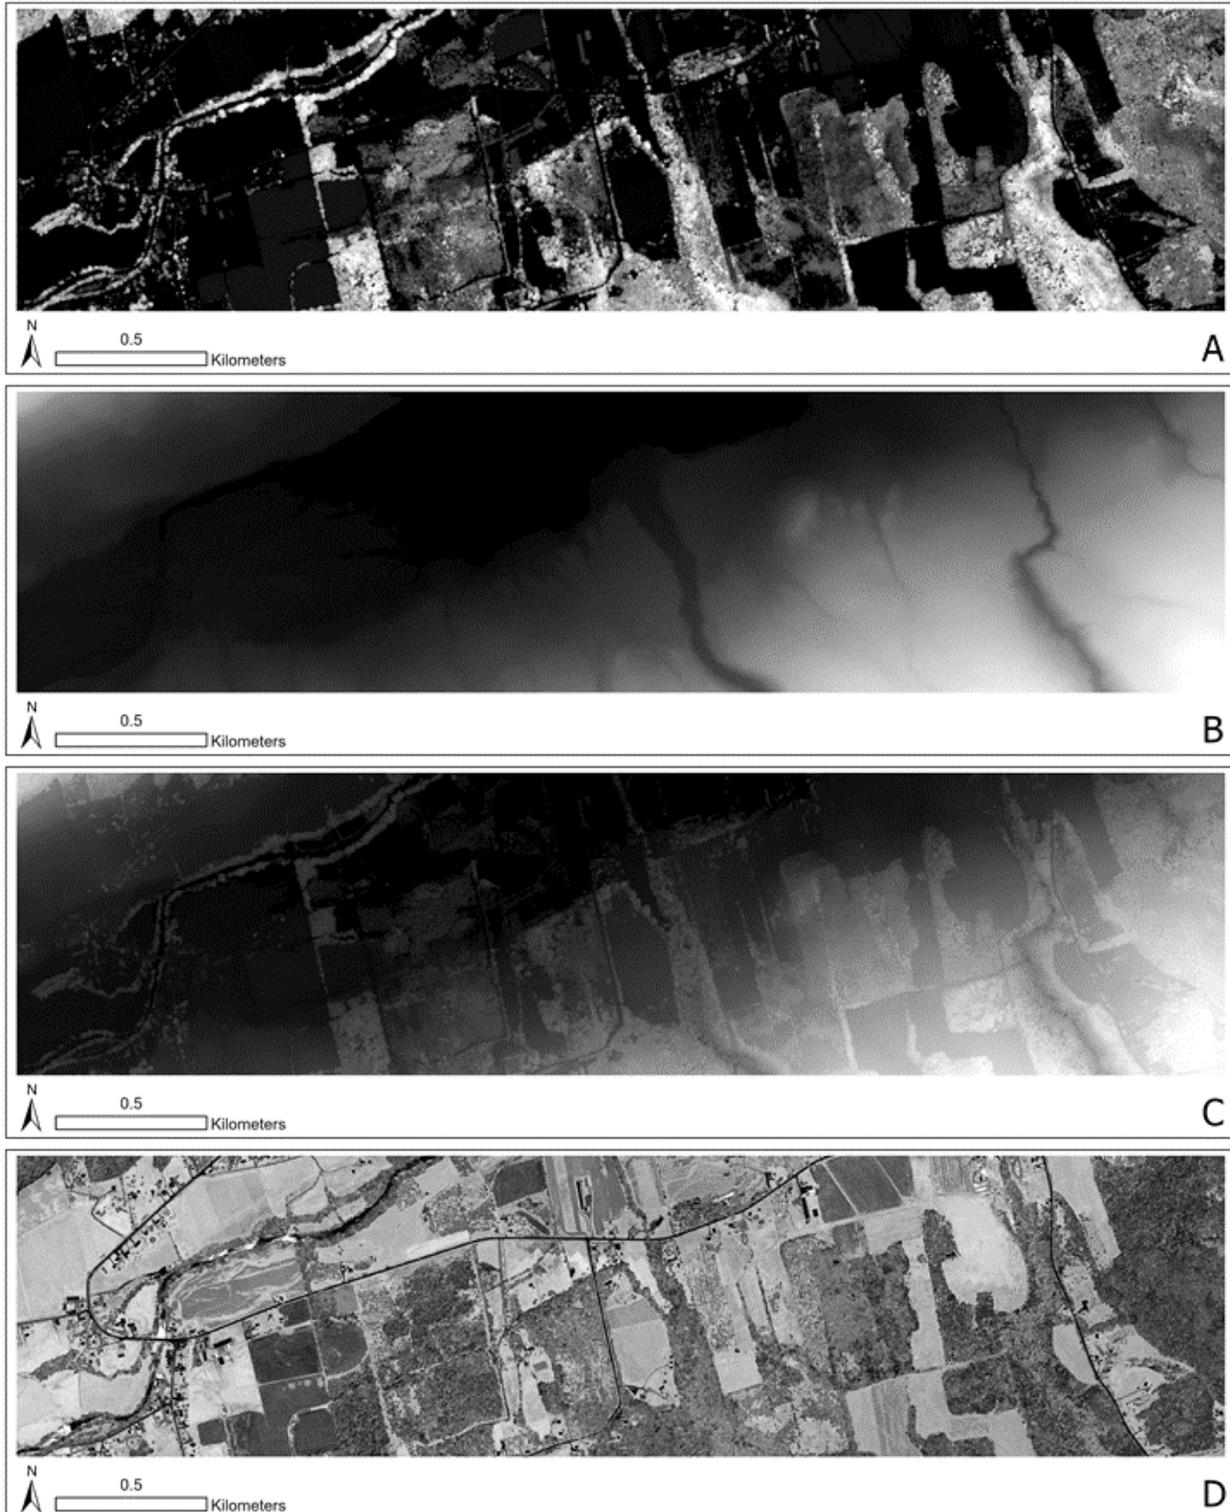
Figure 2. A comparison of potential lidar products to use as inputs to the SVM classifier. A: canopy height model (CHM); B: digital elevation model (DEM); C: digital surface model (DSM); and D: point return intensity (INT).

A support vector machine (SVM) classifier was selected to segment and classify raster products derived from the lidar survey data. Common lidar products were used as model inputs including a digital elevation model (DEM), digital surface model (DSM), canopy height model (CHM), and an intensity raster (INT) raster (Figure 2).

The SVM classifier within ArcGIS Pro only accepted three bands of raster input and it was essential to ensure each band provided unique data. It was important to maximize consistency between bands by ensuring that data were collected within a similar timeframe. Composite RGB orthophoto data were considered as a model input (Figure 3), however the temporal separation between the lidar and image data collections was problematic as areas were covered in vegetation in the lidar data but not the orthophotos. The imagery also contained several shadows throughout the scene that caused issues with the classification where shadows were wrongly classed due to their resemblance to other non-shadowed land cover types. These issues made the imagery unsuitable for use in classification and it was excluded from consideration.

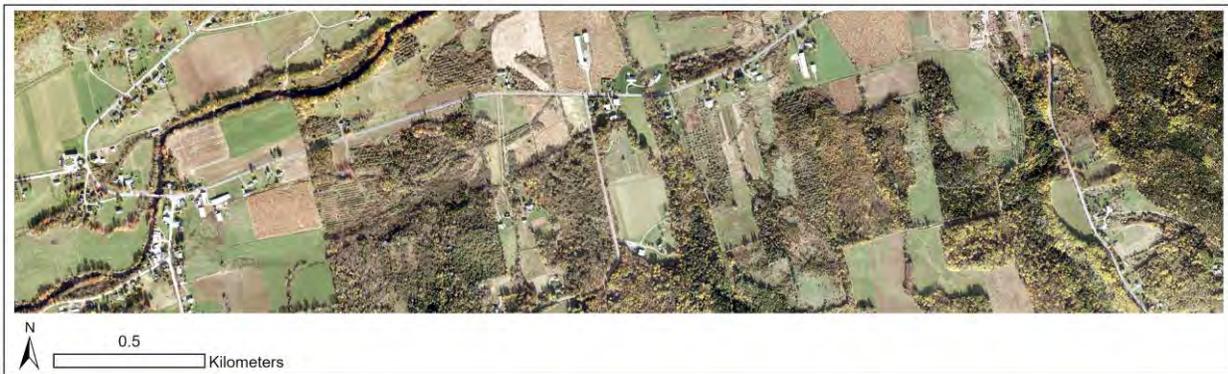
Figure 3. An RGB composite orthophoto clipped to the classification training area.

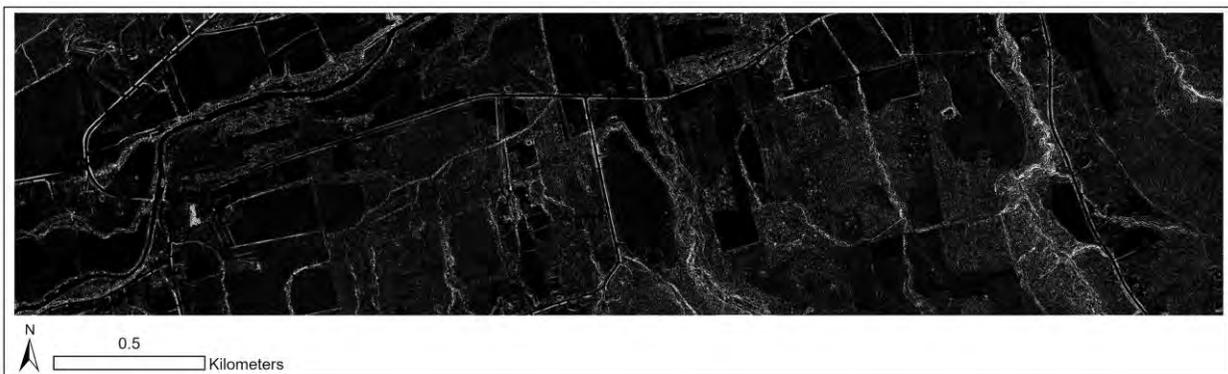
Figure 4. A roughness raster derived from the absolute value of the curvature of the DEM.

A surface roughness estimate was also used as a model input and was generated using a raster function chain in ArcGIS Pro to extract curvature values from the DEM (Figure 4). The use of the roughness raster was investigated but consistently produced poor the results and was removed from consideration.

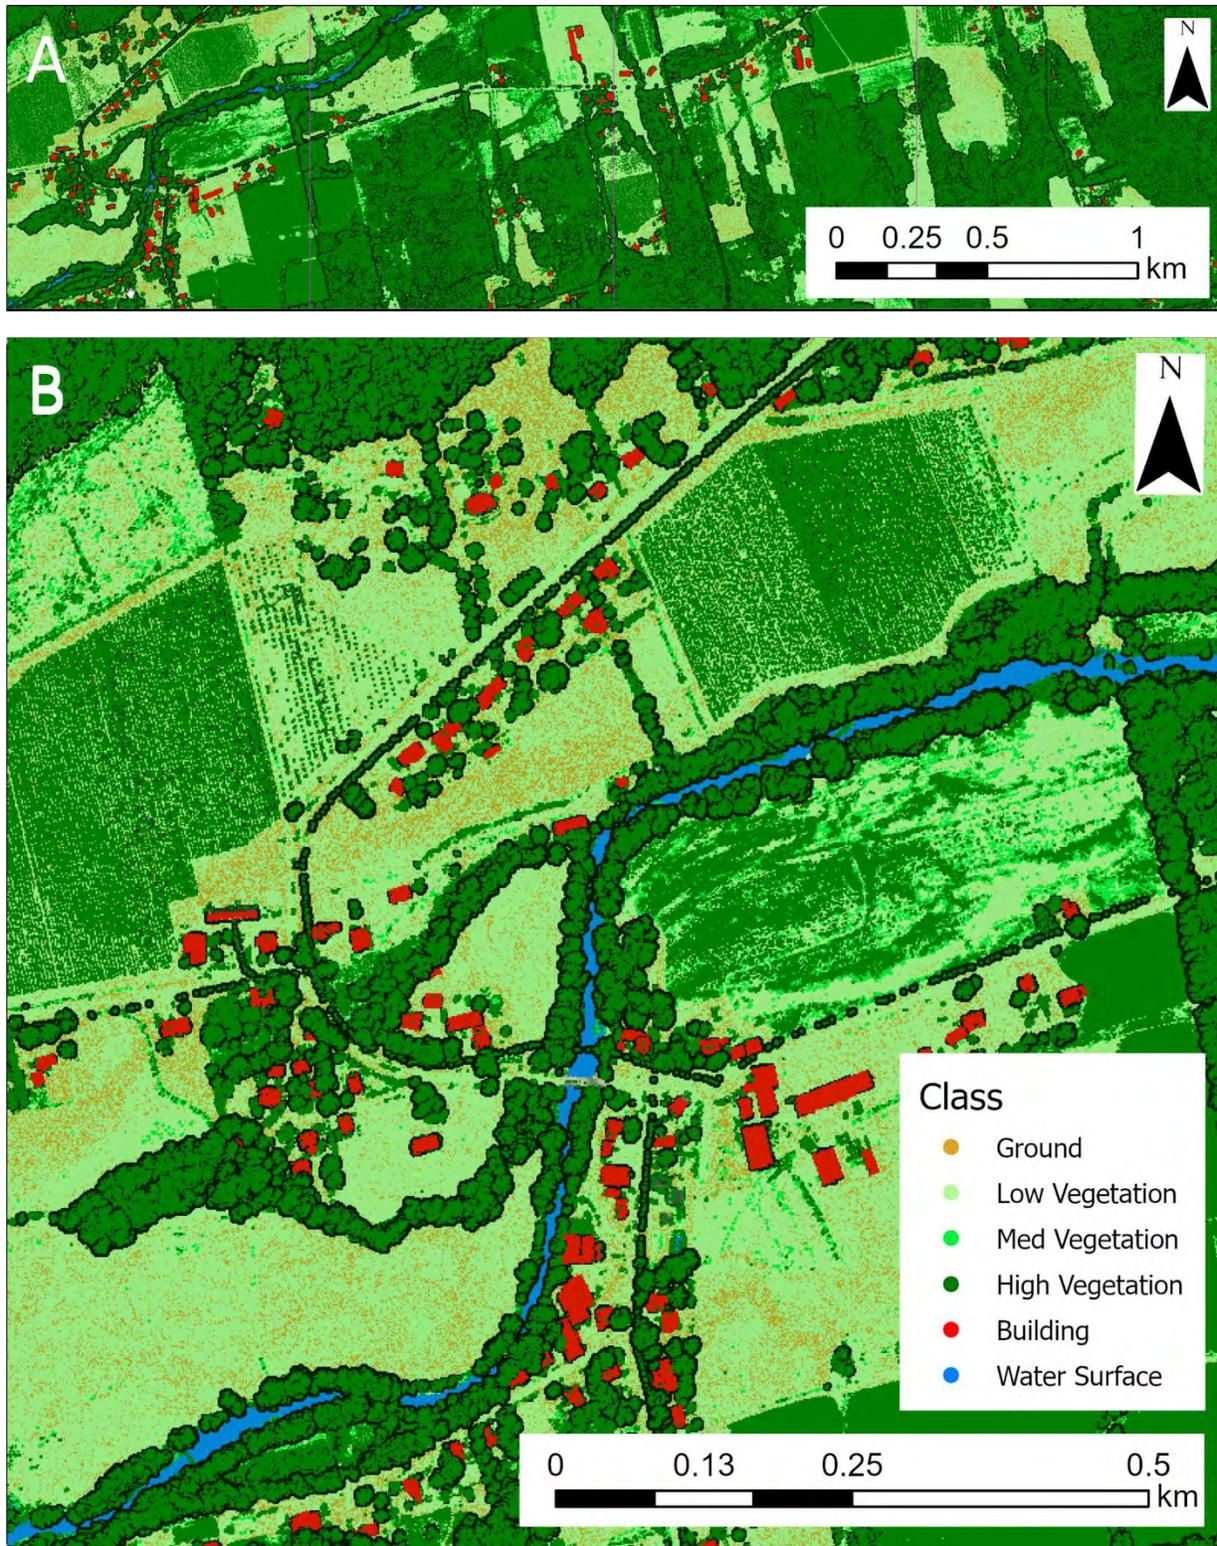
Figure 5. Result of automated building classification for the full extent of the study area (A) and in a single 1 km² tile (B).

An automated building classification was performed using a Terrascan macro to classify building points in four LAS tiles obtained from GeoNova. The results of the building classification viewed in Terrascan are shown in Figure 5.

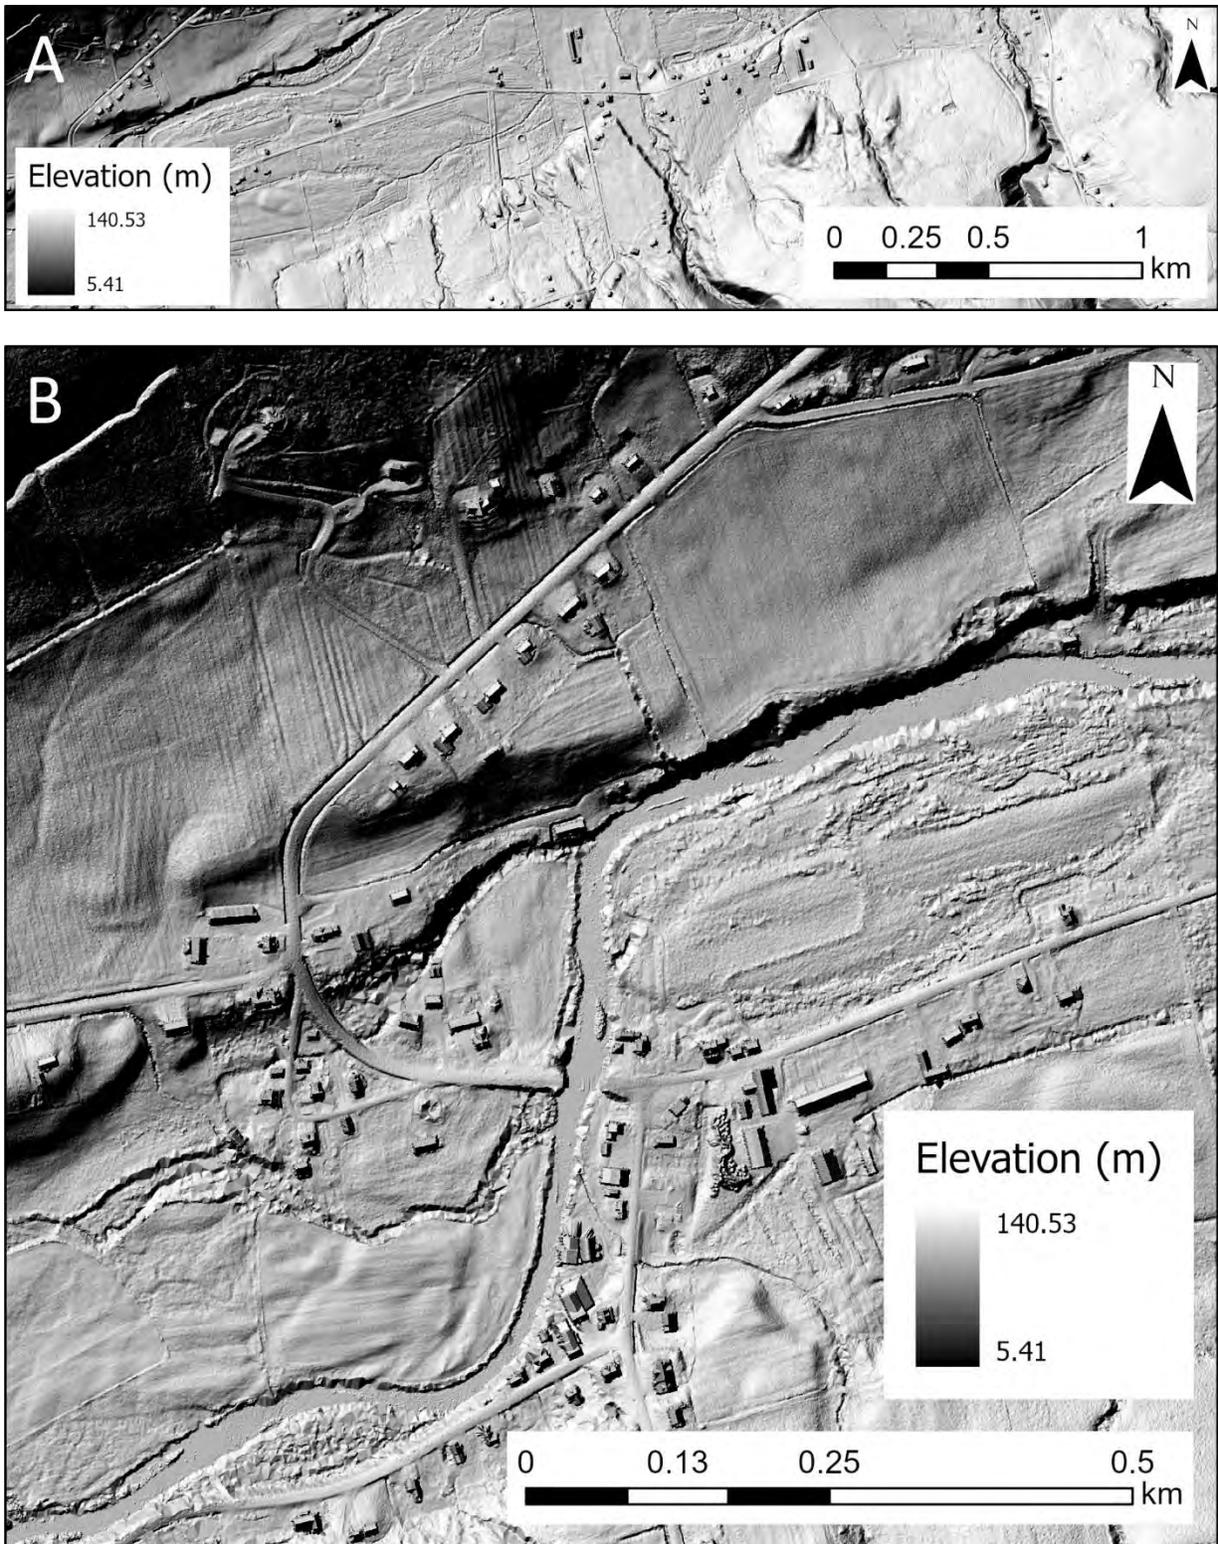
Figure 6. A digital elevation model of the study area containing ground and building lidar returns presented as a hillshade. The extent of the study area is displayed in (A) and a single 1 km² tile is displayed in (B).

Classified building lidar points were used alongside ground returns to generate a 0.5 m DEM with buildings for the study area within the Gaspereau watershed. The resulting raster is displayed as a hillshade (Figure 6). Lidar-derived building footprints attributed with elevation information relative to CGVD2013 were produced from the elevation model. The automated building classification identified 173 buildings within the 4 km² study area (Figure 7).

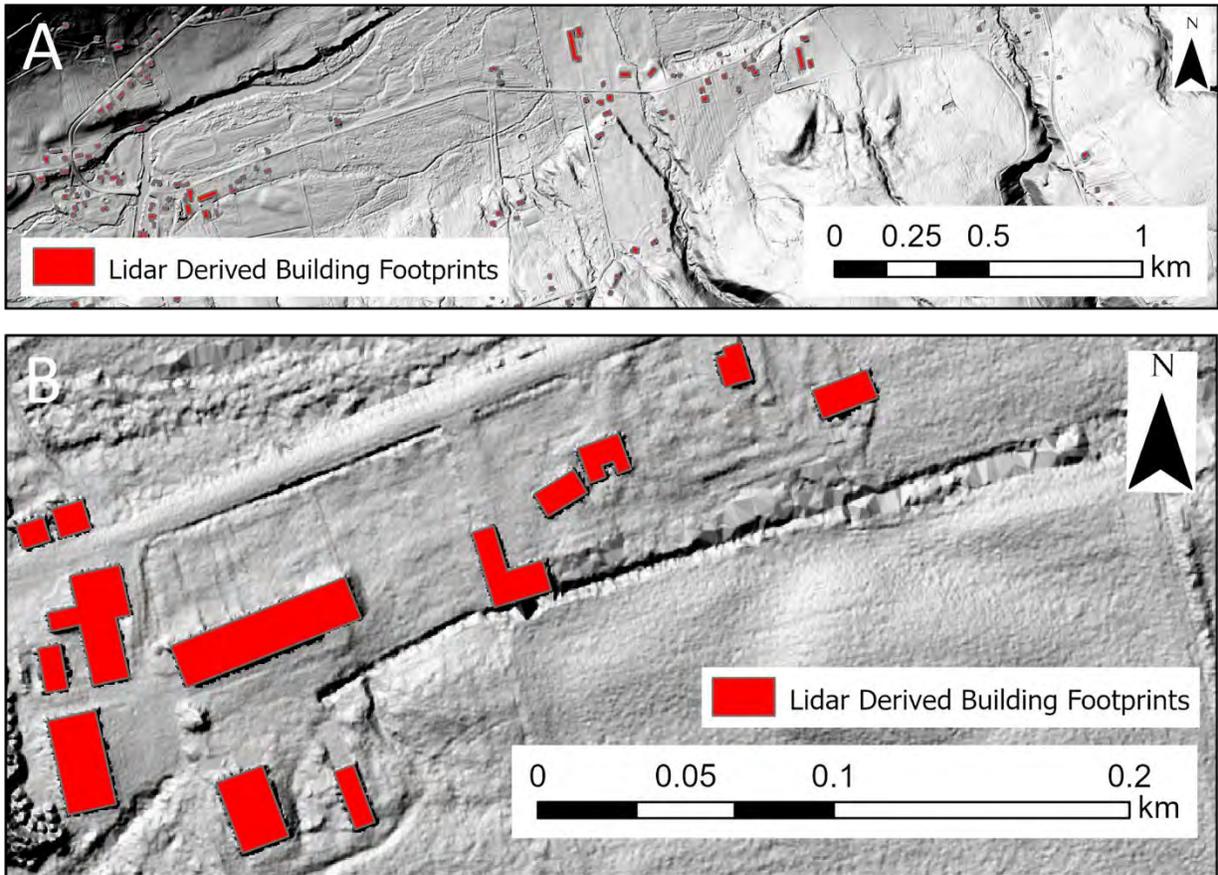
Figure 7. A map displaying building footprints that have been derived from an automated building classification routine. The extent of the study area is displayed in (A) and a closer view of the building footprints is displayed in (B).

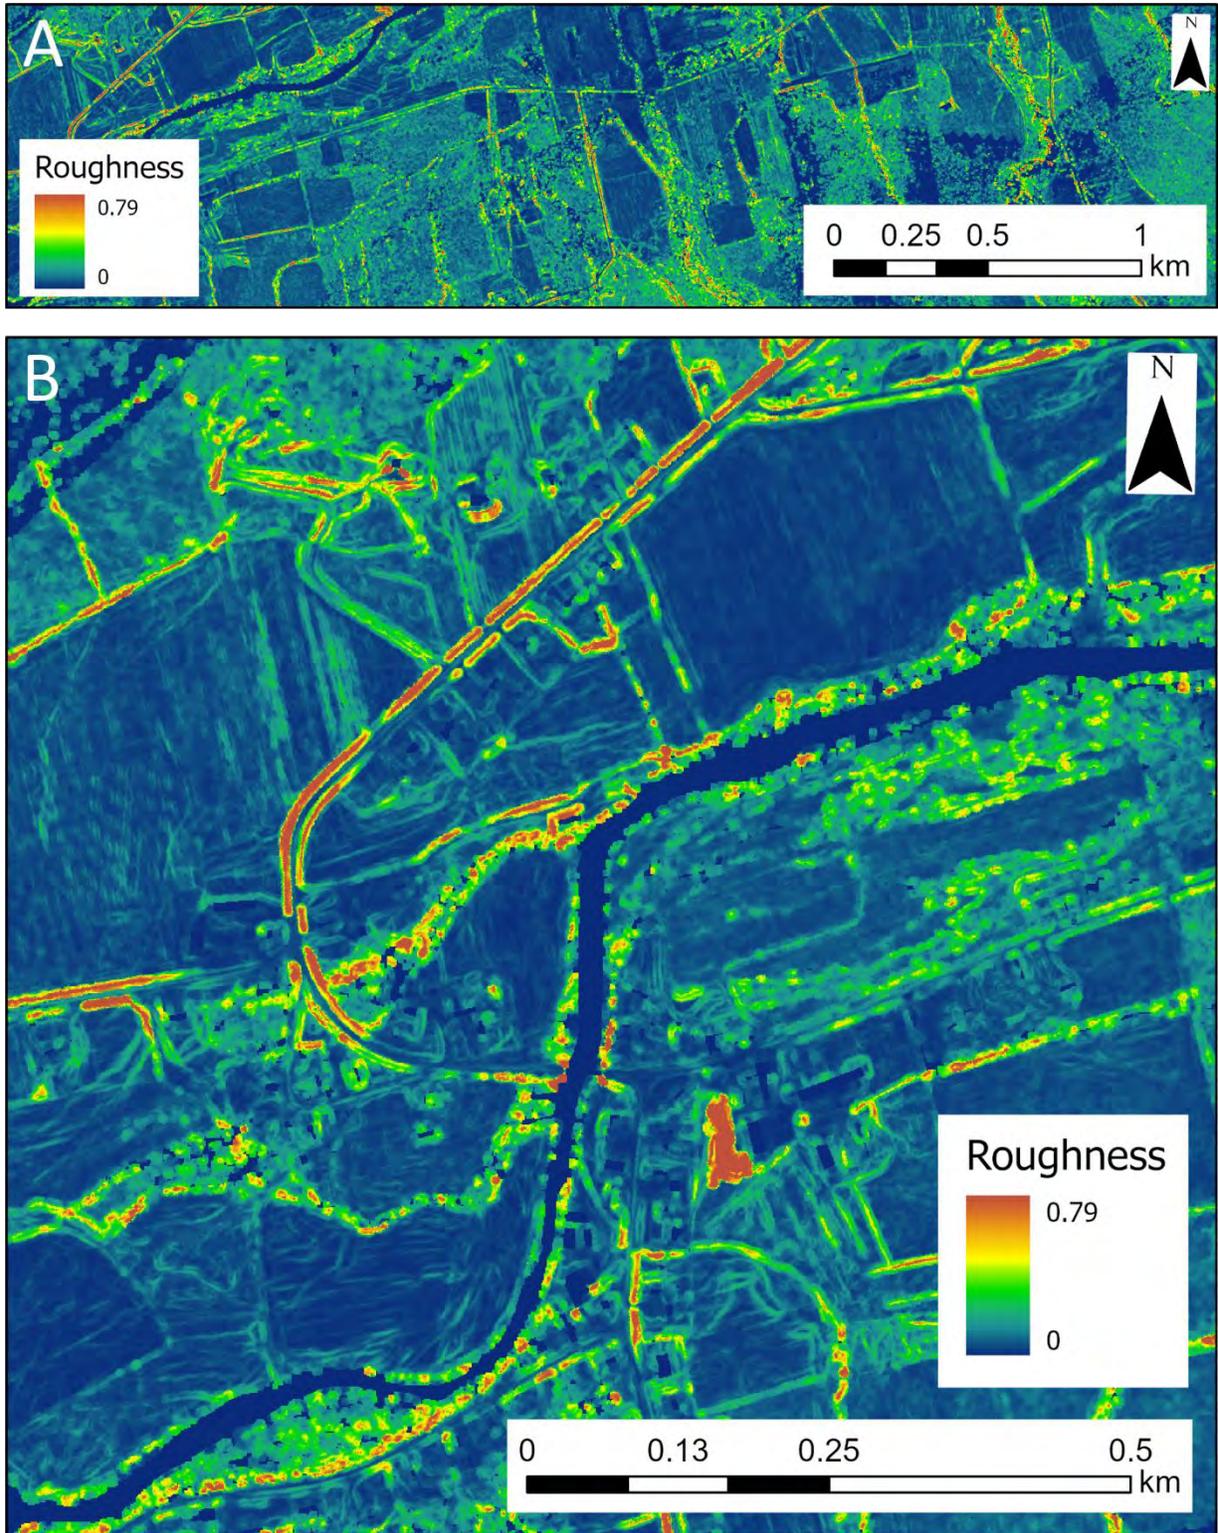
Figure 8. A surface roughness map generated from lidar ground returns for the full extent of the study area (A) and in a single 1 km² tile (B).

Raw lidar data from GeoNova was used to produce layers that described the roughness of the bare earth (Figure 8), low vegetation (Figure 9), and medium vegetation (Figure 10) within the 4 km² study area. High surface roughness was observed around riverbanks, ditches along the side of the road, and portions of agricultural fields where heaps of soil are commonly stored. Higher roughness values corresponded to more resistance to flow. Low roughness values were observed on roads and bare earth agricultural fields. The lowest roughness values corresponded to smooth surfaces that have the least resistance to flow.

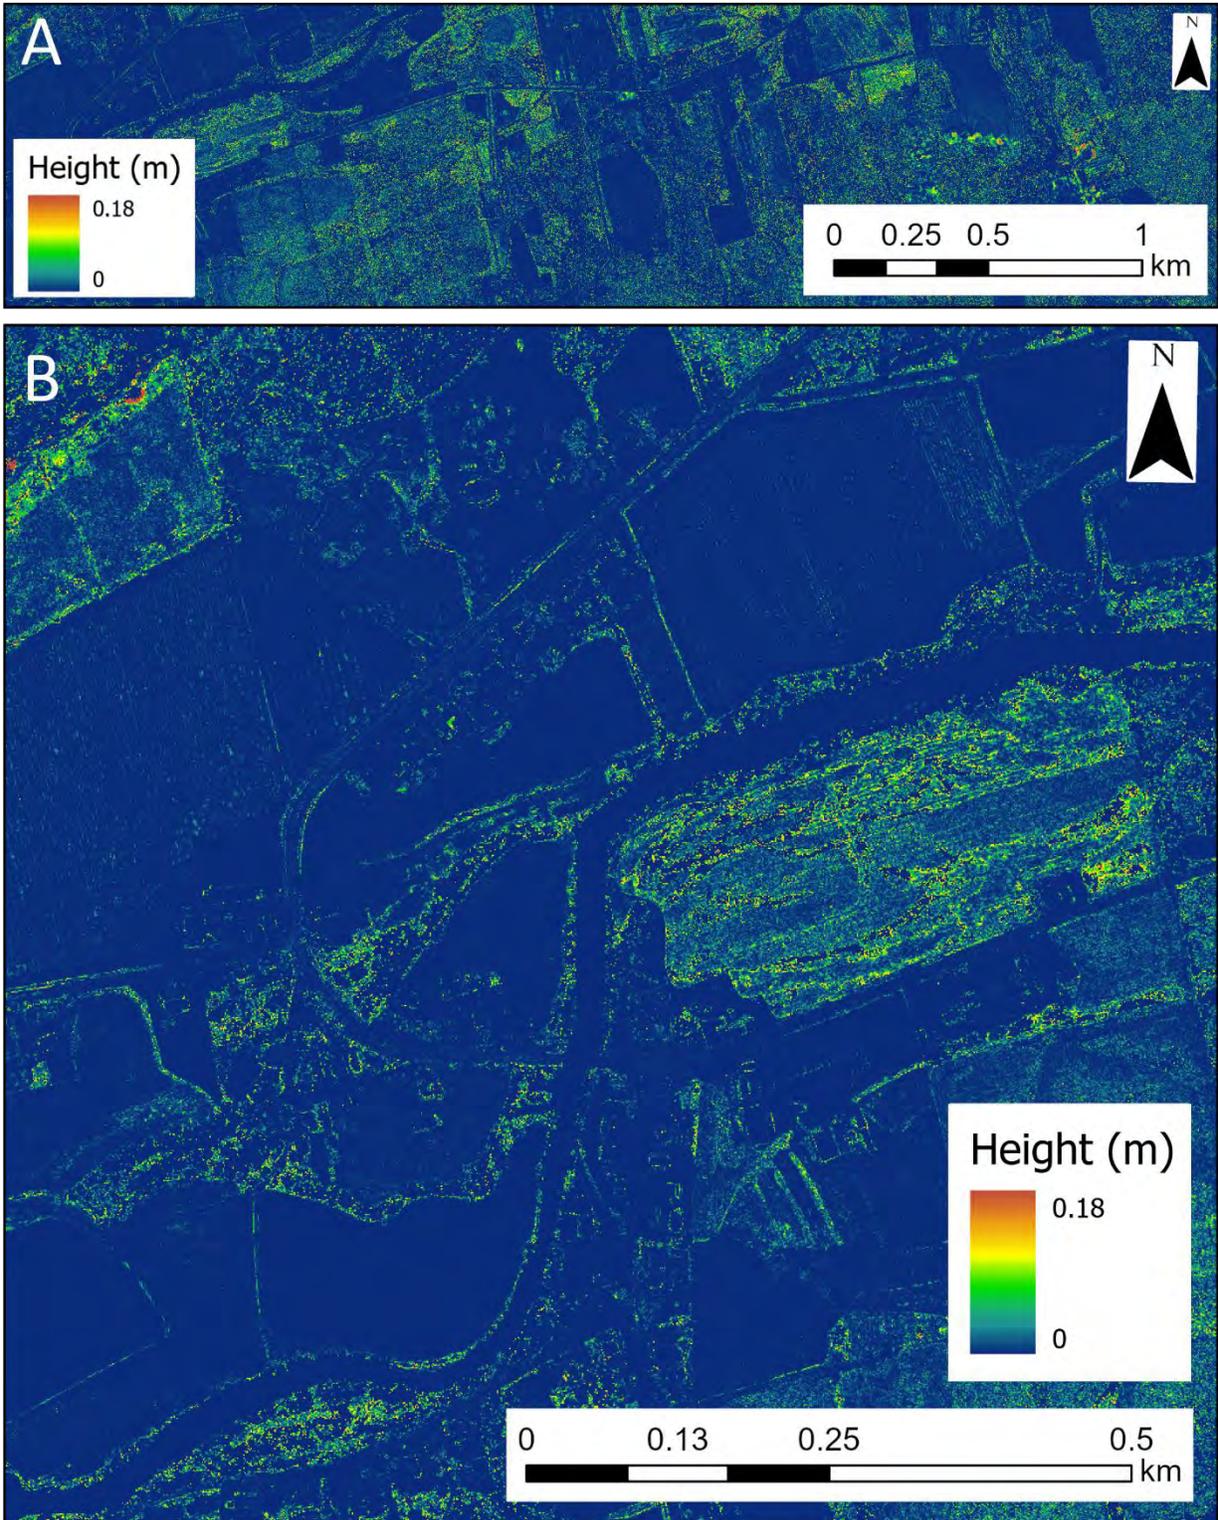
Figure 9. A map that represents the height of low vegetation above the ground class for the full extent of the study area (A) and in a single 1 km² tile (B).

Surface flow is affected not only by the ground topography but also vegetation. Low vegetation (e.g., low-growing grasses and crops) and medium vegetation (e.g., tall grasses, shrubs) also represent less permeable surfaces than bare earth. Low and medium vegetation within the study area grew as high as 18 cm and 41 cm, respectively.

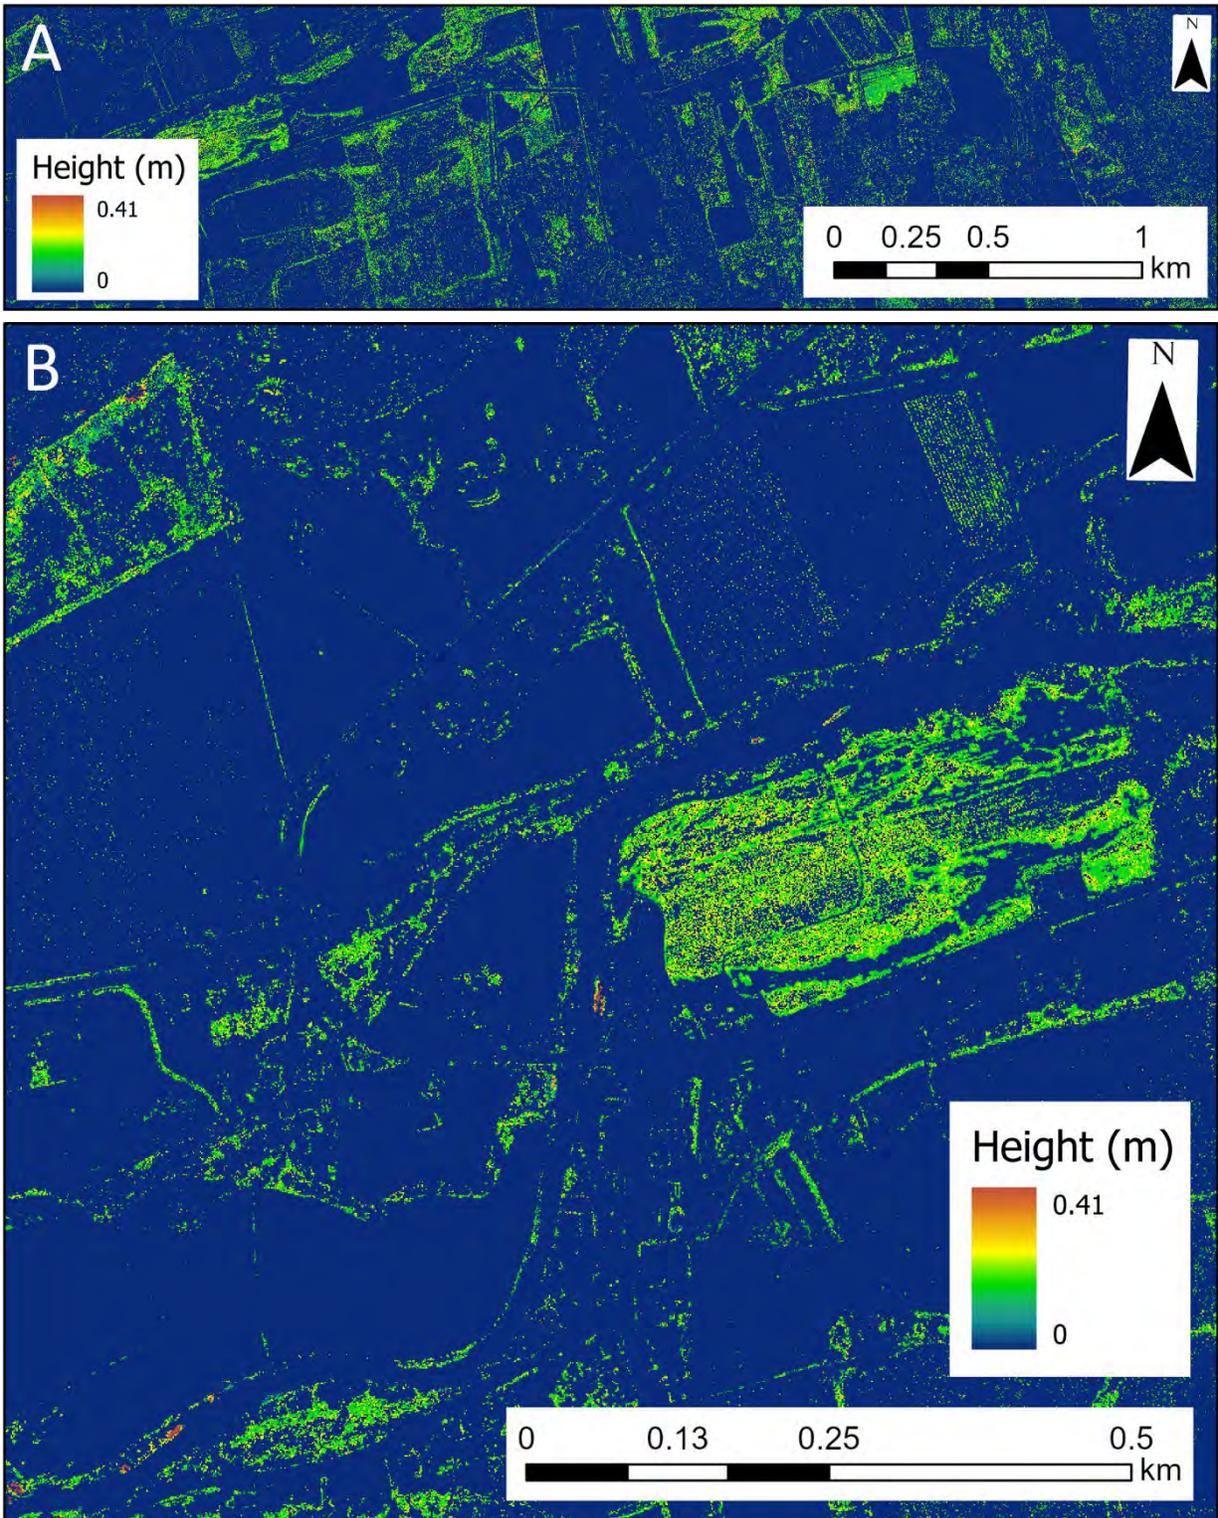
Figure 10. A map that represents the height of medium vegetation above the ground class for the full extent of the study area (A) and in a single 1 km² tile (B).

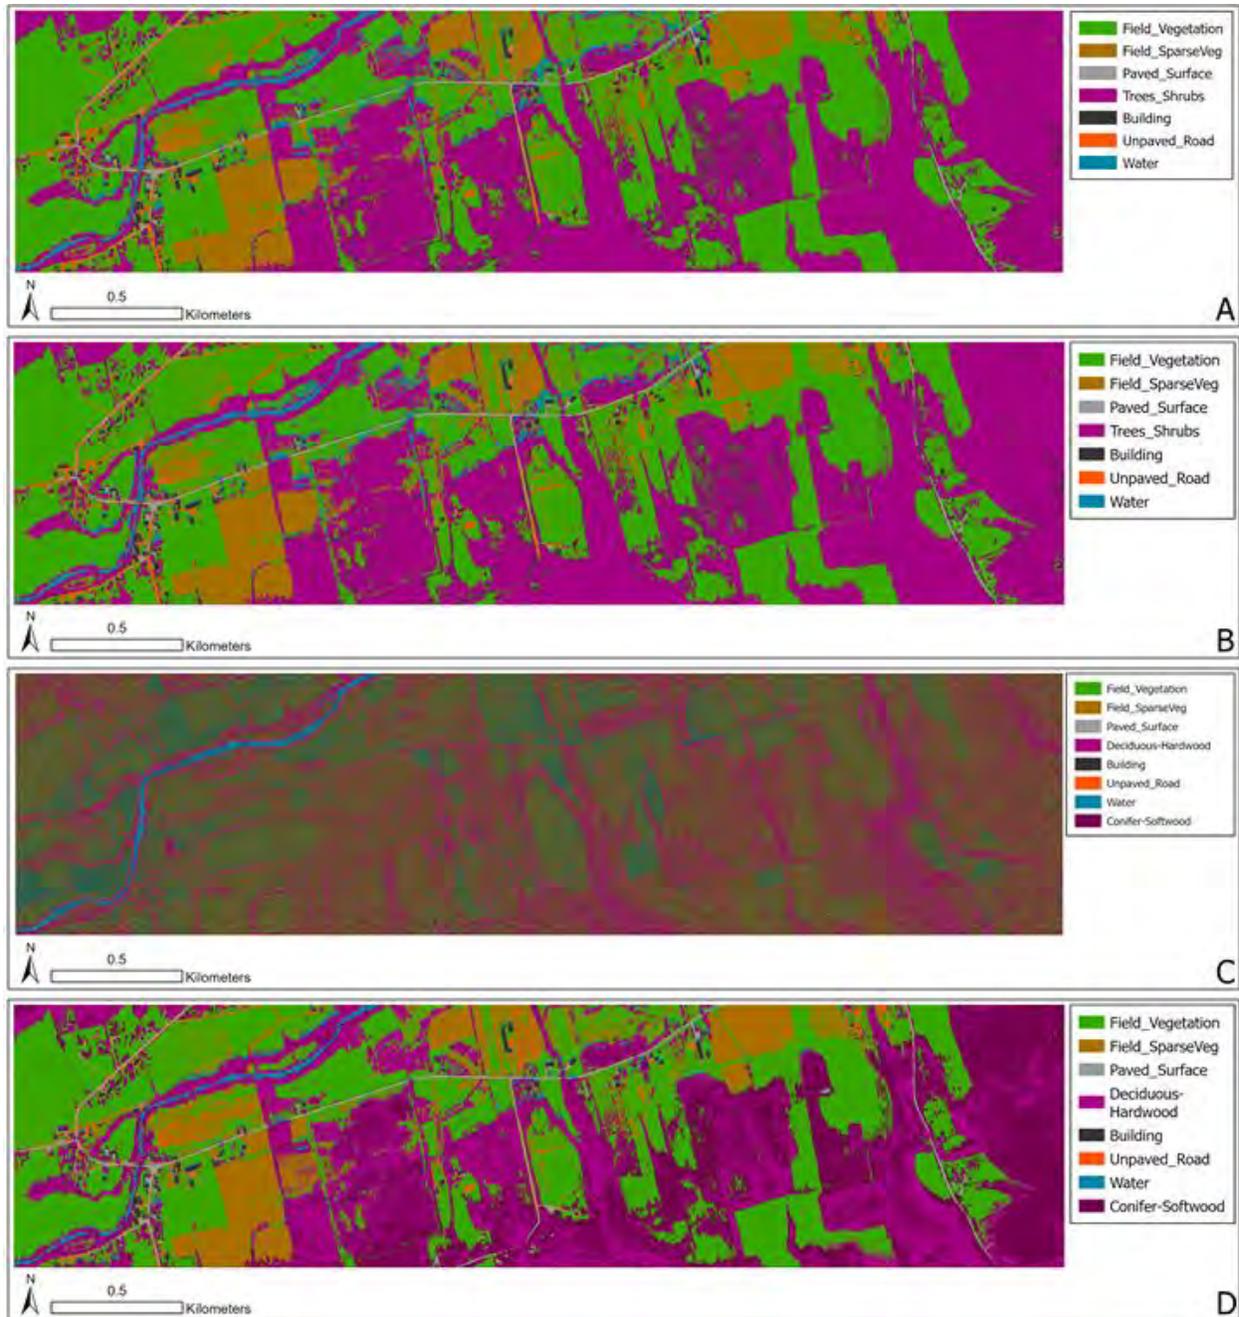
Figure 11. Results of four SVM classifiers, using different inputs and training data. A: CHM, DEM, and INT; B: Only CHM and INT; C: CHM, INT, and roughness; and D: CHM and INT with new training sites and distinction between soft and hardwood trees.

SVM results accuracies were assessed using random points within the validation data generated using the Create Accuracy Assessment tool within ArcGIS Pro. Confusion matrices were generated using the randomly sampled points to quantify errors between classes and identify problematic classes to guide model development in an iterative process. Initial results indicated that the CHM, DEM, and INT rasters produced acceptable SVM results (Figure 11). Further model iterations used only the CHM and INT rasters to determine the effect of the DEM's inclusion on the results as classes seemed to be unrelated to absolute elevation. The difference in results where the DEM was used (Figure 11A) or omitted (Figure 11B) were nearly imperceptible. When the roughness raster was added as an input the river was especially well classified, however each other class became inaccurate (Figure 11C). Based on the quality of the initial results additional forest training sites were added to the model and classes were defined for hardwood and softwood tree cover types. The added complexity did not negatively impact other classes and generated fewer misclassified building pixels in tree stands (Figure 11D).

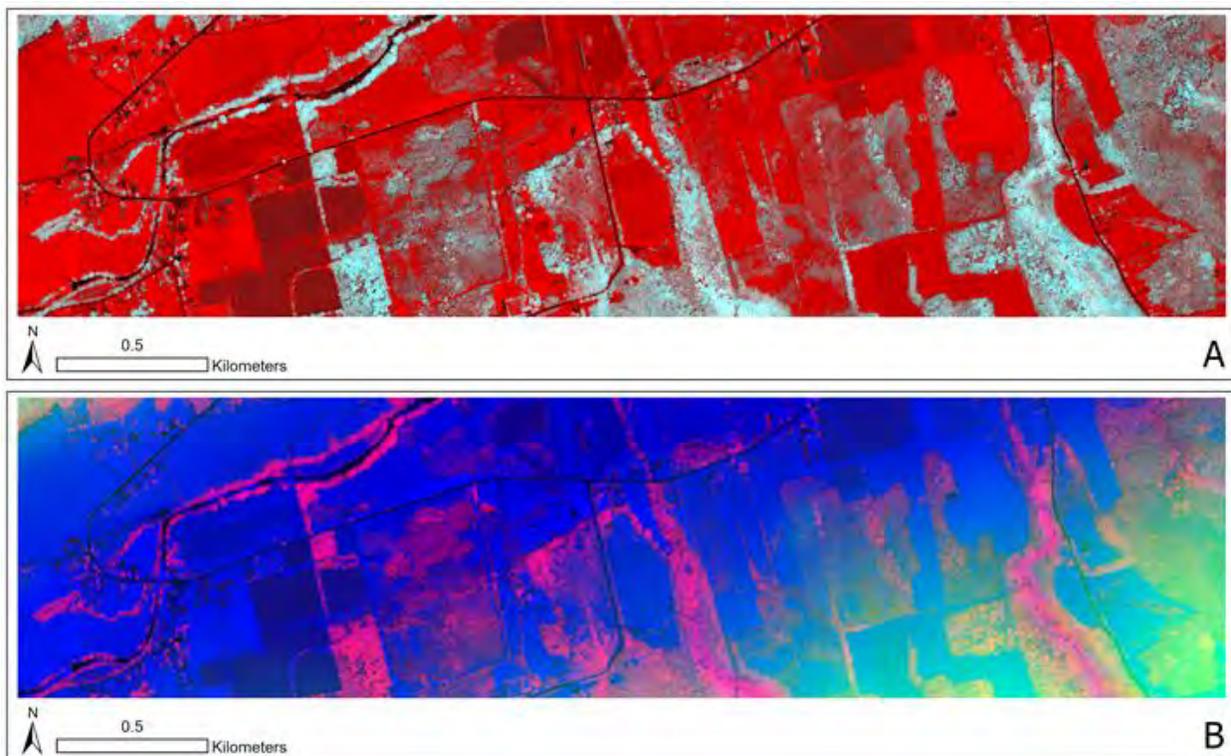
Figure 12. Two of the composites investigated for use with the SVM classifier. Note the colour change at the edges of B resulting from the inclusion of the DEM. A: Composite of the CHM and INT rasters; and B: Composite of the CHM, DEM, and INT rasters.

The iterative improvement process determined that the CHM and INT rasters provided the highest quality unique data to support classification. The CHM provided high contrast between the ground and tall objects such as buildings and trees, while the INT raster provided high contrast between areas of

vegetation, bare soils, and pavement. These were considered important factors when classifying impervious surfaces for the purpose of flood mapping (Figure 12).

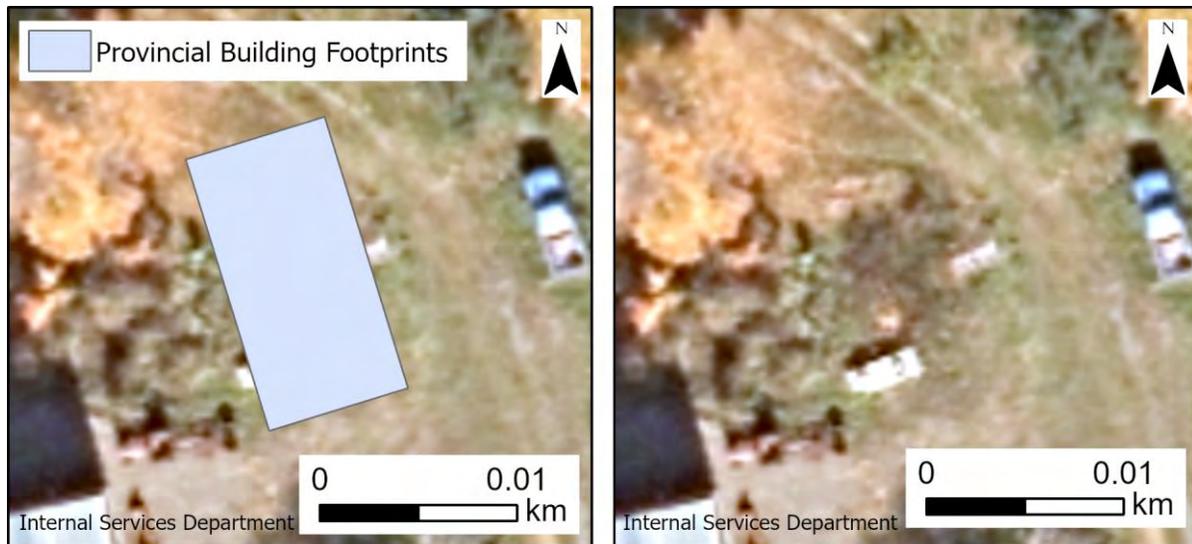
Figure 13. A comparison of a building footprint identified by the province with the 2015 orthoimagery used to digitize it.

The biggest source of missing footprints discovered during verification of the classification procedure was simply that the buildings were not present in the point cloud. Six buildings fell into this category, as confirmed by taking cross-sections corresponding to the location of each missing building footprint. Of these six buildings, five were also absent in the 2015 orthoimagery used to digitize the footprints. It is unknown why one building was present in the orthoimagery but absent in the digitized provincial footprints. Figure 13 and Figure 14 display the location and cross-section of a building absent in the orthoimagery but identified by the province.

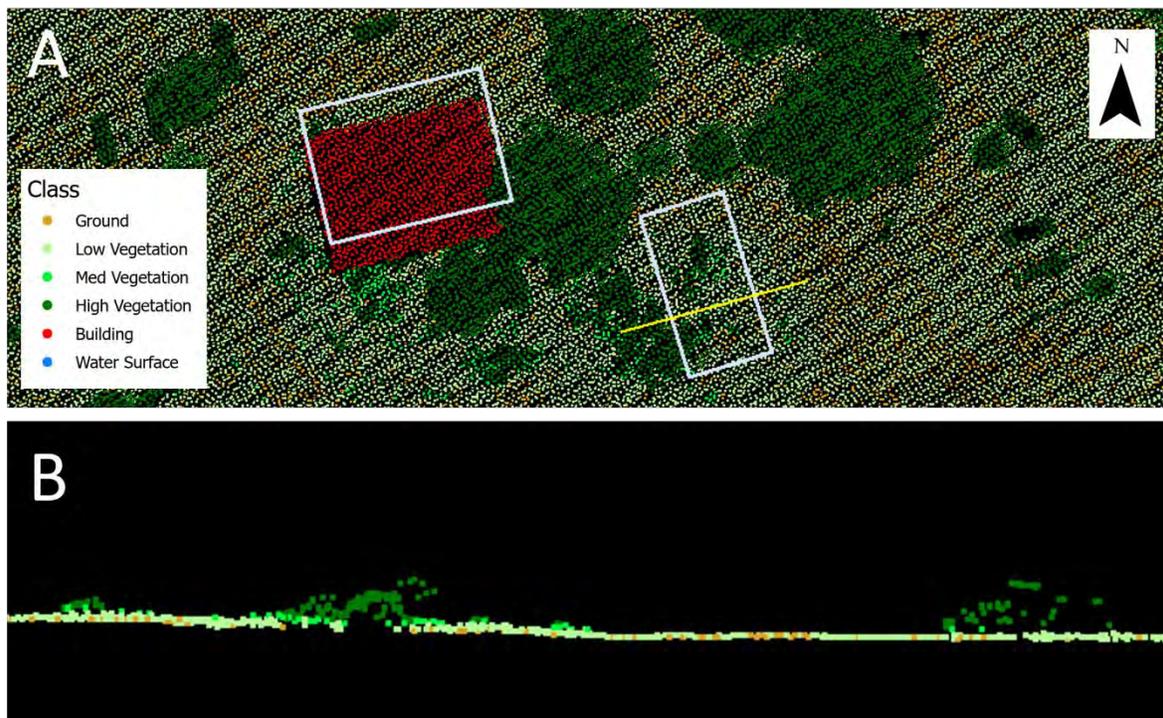
Figure 14. A cross-section of a building as identified by the province but not visible in the point cloud. The location of the cross-section (B) is symbolized by a yellow line (A). Provincial building footprints are symbolized with a white polygon (A).

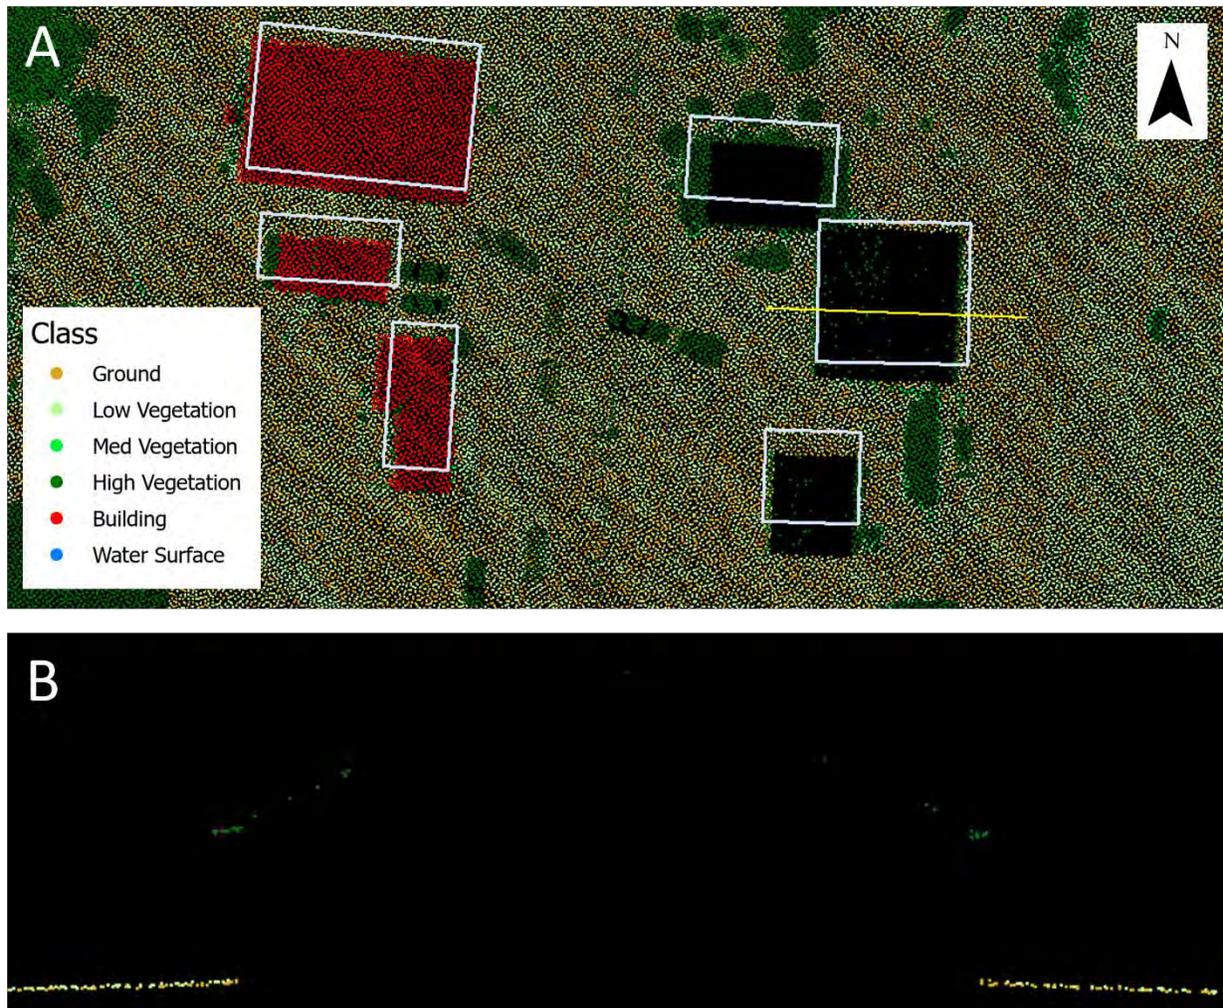
Figure 15. A cross-section of a building that was excluded from the automated building classification due to sparse lidar points. The location of the cross-section (B) is symbolized by a yellow line (A). Provincial building footprints are symbolized with a white polygon (A).

Four buildings could not be classified with the automated routine due to a sparsity in high vegetation points corresponding to buildings. Figure 15 shows a cross-section of a building with insufficient point density for classification. Asphalt shingles do not generally produce high amplitude lidar returns as a large portion of the pulse energy is absorbed or reflected away from the sensor. Consistent collection of these features requires proper system operation and an adequate lidar pulse strength.
