Analysis of Lidar Data for Improved Flood Risk Mapping:

Enhanced Lidar Point Cloud Classification and Product Development

Nova Scotia Community College
Applied Geomatics Research Group
NSCC, Middleton, NS
Tel. 902 825 5475
Email: timothy.webster@nsc.ca

Colin MacDonald
Director, Geographic Information Services
ICT Services, Internal Services Department
Government of Nova Scotia
5161 George St.
Halifax, NS B3J 2Y1
March 31st, 2022

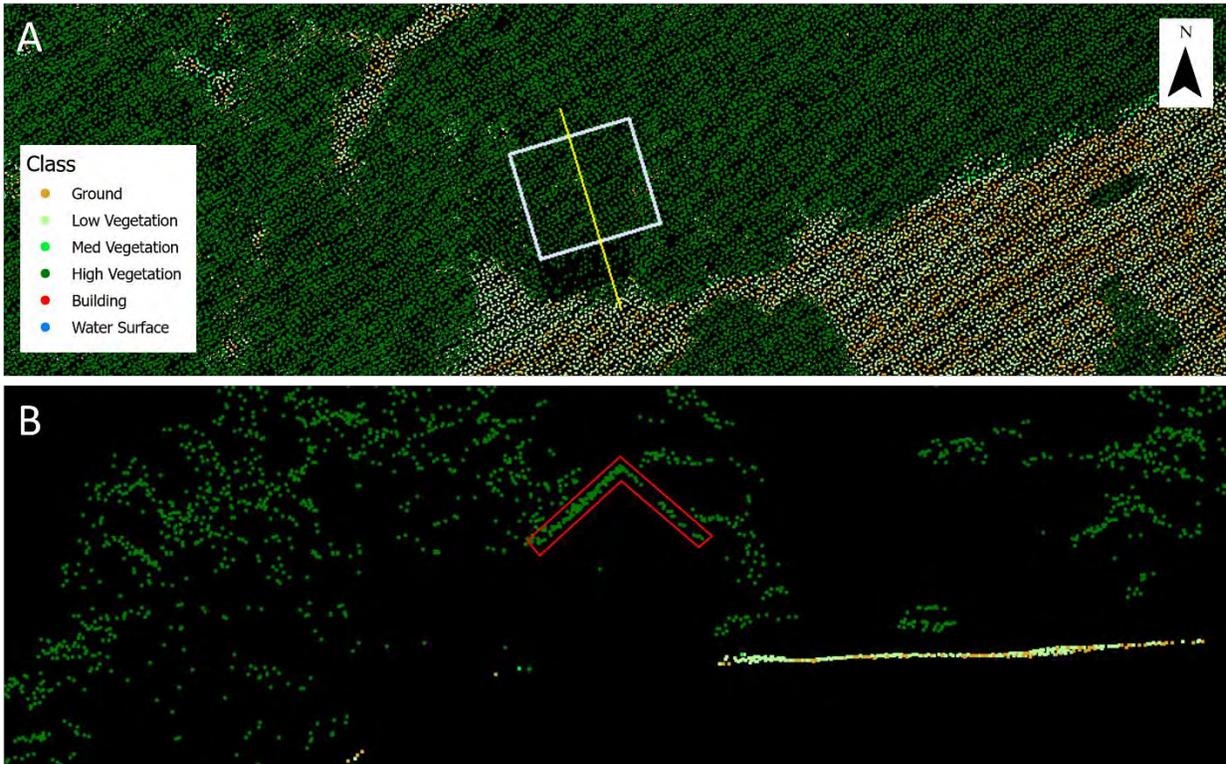
Figure 16. A cross-section of a building left unclassified by the automated routine due to partial occlusion of the roof. The location of the cross-section is symbolized by a yellow line (A) and the probable location of building points is outlined in red (B). Provincial building footprints are symbolized with a white polygon (A).

Three buildings were not classified by the automated classification routine due to partial or complete occlusion of building points. Figure 16 shows the location of a building that could not be identified by the classification routine due to partial occlusion of the roof by trees.

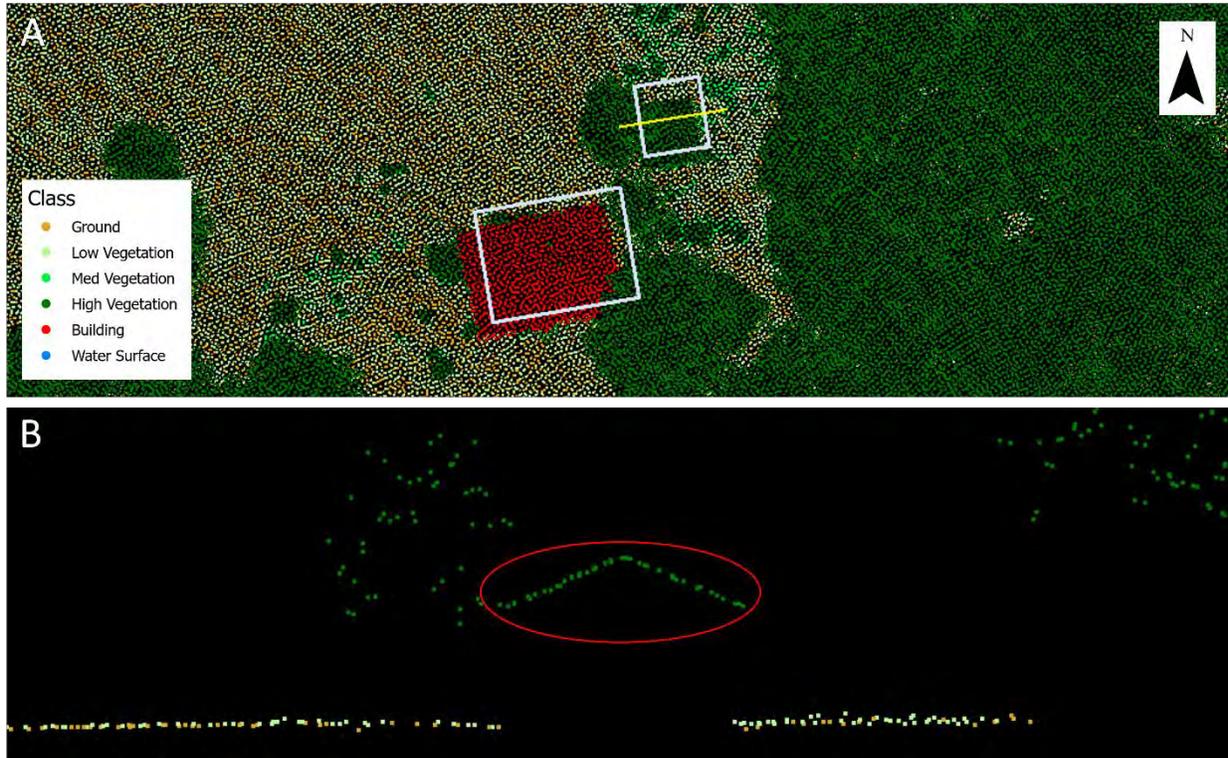
Figure 17. A cross-section of a building that was too small to be identified by the classification routine. The location of the cross-section is symbolized by a yellow line (A) and probable building points are circled in red (B). Provincial building footprints are symbolized with a white polygon (A).

Finally, three buildings were not classified due to being too small (<40 m²) to be identified by the classification routine. Figure 17 shows the location of a building approximately 30 m² in size.

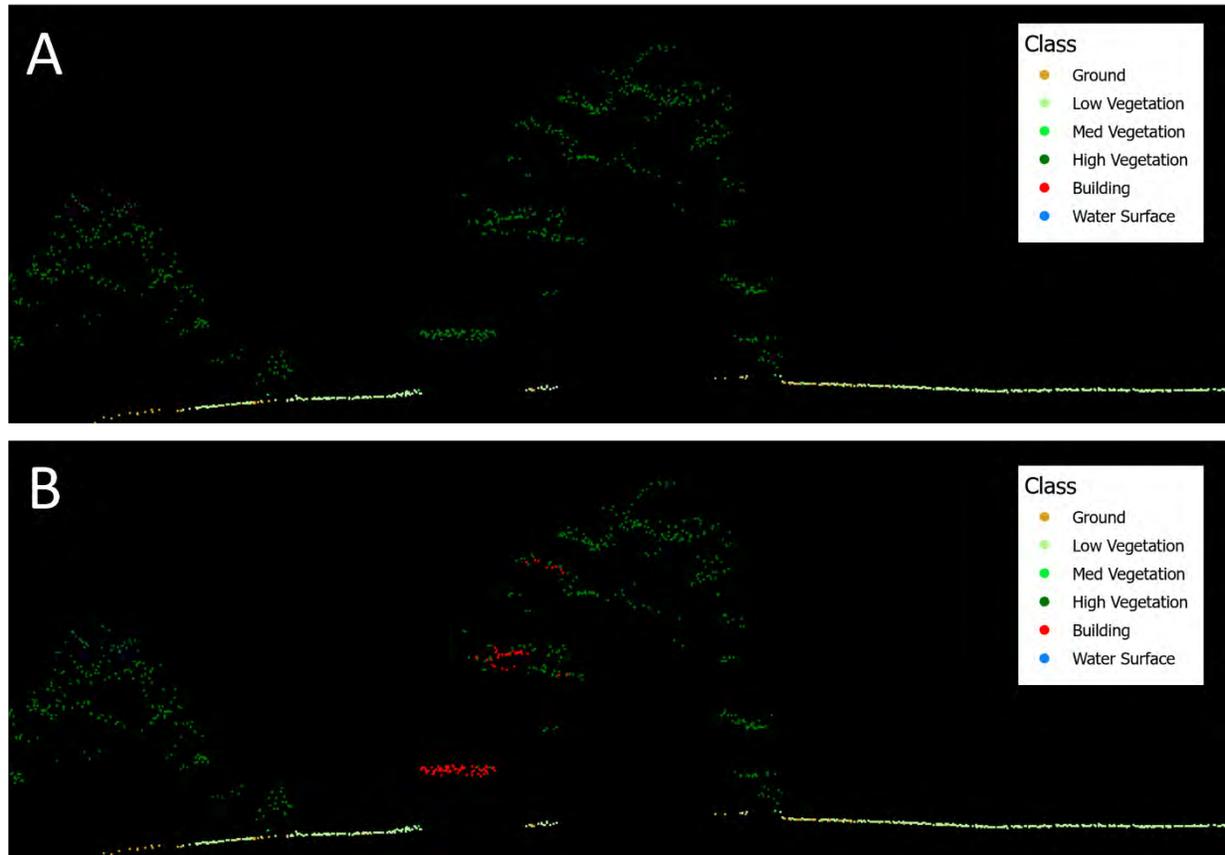
Figure 18. A cross-section of a tree after the automated building classification was conducted with a Very Strict parameter (A) and a Strict parameter (B).

The building classification routine was tested using parameters that ranged from very strict to very relaxed for how closely the points must follow a planar surface. It was determined that using strictest possible rules resulted in the fewest amount of erroneously classified points, therefore, decreasing the amount of time required for manual classification without significantly increasing the total processing time (Figure 18).

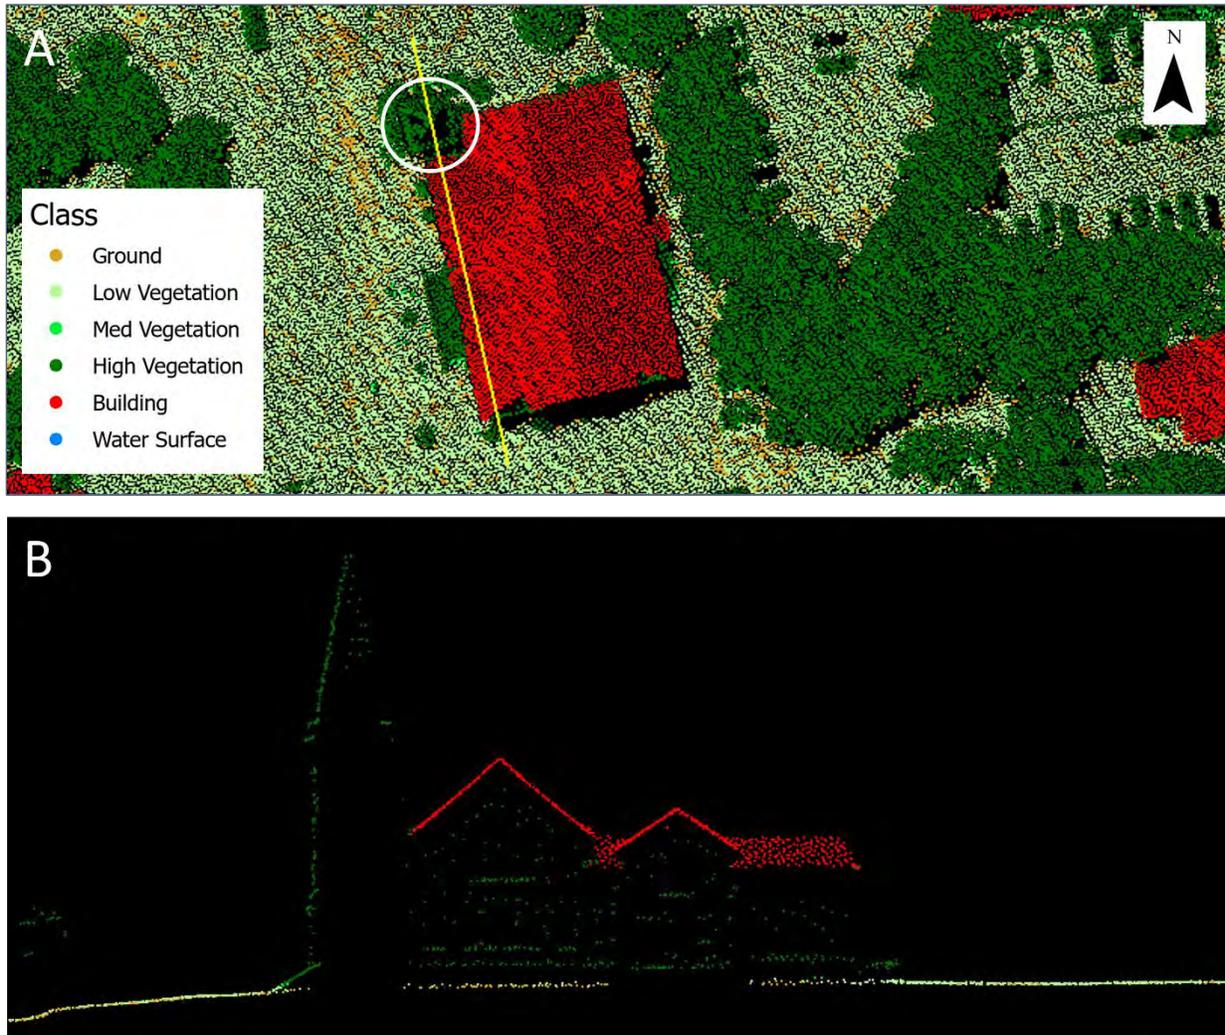
Figure 19. A cross-section of a church. The location of the cross-section (B) is symbolized by a yellow line (A). The location of the church steeple is circled in white (A).

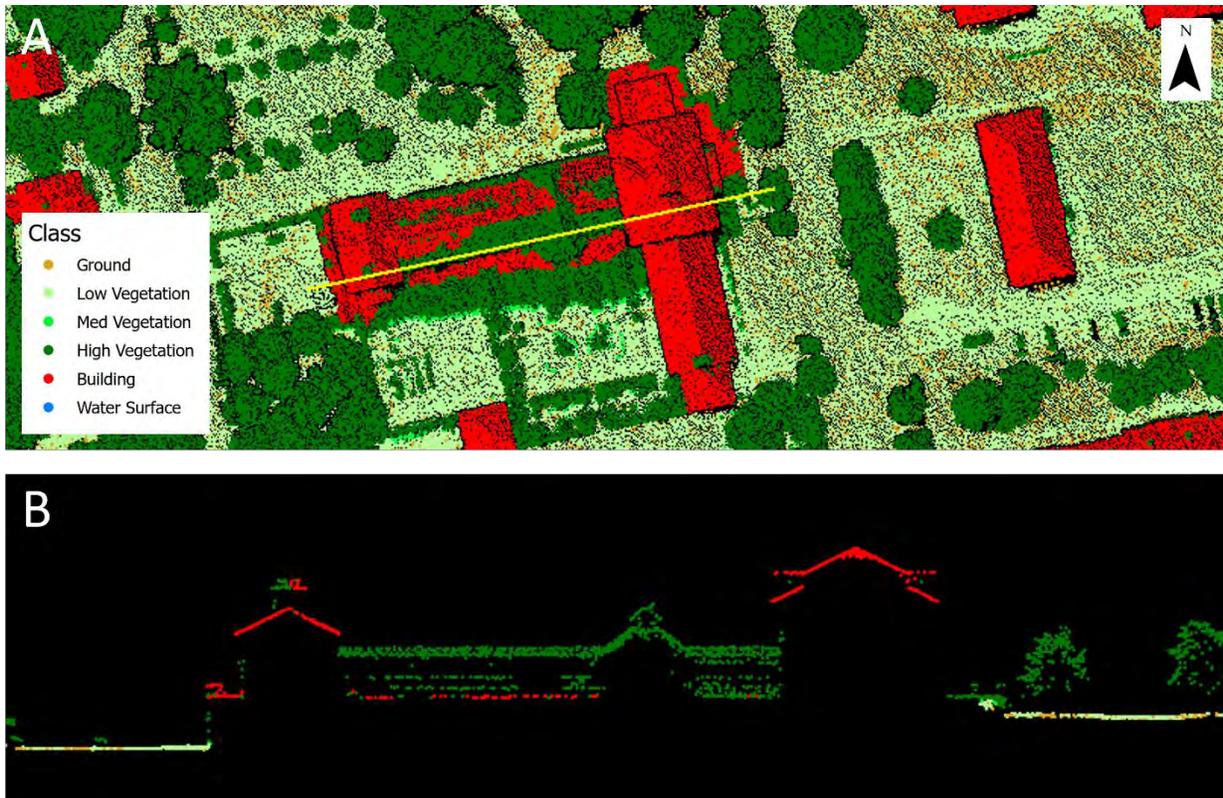
Figure 20. A cross-section of a greenhouse that failed to be accurately classified by the automated routine. The location of the cross-section (B) is symbolized by a yellow line (A).

greenhouses failed to be accurately classified by the automated routine due to an inability to detect a planar surface (Figure 20).

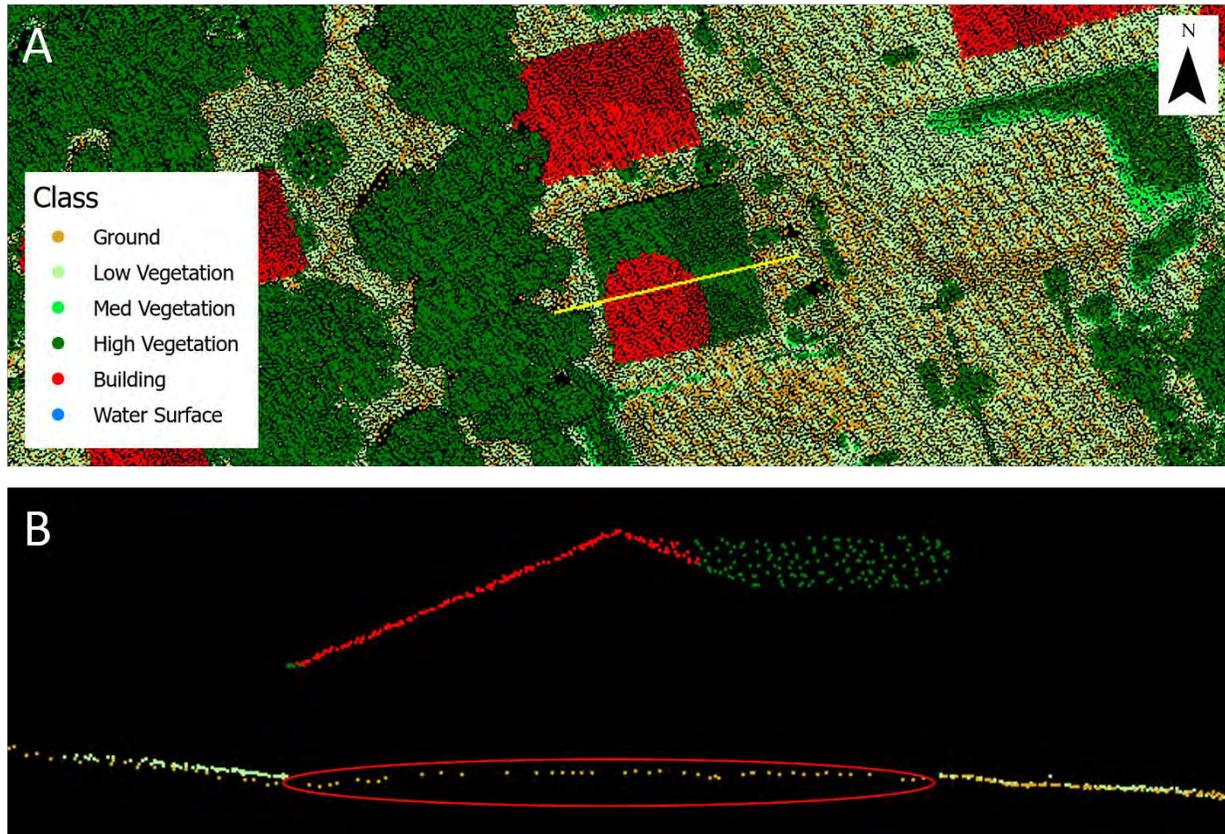
Figure 21. A cross-section of a building that was not entirely identified by the automated classification routine due to erroneous ground points underneath the building points. The location of the cross-section is symbolized by a yellow line (A) and ground points are circled in red (B).

As the detection of building points was based on empty areas in the ground class, an instance was noted where the presence of ground points led to a portion of a roof being excluded from classification (Figure 21). The accuracy of the ground classification was determined to be a critical variable for the building classification routine with difficulties arising when single LAS tiles contained data collected over a relatively large timeframe.

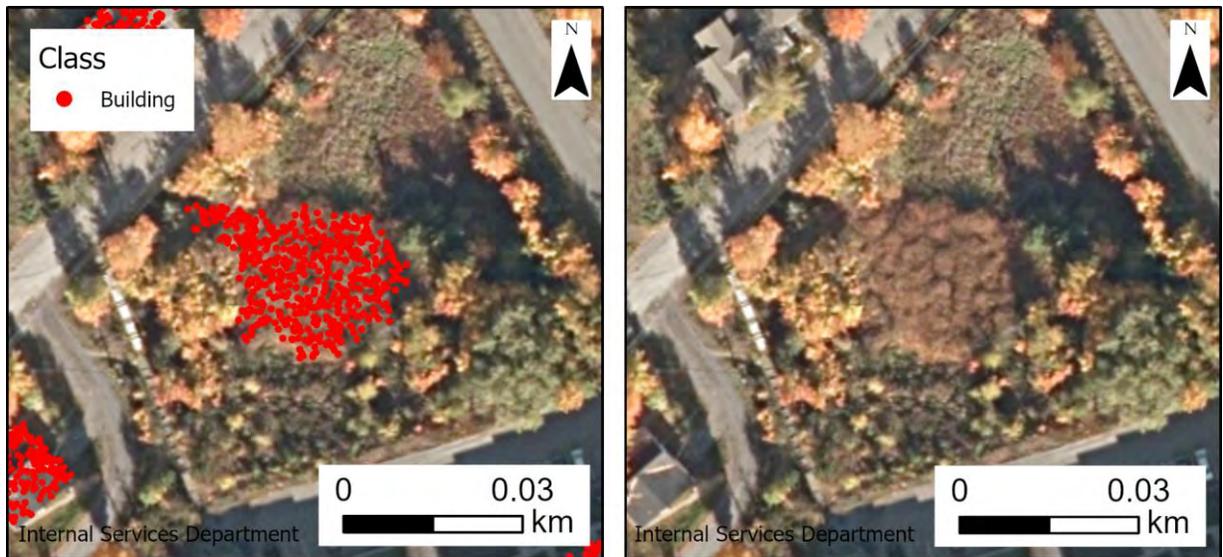
Figure 22. Maps showing the location of a group of misclassified building points in comparison to 2015 orthoimagery.

An instance of misclassification was observed where a dense cluster of high-vegetation points was classified as a building. A likely explanation for this error in classification is that the vegetation had a fairly uniform height, resulting in the routine detecting a planar surface (Figure 22; Figure 23).

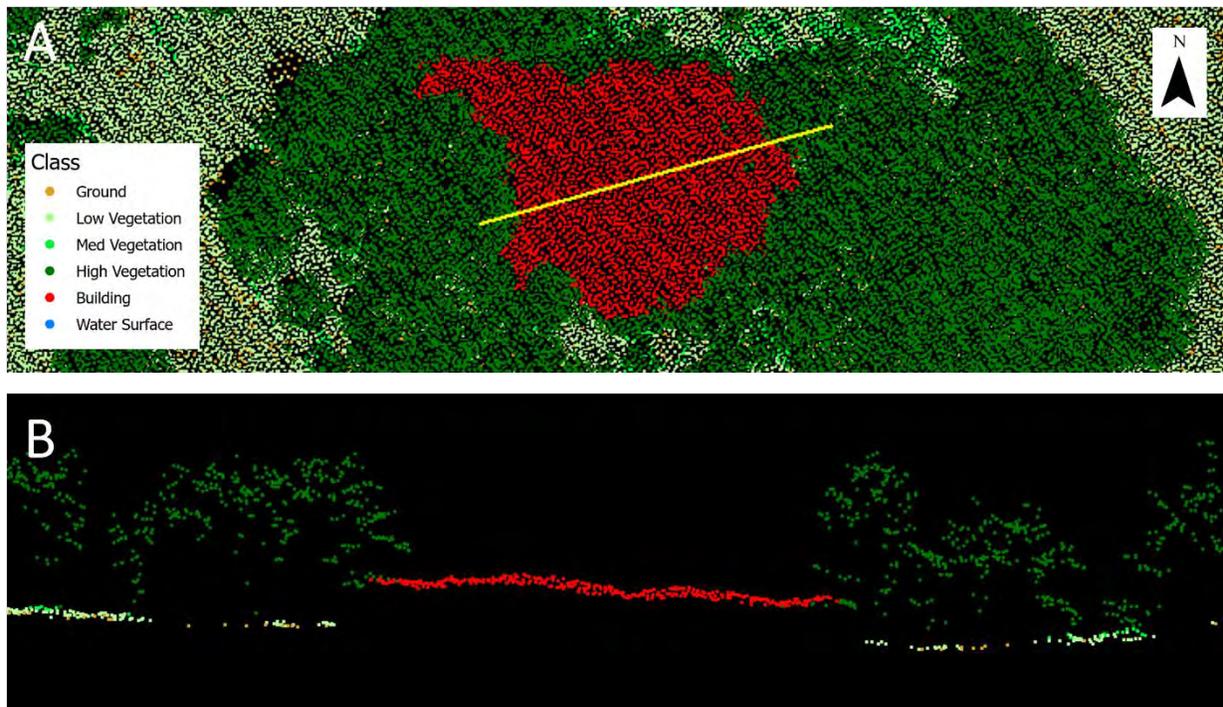
Figure 23. A cross-section of dense vegetation misclassified as a building by the automated routine. The location of the cross-section (B) is symbolized by a yellow line (A).

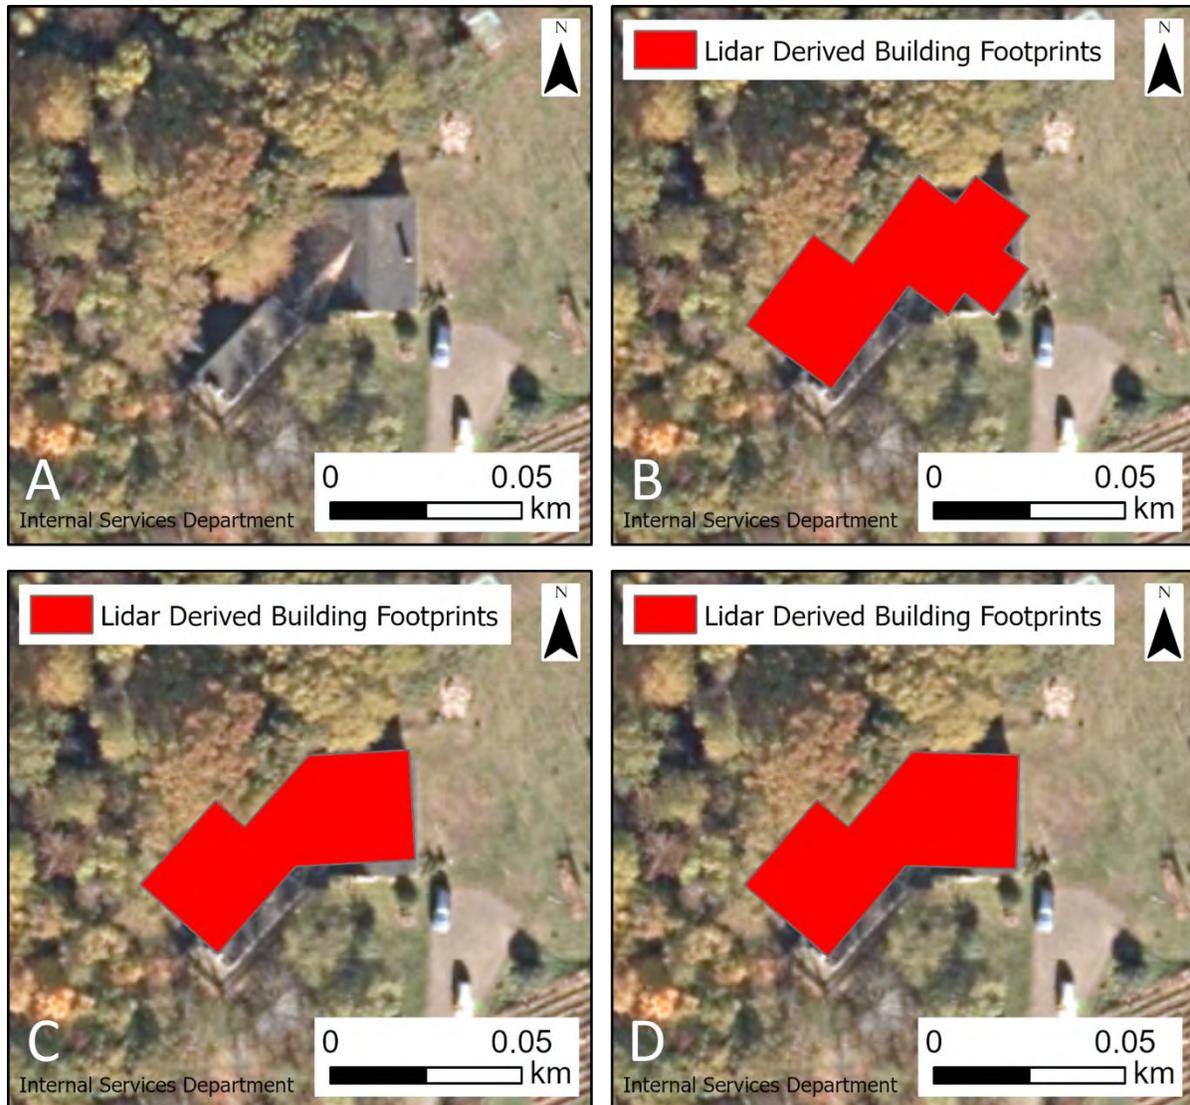
Figure 24. Maps showing a comparison between 2015 orthoimagery (A) and lidar-derived building footprints that have been regularized using right angles (B), right angles and diagonals (C), and any angle (D).

Different building footprint regularization methods were explored with the Regularize Building Footprint tool. The right angles method had the quickest processing time (Table 5), however, it was found to have a tendency to overgeneralize building footprints. Incorporating both 45° and 90° angles in the generation of polygons resulted in footprints that matched irregular building roofs more accurately. Allowing the construction of polygons using any identified angles, on the other hand, resulted in irregular footprints that didn't necessarily match the actual shape of the building roof. This method also required the most processing time and computational resources. Figure 24 and Figure 25 display a comparison of different building regularization parameters.

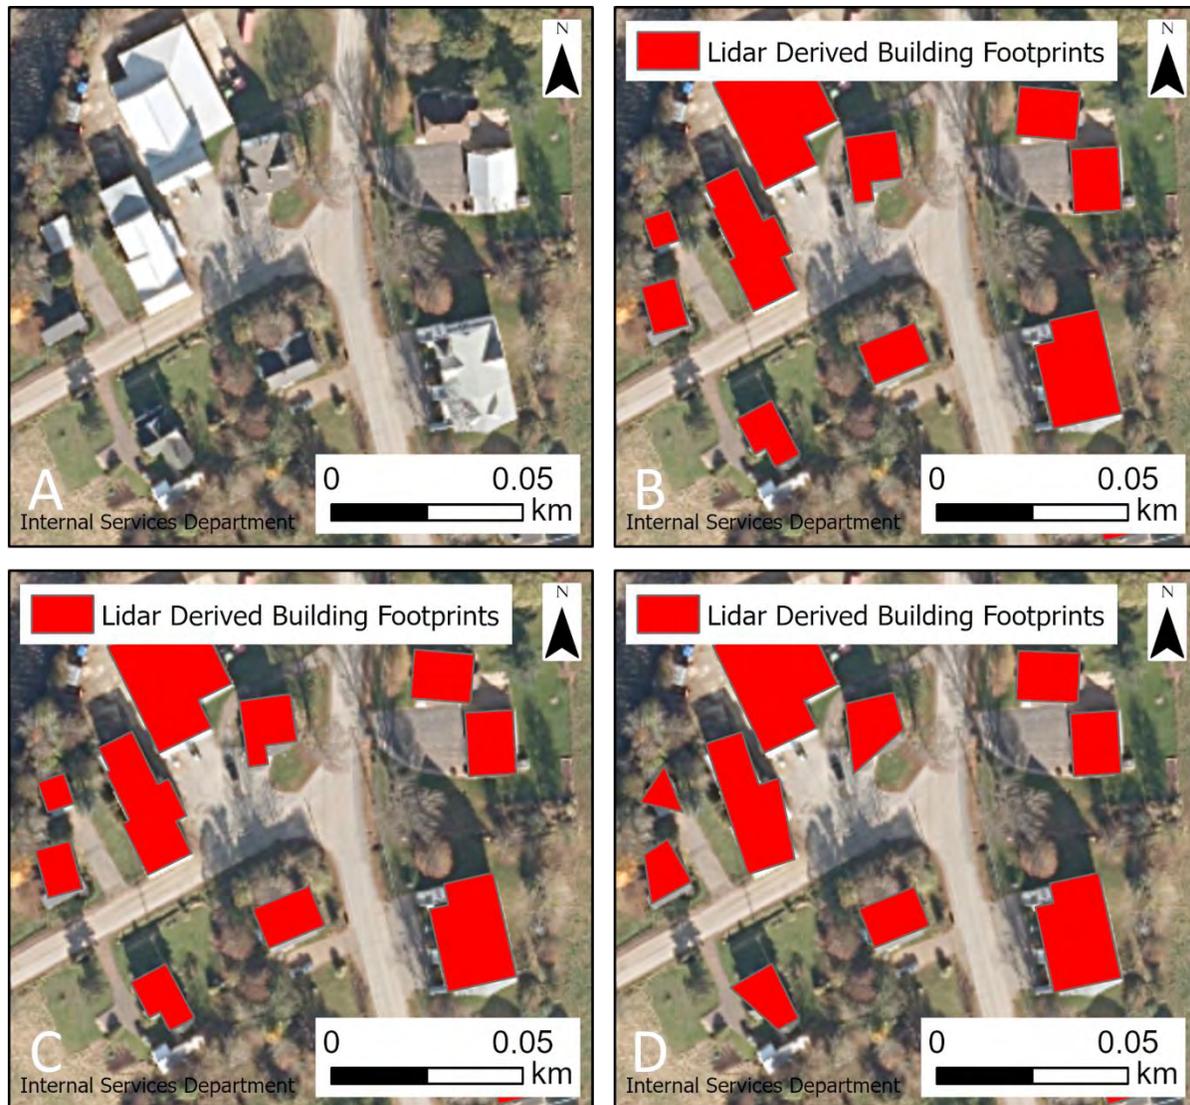
Figure 25. Maps showing a comparison between 2015 orthoimagery (A) and lidar-derived building footprints that have been regularized using right angles (B), right angles and diagonals (C), and any angle (D).

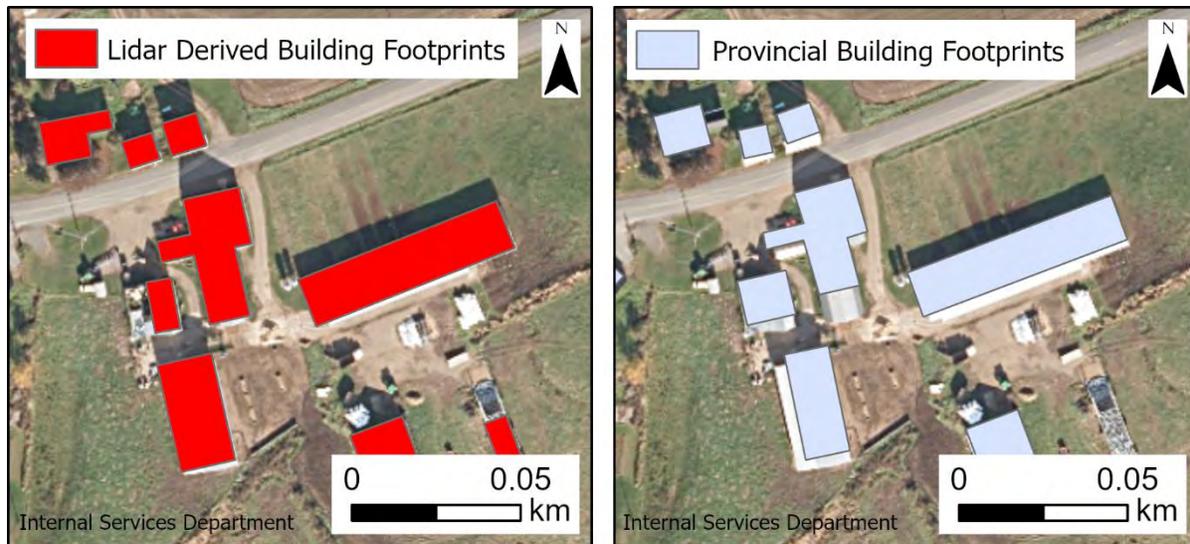
Figure 26. A side-by-side comparison of the lidar-derived and provincial building footprints.

The shapes of the lidar-derived building footprints were qualitatively assessed through comparison to 2015 orthoimagery acquired by the province. Overall, the building footprints showed a good representation of the building boundaries. The lidar-derived building footprints also tended to have a greater positional accuracy and provided a less generalized building roof shape in comparison to the provincial building footprints (Figure 26).

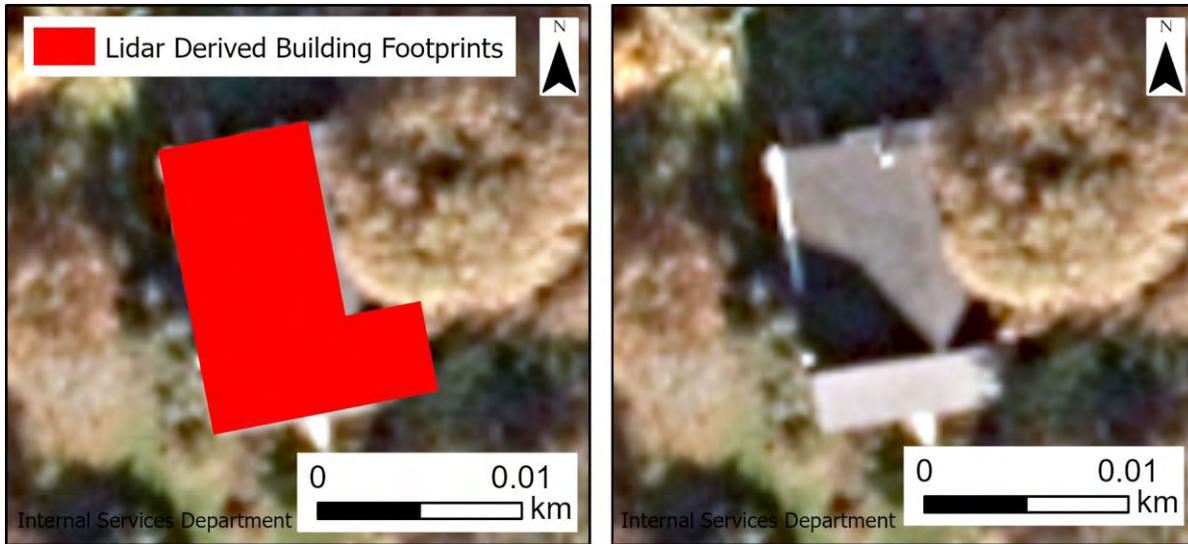
Figure 27. A comparison of a lidar-derived building footprint with 2015 provincial orthoimagery. Note the tree in the top right corner that partially covers the roof.

The building footprint regularization process worked best for buildings that had a simple roof shape and were not in close proximity (<1 m) to trees. The largest contributing factor to the generation of inaccurate lidar-derived building footprints was the presence of trees that partially covered the building roof. Lidar points that belonged to buildings were either too sparse or non-existent when situated underneath dense vegetation, resulting in these irregular building shapes. Figure 27 and Figure 28 show an example of a building footprint which did not accurately represent the true shape of the building roof due to partial coverage by a tree.

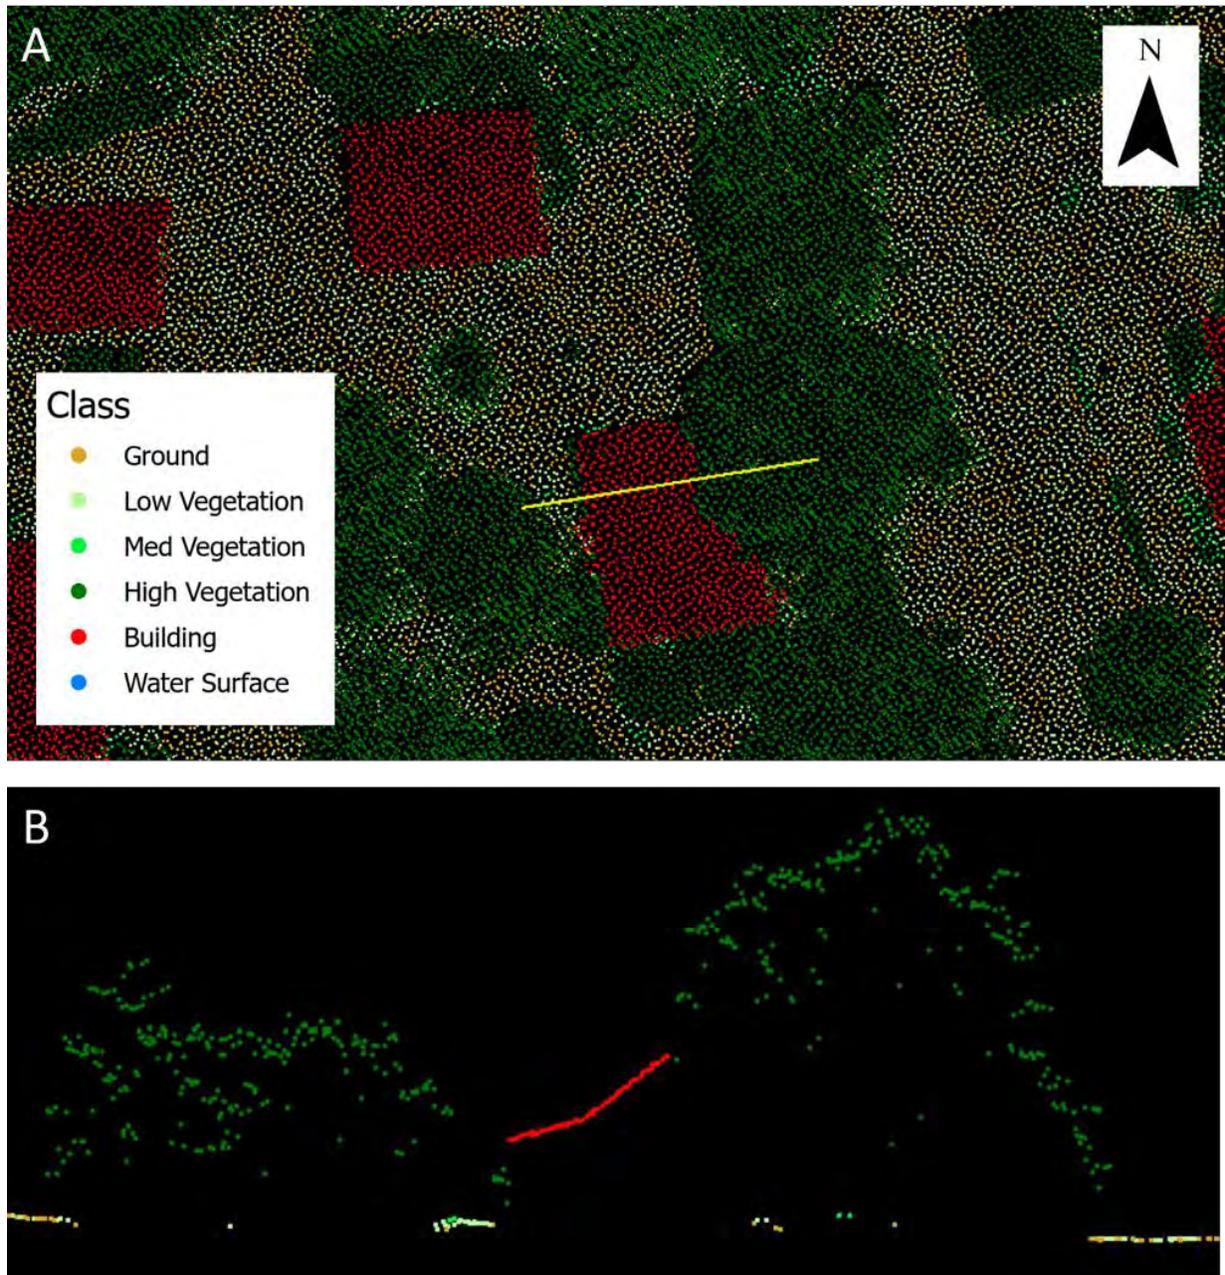
Figure 28. A cross-section of a building that is partly covered by high vegetation points. The location of the cross-section (B) is symbolized by a yellow line (A).

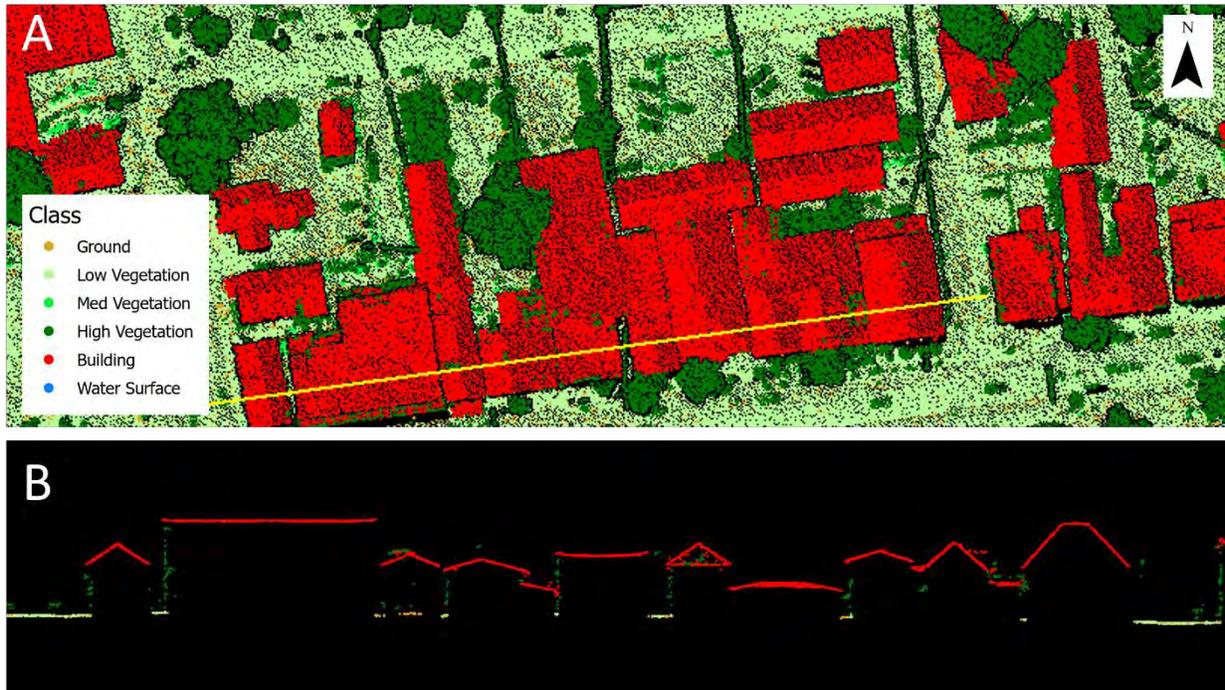
Figure 29. A cross-section of several buildings with adjacent or near-adjacent roofs. The location of the cross-section (B) is symbolized by a yellow line (A).

A limitation of producing building footprints through lidar-derived methods was identified in the expanded study area, where there were buildings that were adjacent or in very close proximity (< 0.5 m) to one another. Figure 29 and Figure 30 show a cluster of buildings that have resulted in one merged footprint representing the elevation values of several buildings.

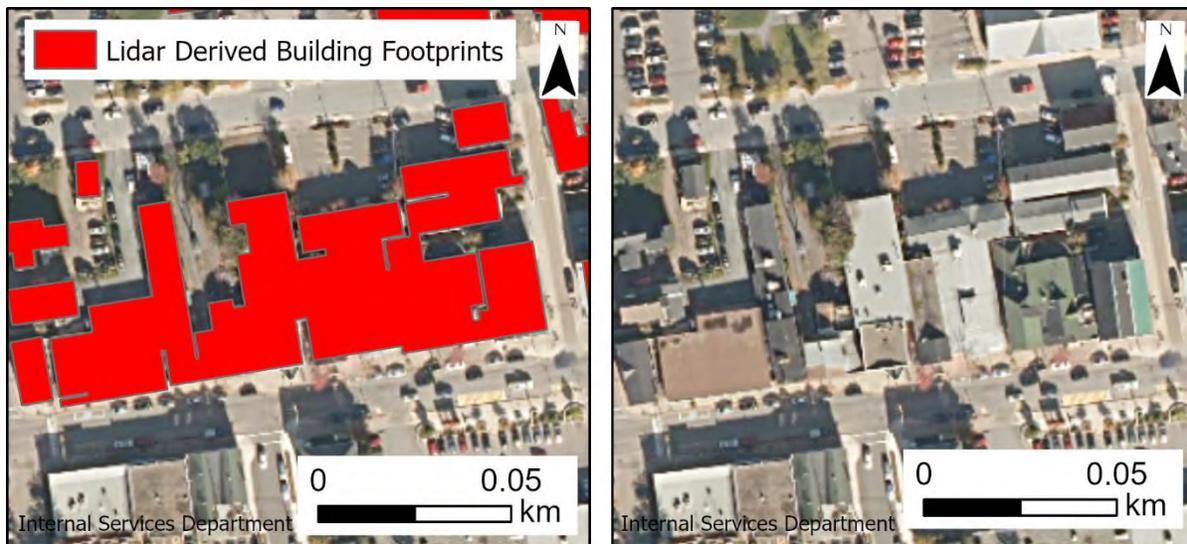
Figure 30. A building footprint that represents several buildings in very close proximity to one another.

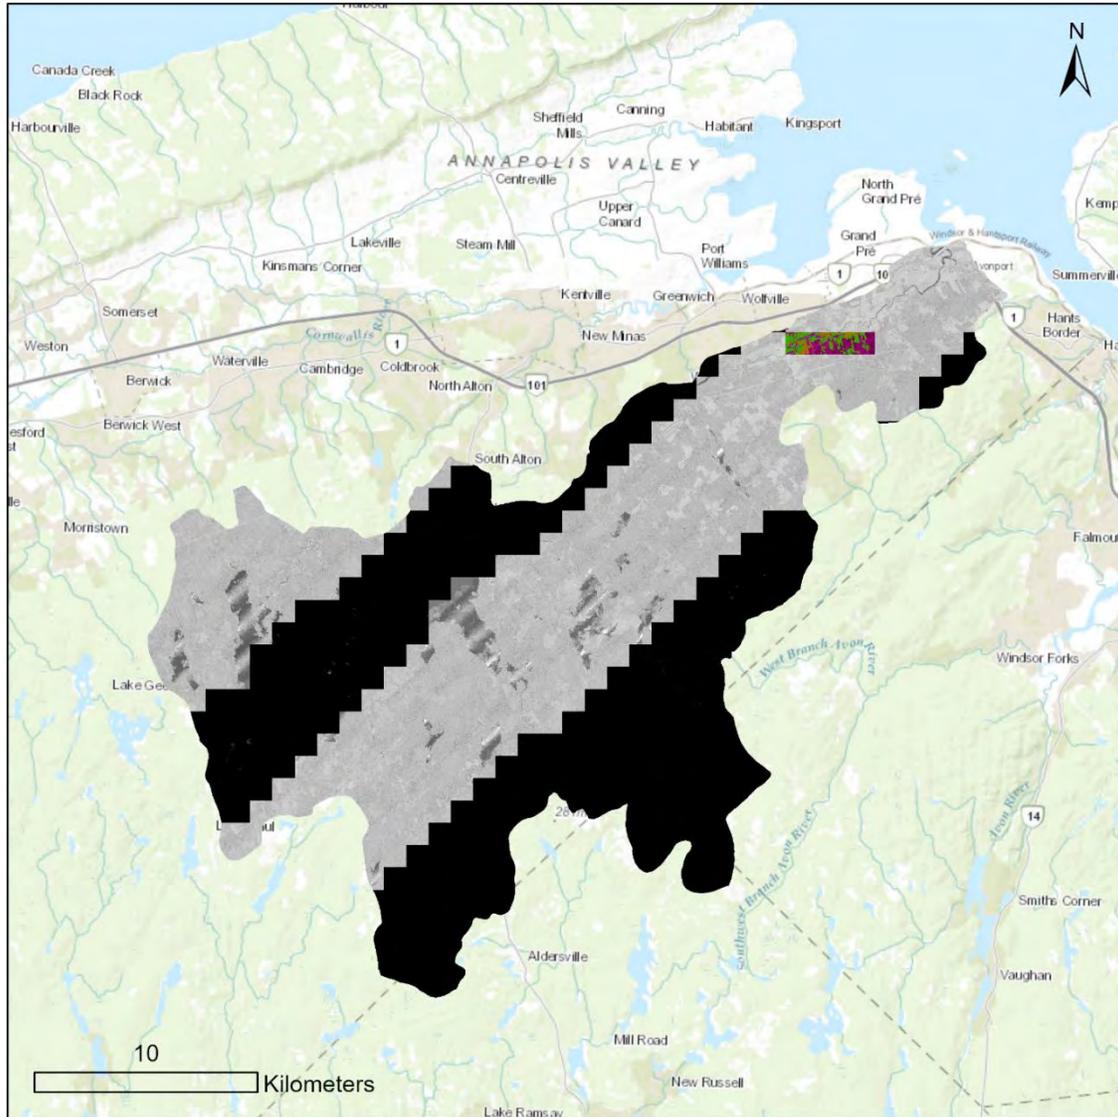
Figure 31: Overview of the full Gaspereau River – Black River watershed INT raster to demonstrate issues with the data. Classified training area overlaid for context.

Large scale classification was investigated at the level of the entire watershed. The SVM classification process is normally scalable and developed classifiers could be applied to a larger study area. However, issues were encountered where the intensity data from the lidar were not consistent between collection dates (Figure 31). Lidar intensity values collected during the 2020 collection were recorded at a much different scale when compared to the data collected during the 2019 collection. Lidar intensity values would need to be normalized prior to using the developed SVM classifier.
