# Drone Data Collection 2023: Big Lorraine Technical Report

The Nova Scotia Community College Applied Geomatics Research Group (NSCC-AGR) was contracted by Emera Newfoundland and Labrador to collect airborne imagery using drones to monitor the position of a critical breakwater at the Big Lorraine, NS grounding site. Drone survey data were successfully collected on October 14<sup>th</sup>, 2023. Quality assurance and control measures have validated that the collected data meet or exceed all project specifications and were accurate to +/-5 cm. Survey results were compared against positions collected by NSCC in August of 2022 to confirm that the breakwater position had remained consistent between surveys. A major storm event, hurricane Fiona, occurred between the two survey dates. While no signs of deformation were observed along the crest of the breakwater, large boulders were shifted, and a significant volume of material was deposited inland at the beach located east of the breakwater. It is possible that marine water was routed inside the control structure at the north tip of the east wall. If incursion is to be prevented, it is advised that the eastern breakwater be extended to t

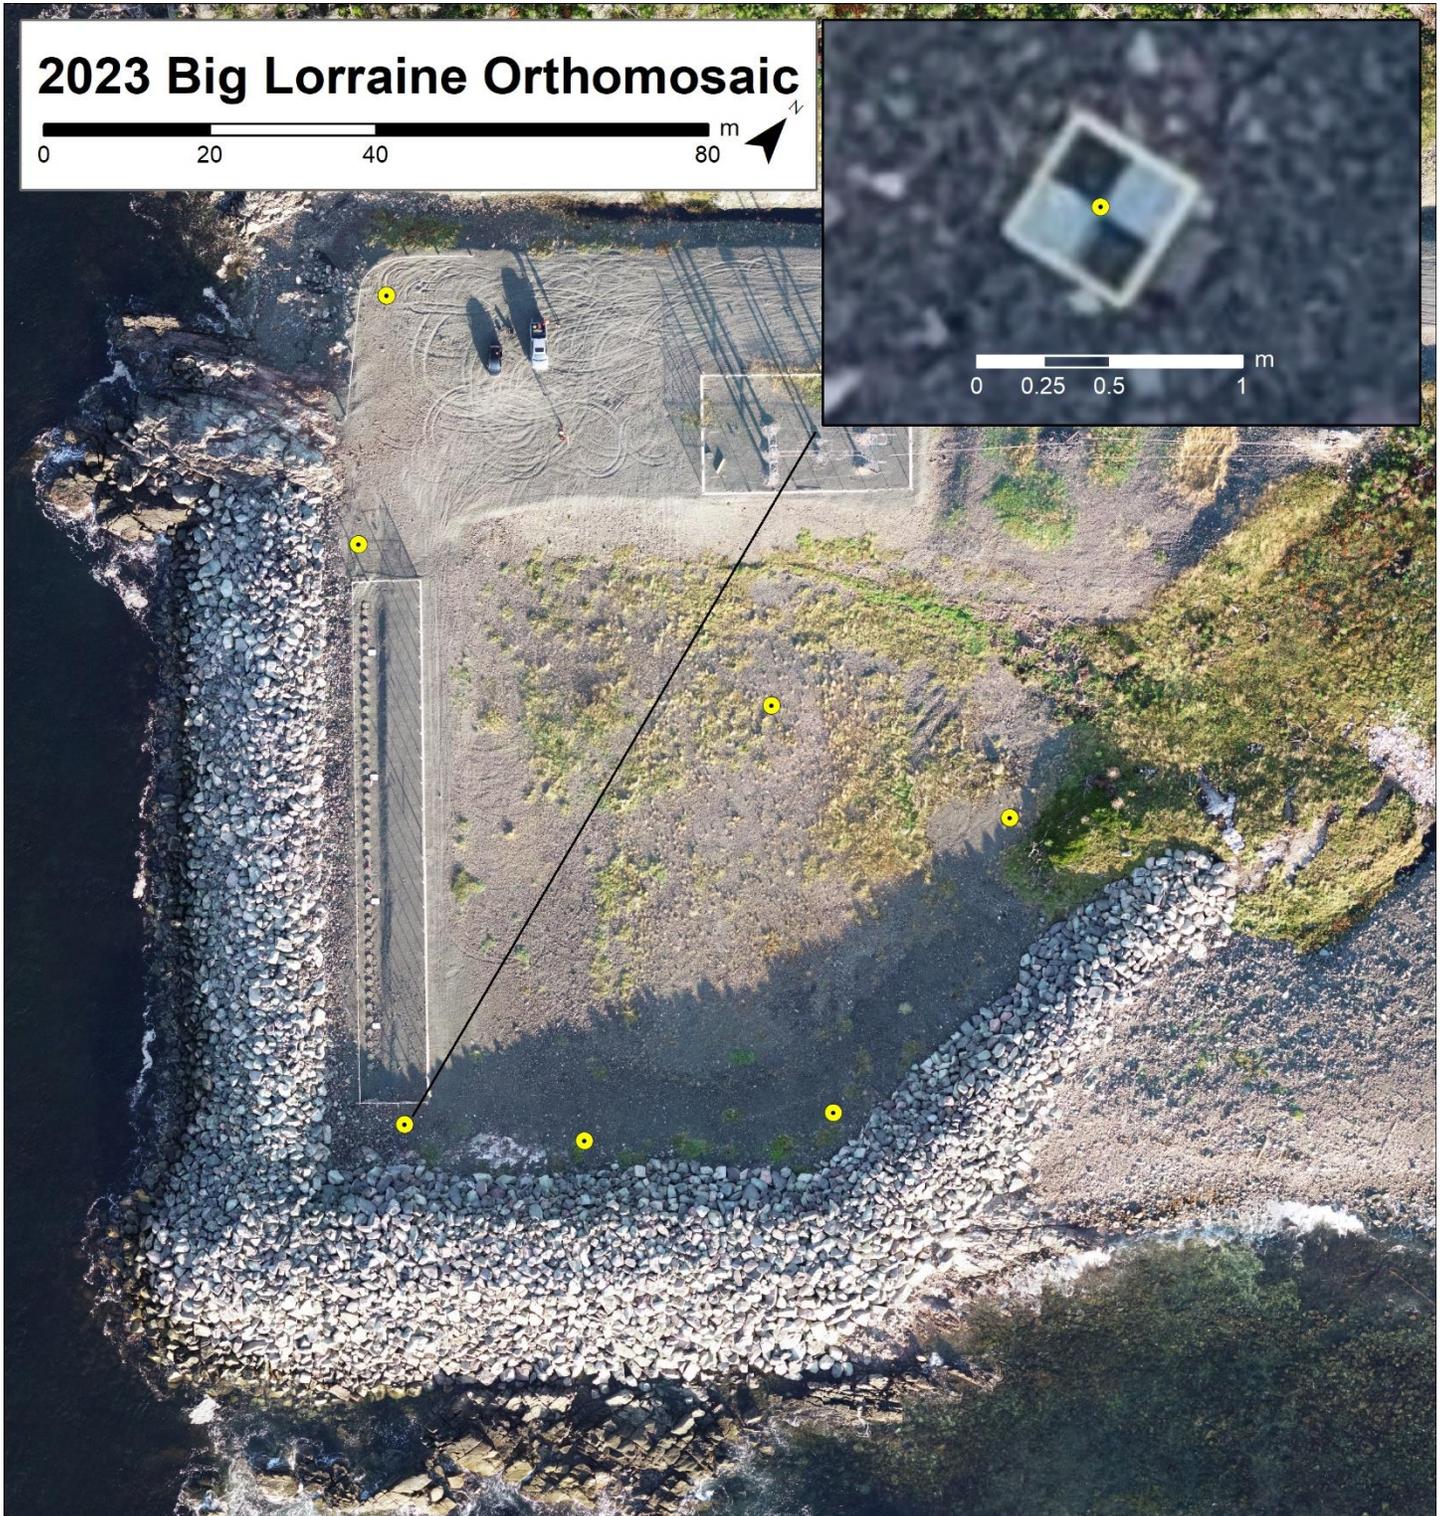
Image mosaics were found to be of acceptable quality. Shadowing was observed within the site due to the sunrise, but all imagery was found to be suitable for positioning and survey products were not impacted negatively (Figure 1).

Figure 1. Big Lorraine grounding site photo mosaic demonstrating excellent horizontal alignment over control targets.

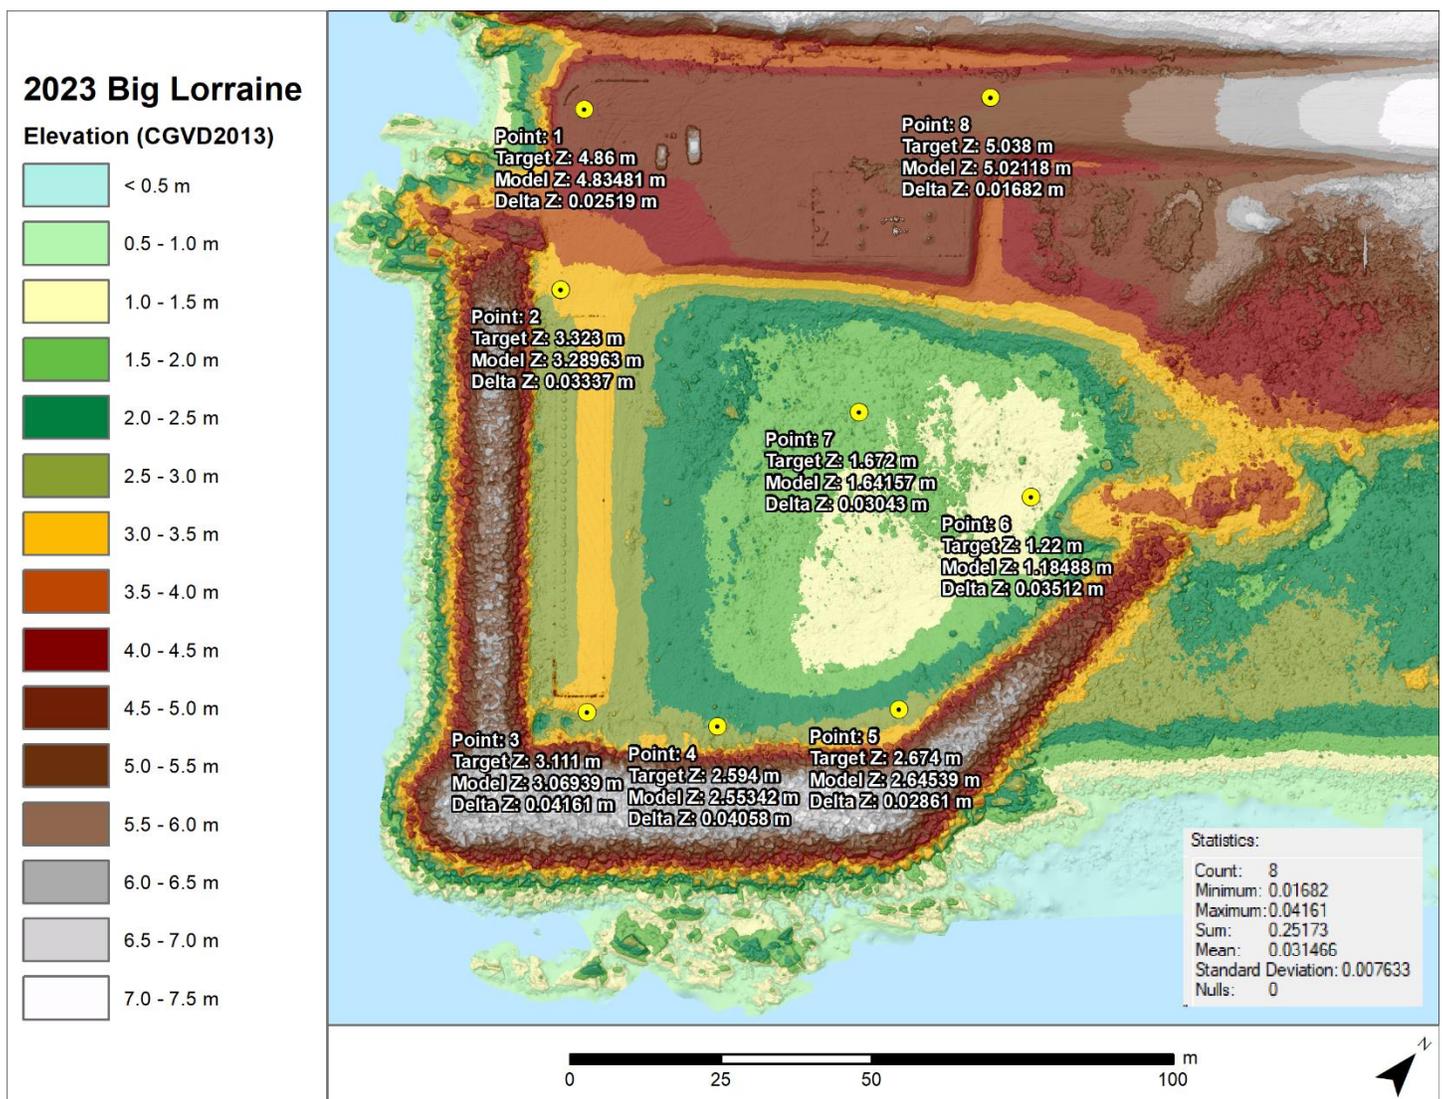
A digital surface model was generated by binning dense cloud elevation data at a resolution of 0.02 m. The resulting elevation model ranged from -1.0 m offshore to >10.0 m in elevated area north of the breakwater (Figure 2). Rasterized elevation data were validated using the GNSS control points. Elevation residuals were computed by subtracting the RPAS model elevations from the GNSS checkpoint elevations. Residuals ranged from -0.017 m to 0.042 m with a mean of 0.031 m and standard deviation of 0.008 m (Figure 2). Quality assurance and control measures validated that the collected data exceeded project specifications.

Figure 2. Colour graduated elevation model of the Big Lorraine site survey showing elevations along the extent of the breakwater structure and agreement with established checkpoints.

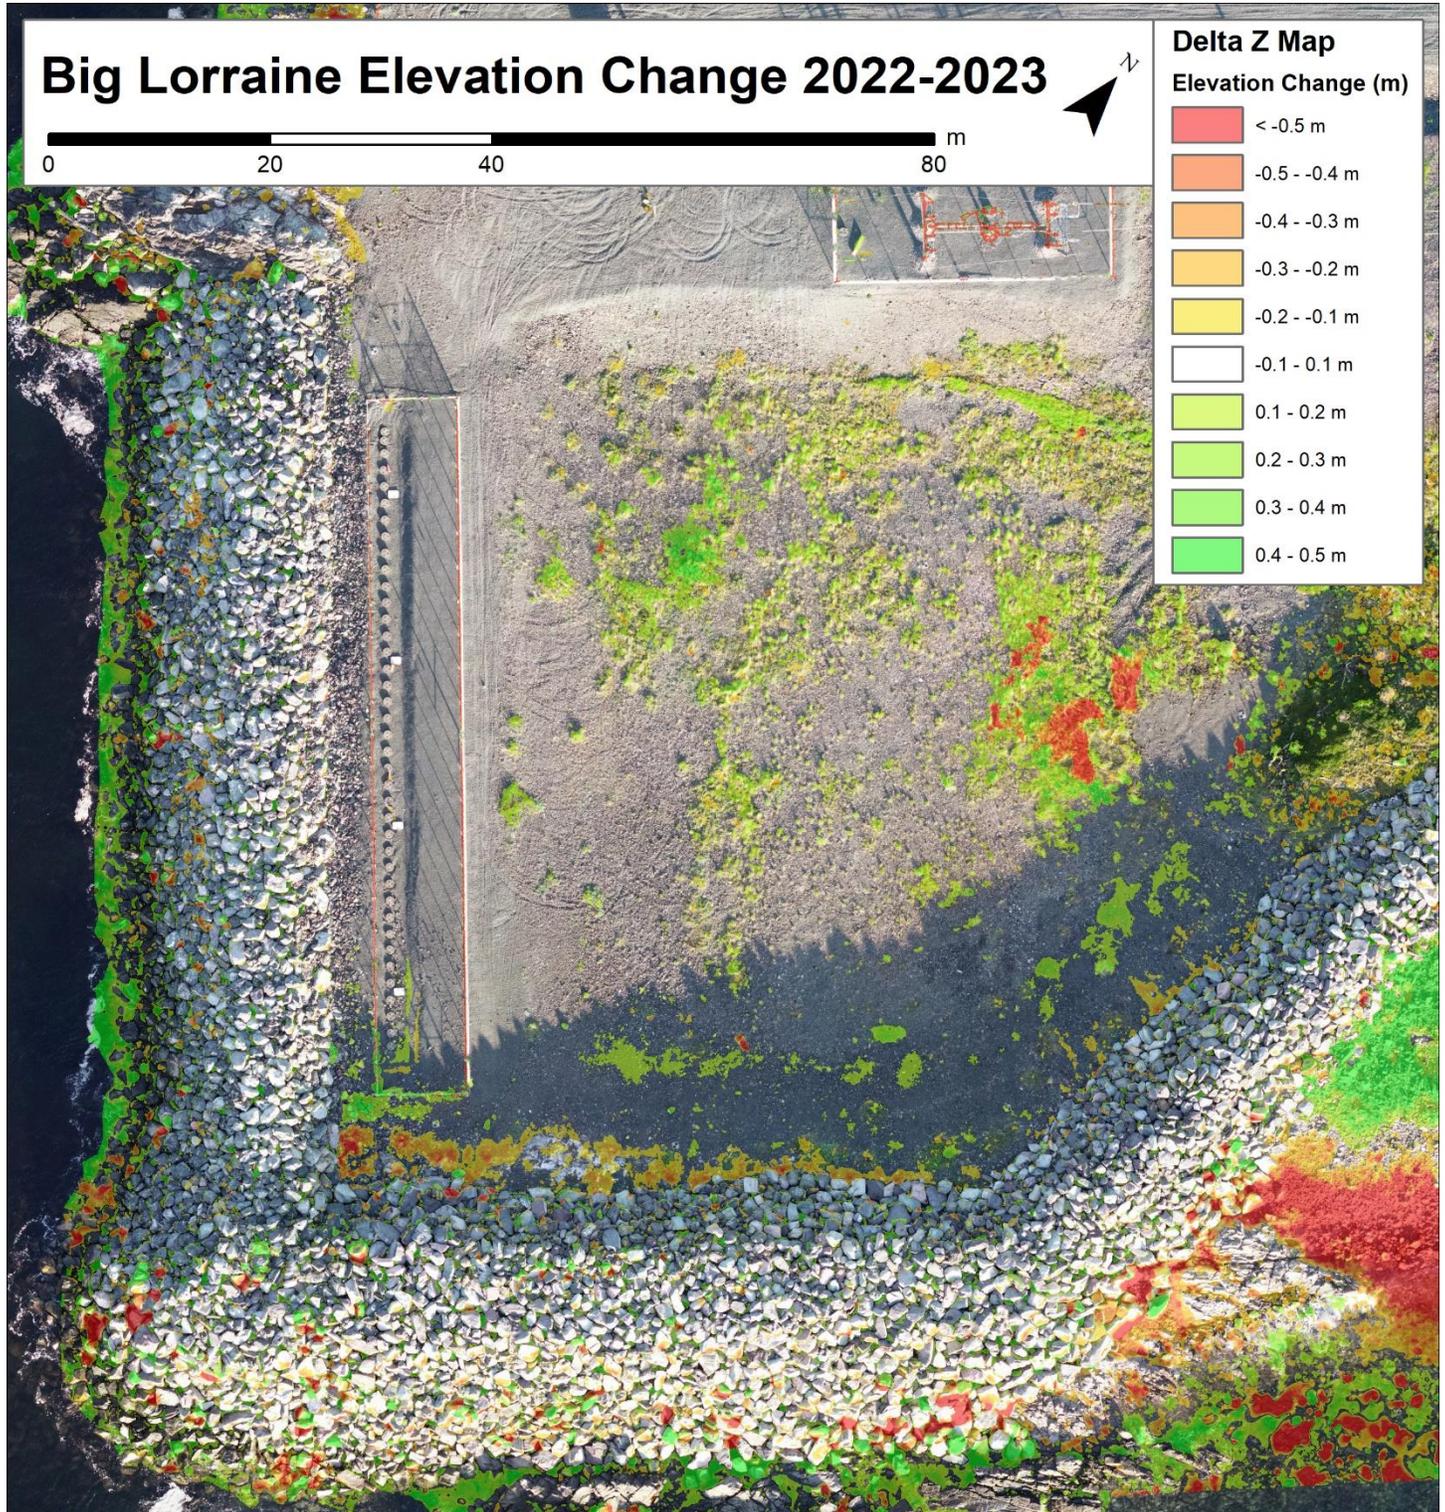
A baseline position of the Big Lorraine breakwater was successfully established during the 2022 survey. 2023 survey elevations were produced and assessed to determine if the breakwater position had changed between 2022 and 2023. Direct comparison of accurately georeferenced elevations demonstrated that no significant portion of the breakwater had shifted more than 10 cm between 2022 and 2023 (Figure 3).

Figure 3. Comparison of 2022 and 2023 survey elevations. Negative values (red scale) denote a loss of material.

No significant elevation changes of the breakwater crest were observed between 2022 and 2023. Elevation differences were observed for individual boulders primarily located on the oceanward of the breakwater, and a large portion of the beach east of the breakwater. It is possible that water was routed behind the breakwater at the lowest points on the north corner of the east wall. In 2022, this unfortified area contained a natural high point > 4 m in elevation with lower sections located to the north and south at elevations of 3.0 - 3.5 m and 3.5 – 4.0 m respectively (Figure 7). In 2023, material loss was measured in the low section on the northern tip of the east wall, south of the natural high point, where the elevation was lowered by roughly 0.8 m. The material may have been removed by water entering the controlled area during the event that caused the beach movement, likely Fiona (Figure 8). Additional protection may be required in the low sections identified north of the breakwater to prevent incursion of water during storm events.

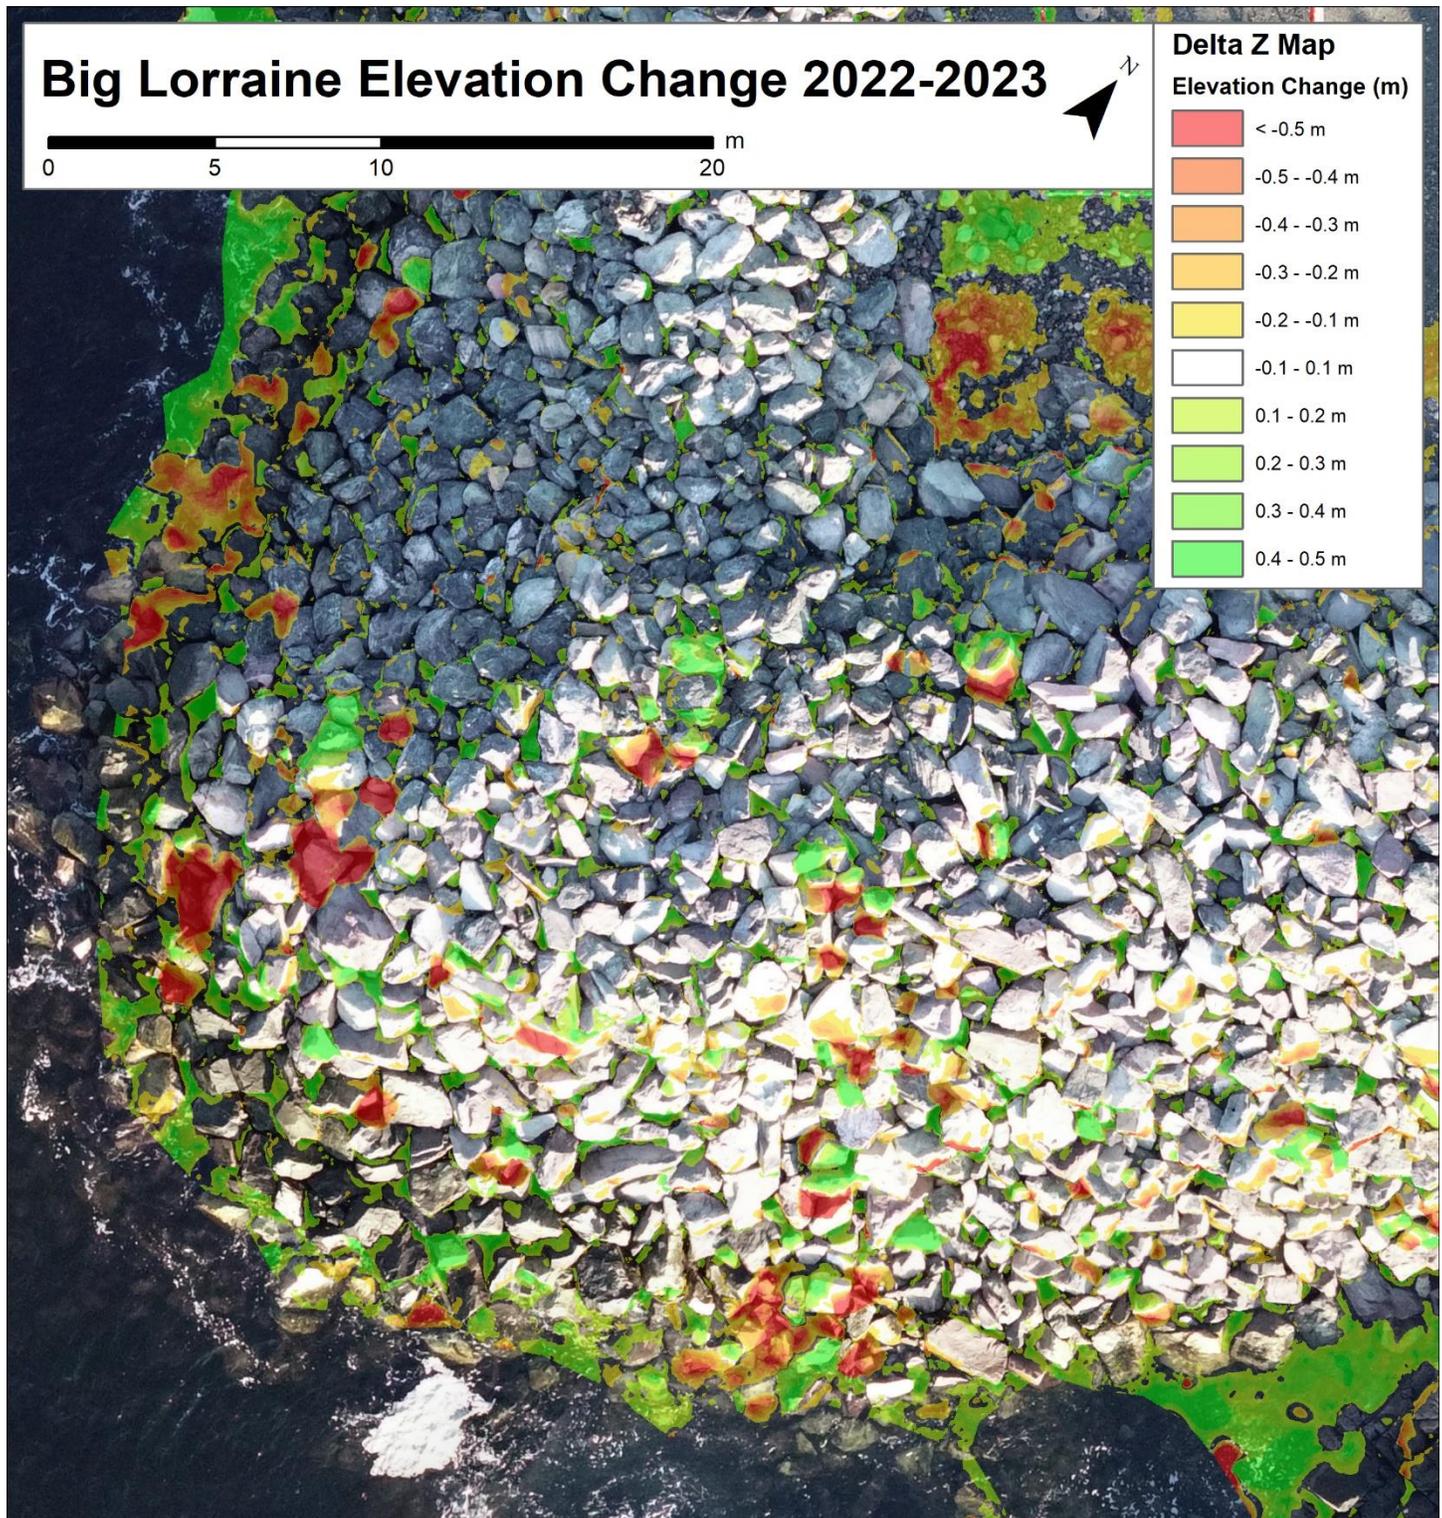
Large boulders were observed to have shifted between the 2022 and 2023 surveys. These shifts occurred primarily on the south corner of the breakwater with other scattered movements observed on the southeast wall, oceanward of the crest (Figure 4).

Figure 4. Close comparison of elevation changes between 2022 and 2023 demonstrates shifts in boulder positions localized primarily on the oceanward of the breakwater crest.

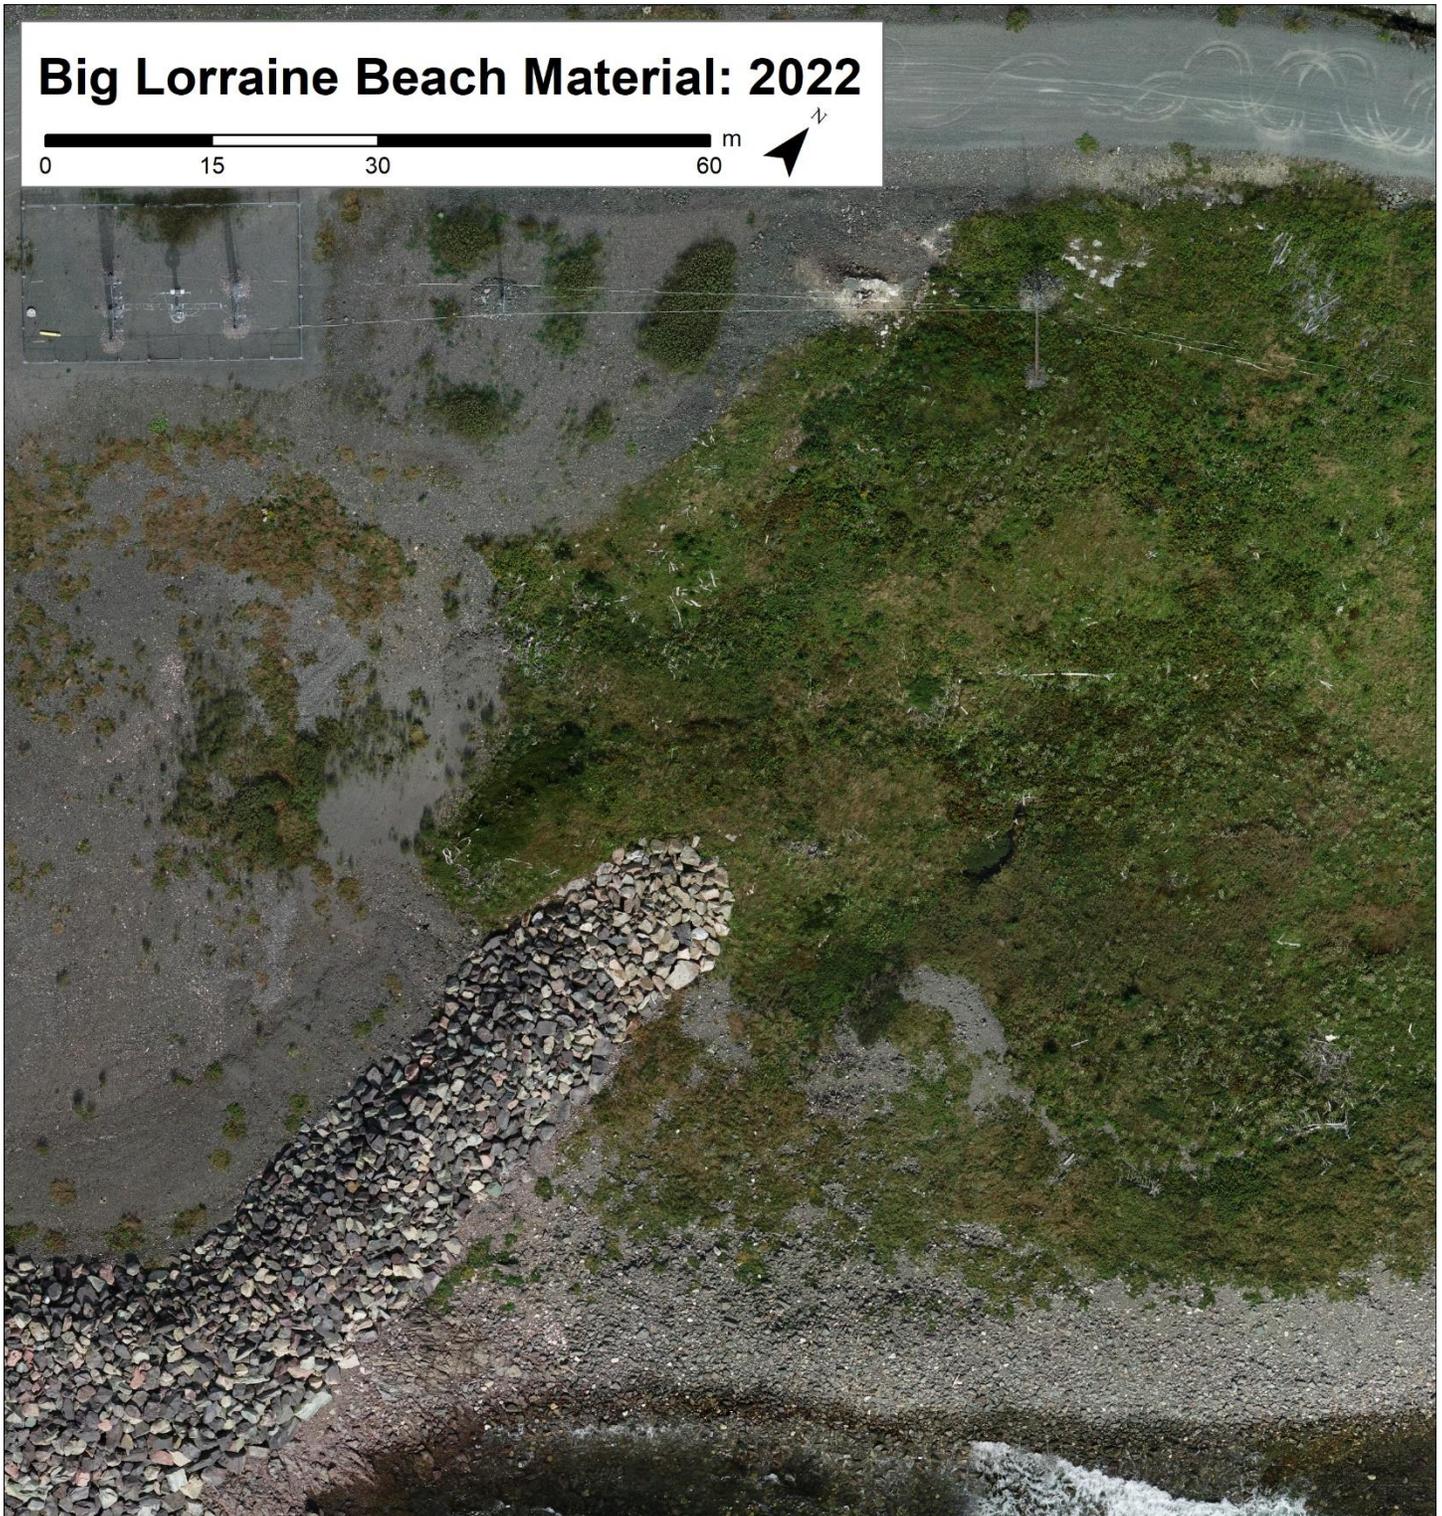
A significant change in beach morphology was observed east of the breakwater where a large volume of material was pushed inland between August 31, 2022 (Figure 5) and October 14, 2023 (Figure 6). It is likely that these significant movements were a result of hurricane Fiona which occurred in late September of 2022.

Figure 5. Imagery of highly vegetated beach material east of the Big Lorraine breakwater prior to hurricane Fiona.

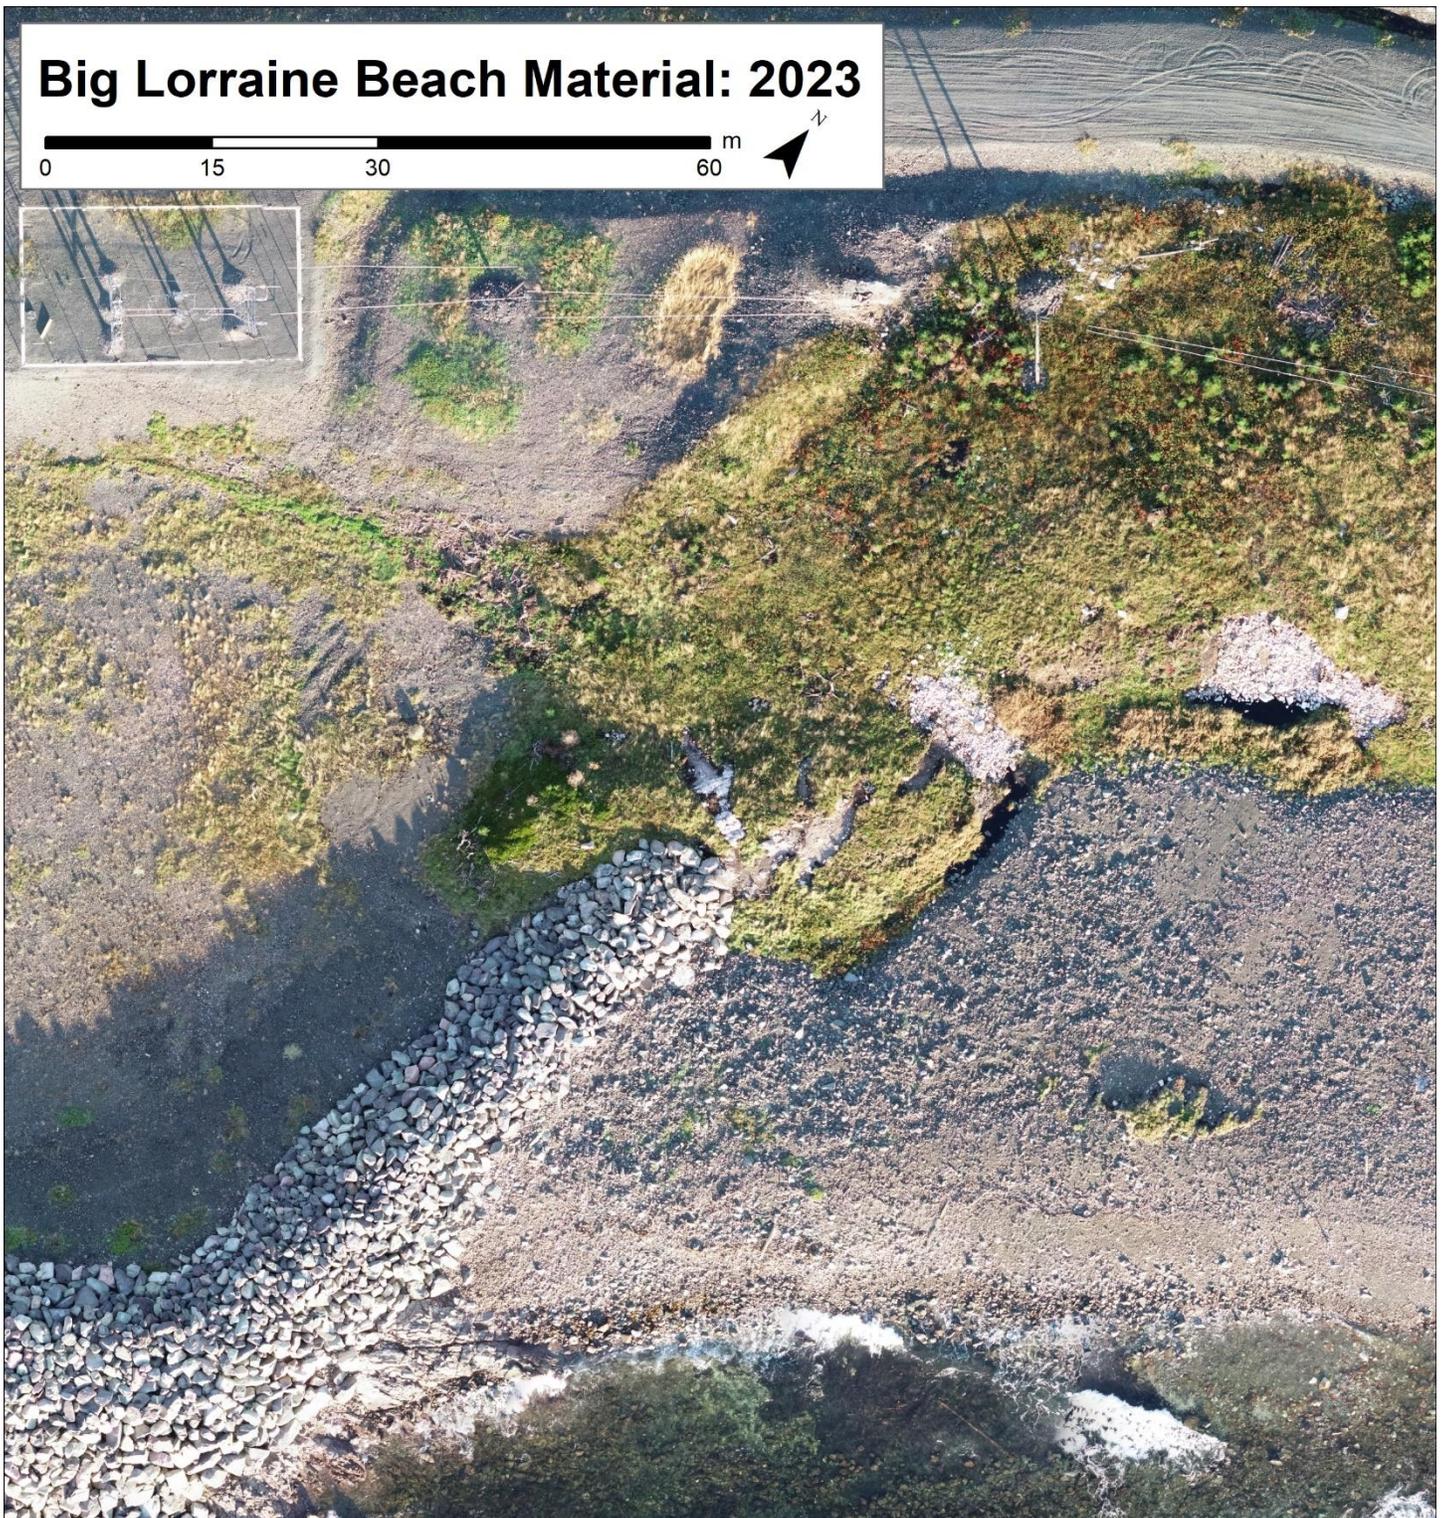
**Figure 6. Imagery of raised inland beach area void of vegetation east of the Big Lorraine breakwater post hurricane Fiona.**

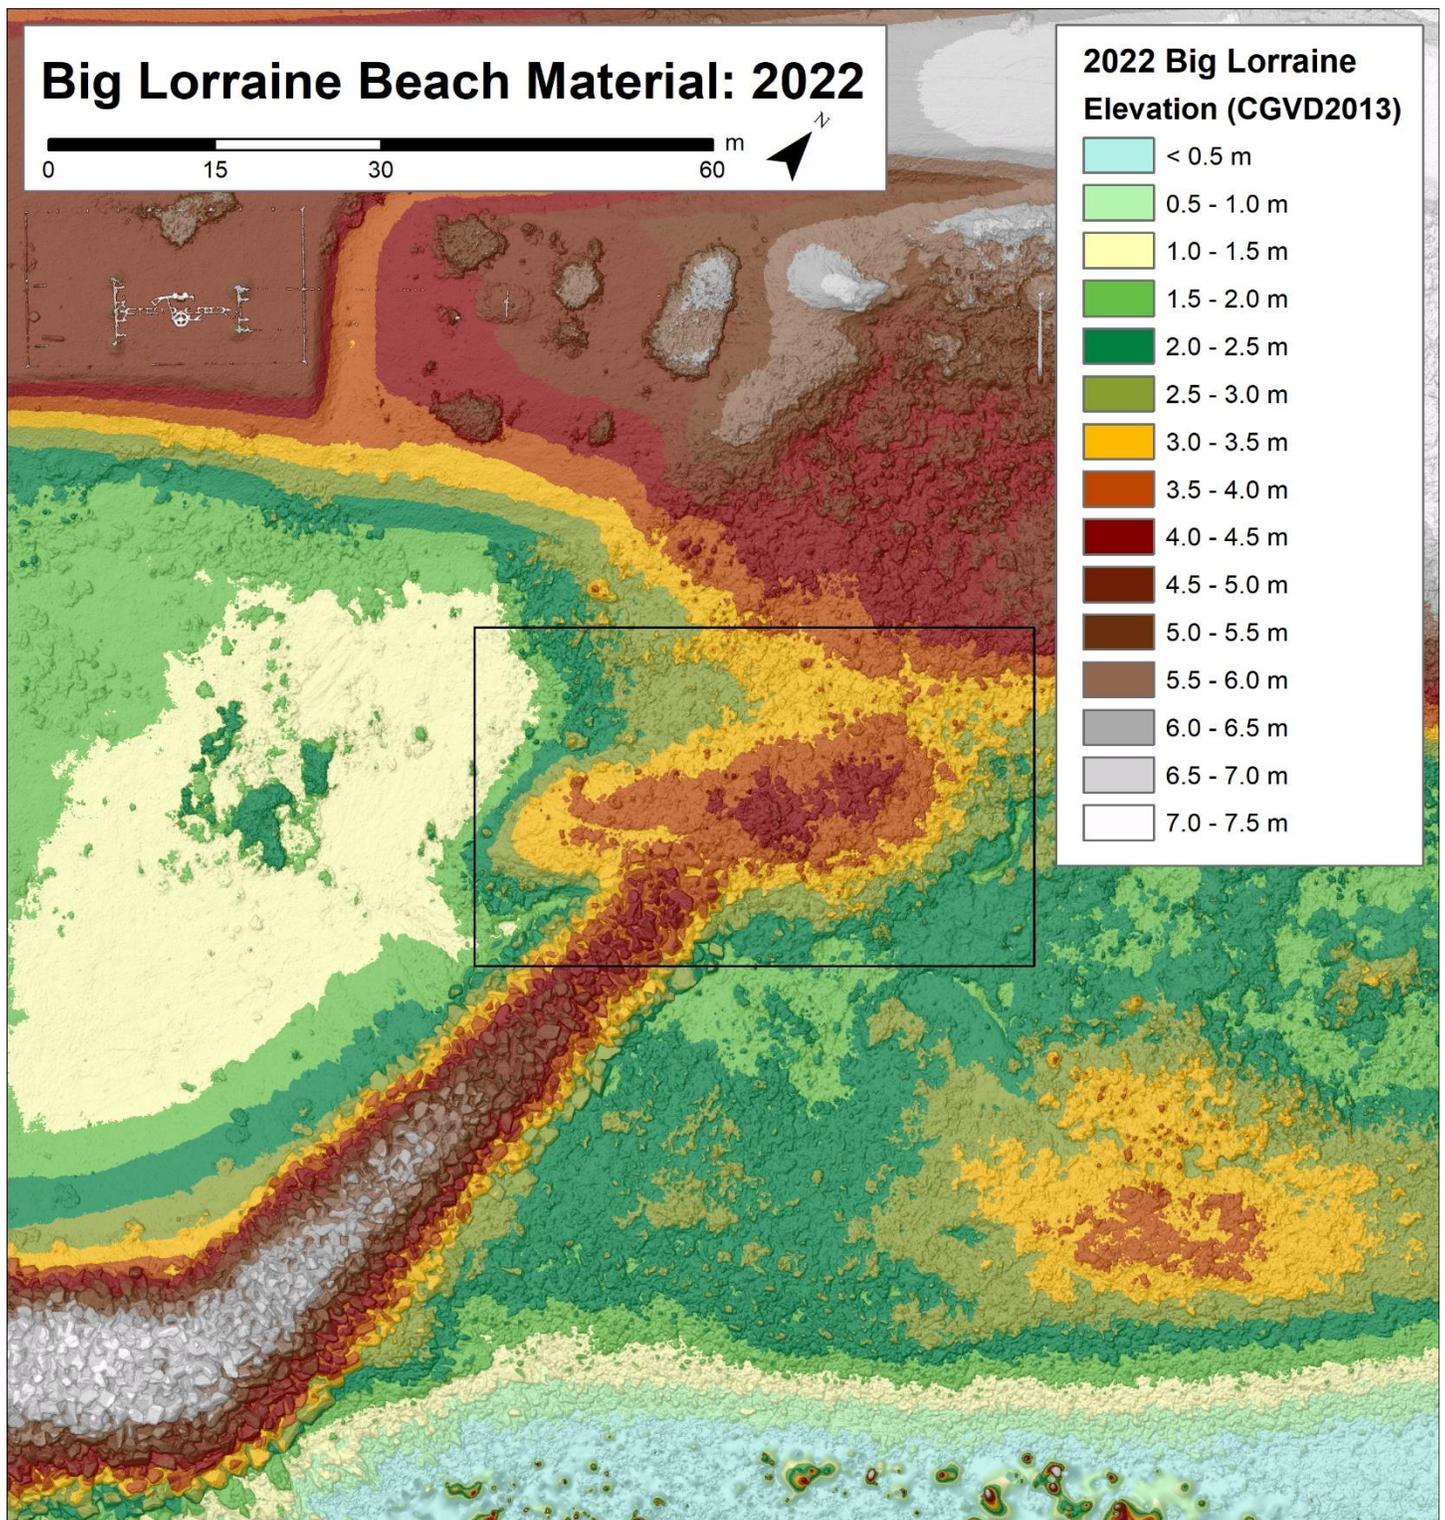
Figure 7. Colour shaded relief model of the beach elevations in 2022 highlighting the lowest portion of the protective breakwater.

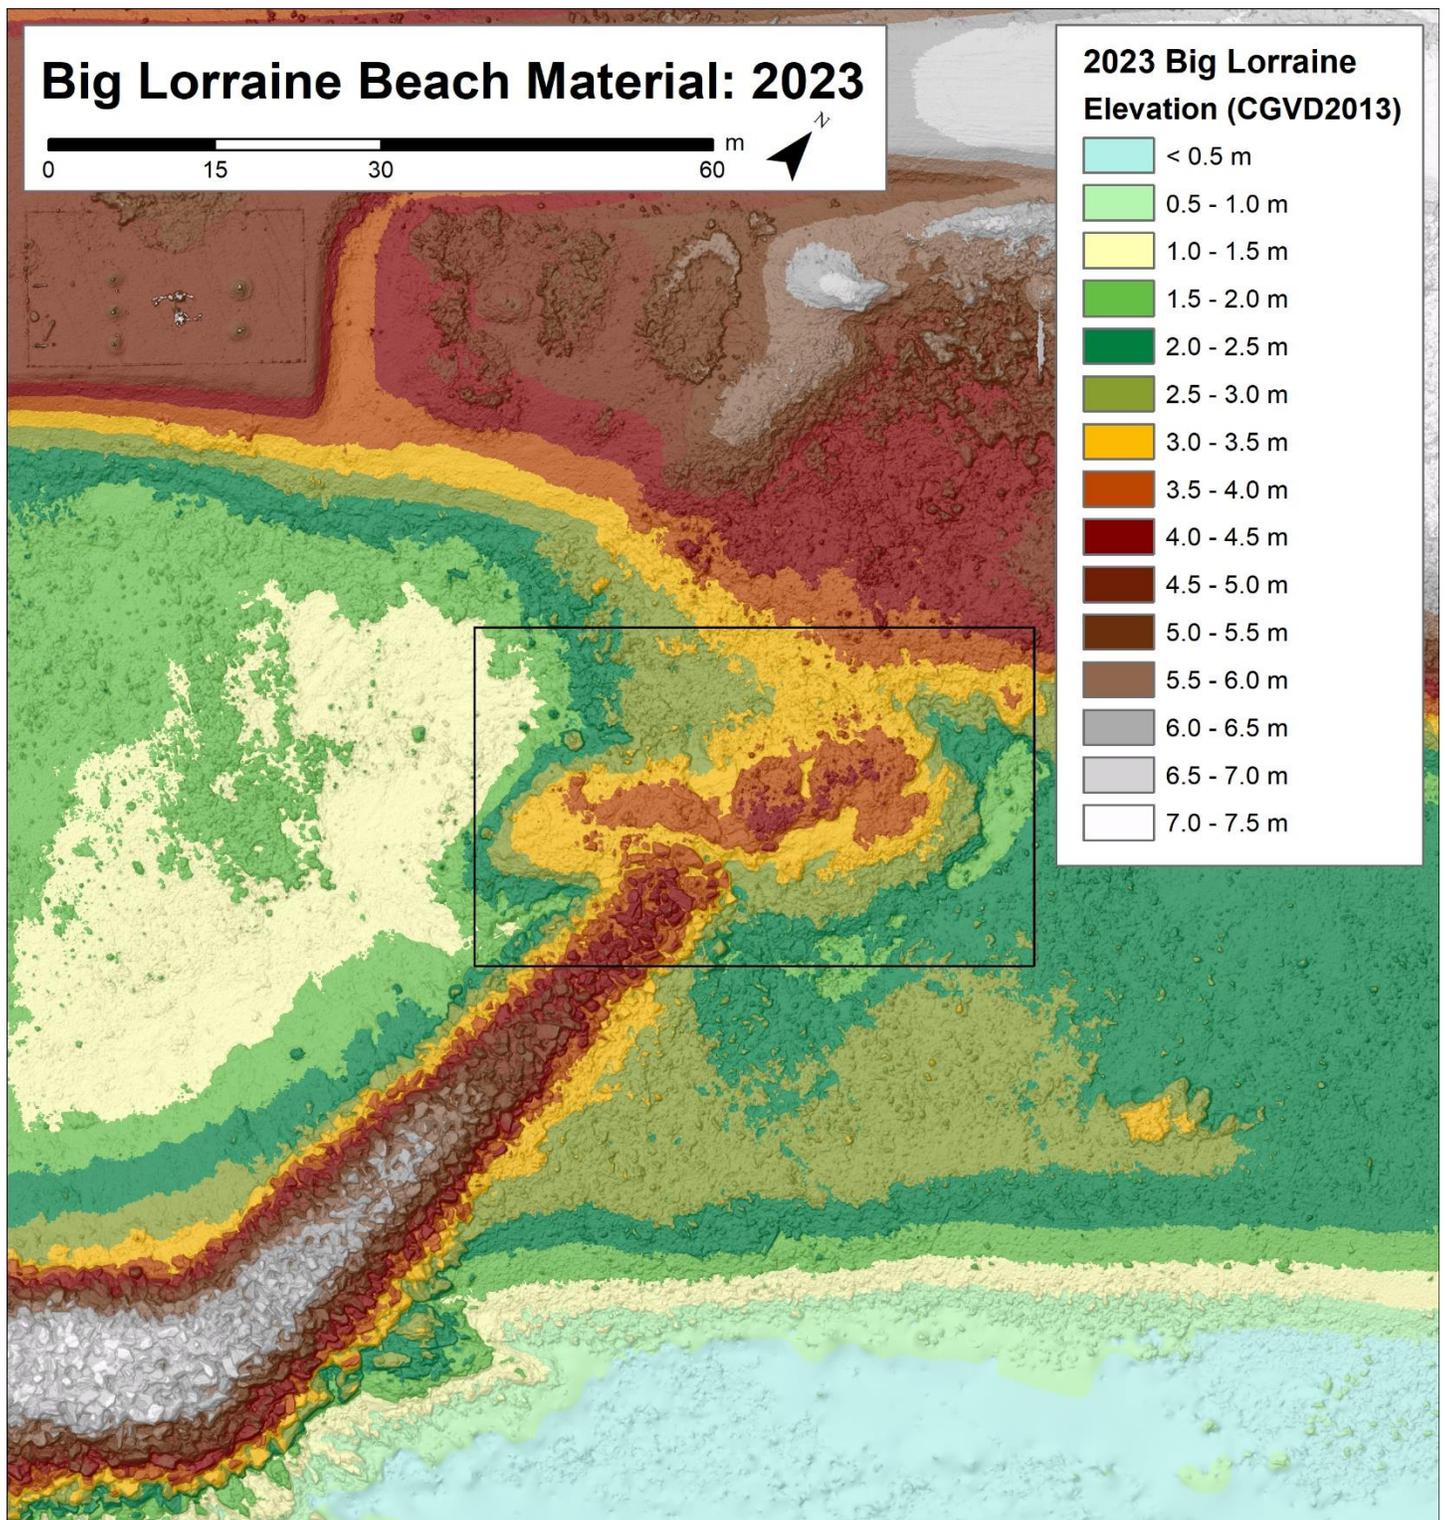
Figure 8. Colour shaded relief model of the beach elevations in 2023 highlighting a loss of material in the channel located at the northern tip of the breakwater.

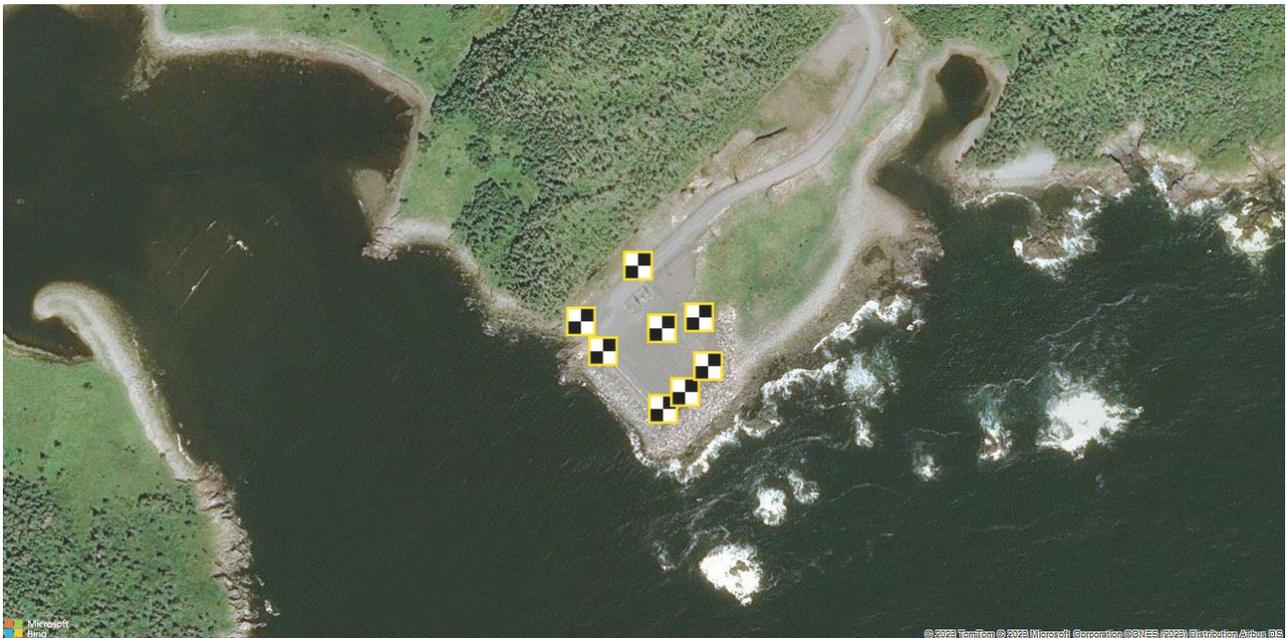
## Ground Control Report

**Survey ID** as395b6a75  
**Aeropoint Set**  
**Date captured** 14 Oct 2023 7:32 AM ADT  
**Points captured** 8  
**Processing method** Propeller network correction  
**Document generated** 17 Oct 2023 4:34 PM ADT

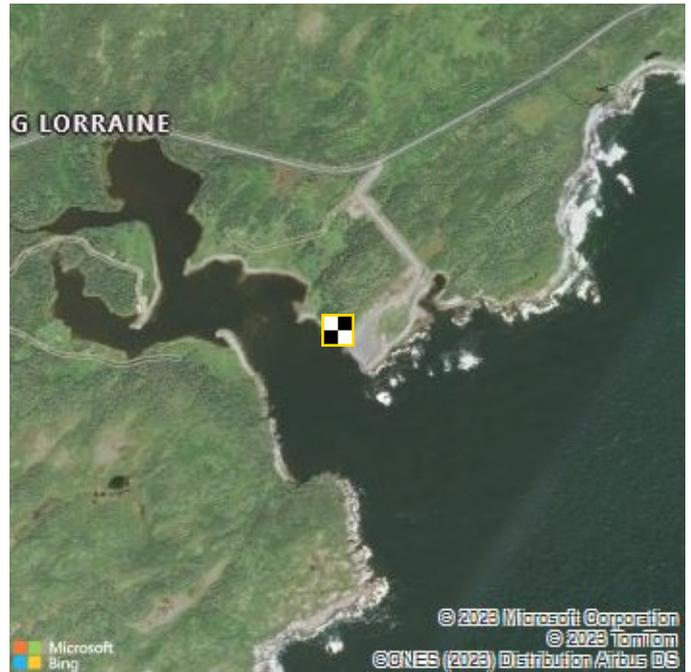
# Point 1

Point Number 1

Global ID acbddc05e5

Data variance 0.4 mm / 0.1 mm / 0.2 mm

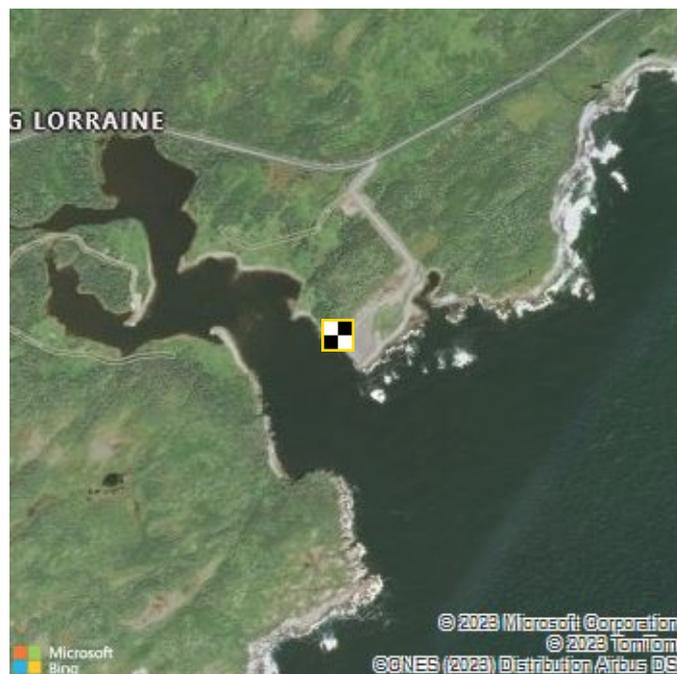
## Point 2

Point Number 2

Global ID aca1c505e8

Data variance 0.4 mm / 0.1 mm / 1.4 mm

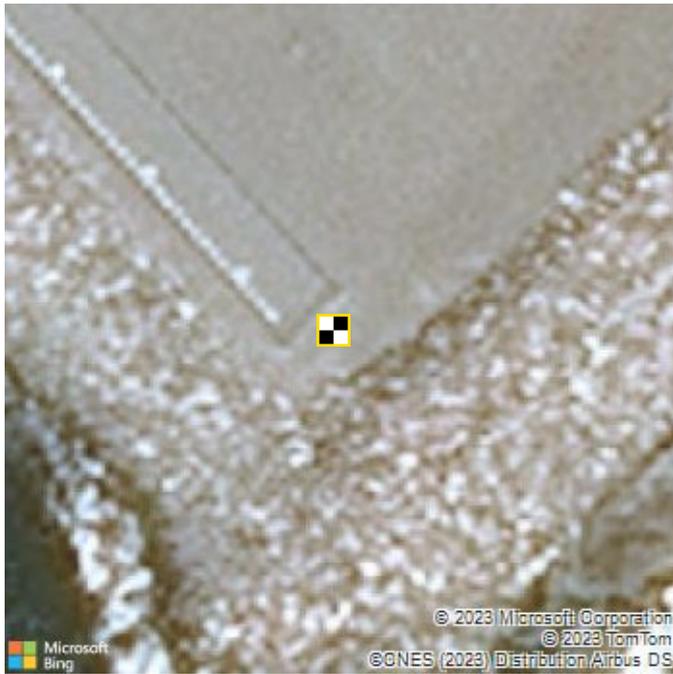
## Point 3

Point Number 3  
Global ID acf5d8b7e9  
AeroPoint ID 7286502

Capture start 14 Oct 2023 7:34 AM ADT  
Capture end 14 Oct 2023 8:33 AM ADT  
Duration 0:59  
Uploaded 14 Oct 2023 12:15 PM ADT

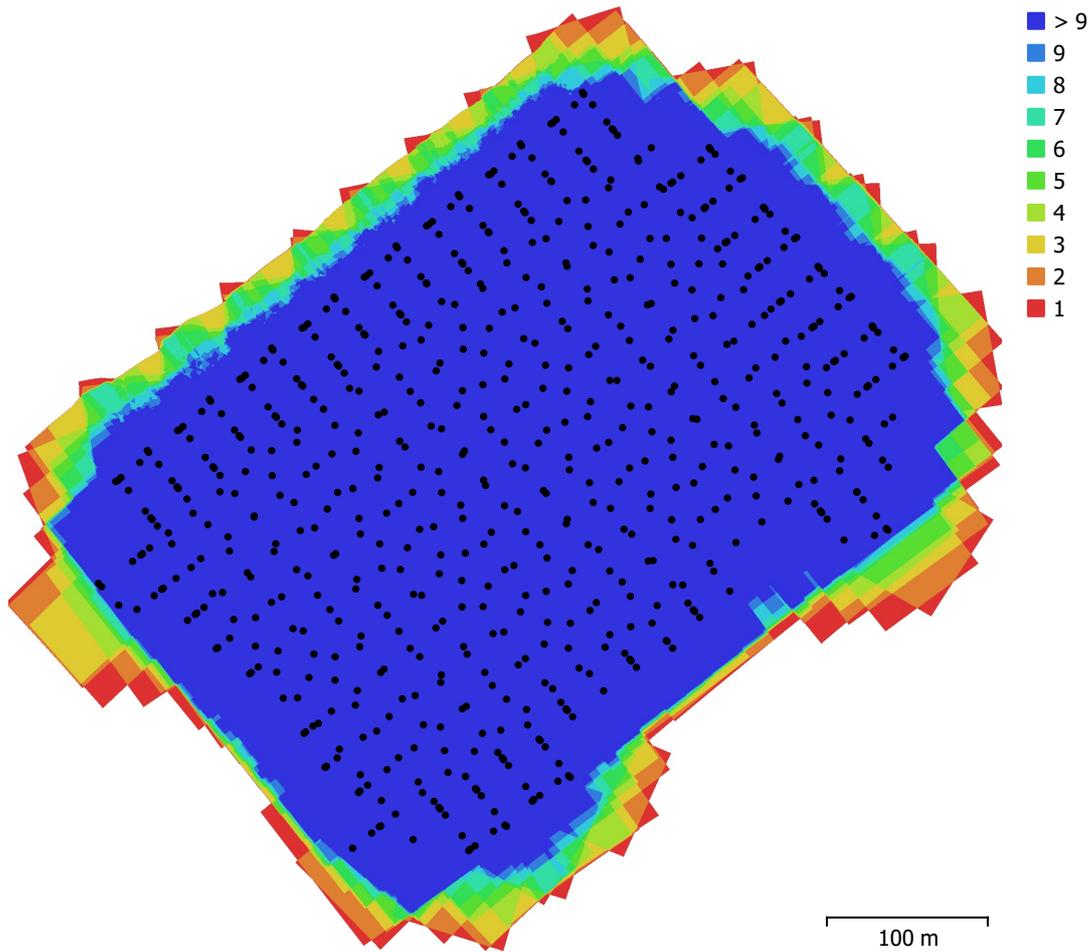
Fig. 1. Camera locations and image overlap.

Number of images:	749	Camera stations:	657
Flying altitude:	73.8 m	Tie points:	2,047,436
Ground resolution:	1.83 cm/pix	Projections:	7,071,586
Coverage area:	0.215 km <sup>2</sup>	Reprojection error:	1.12 pix

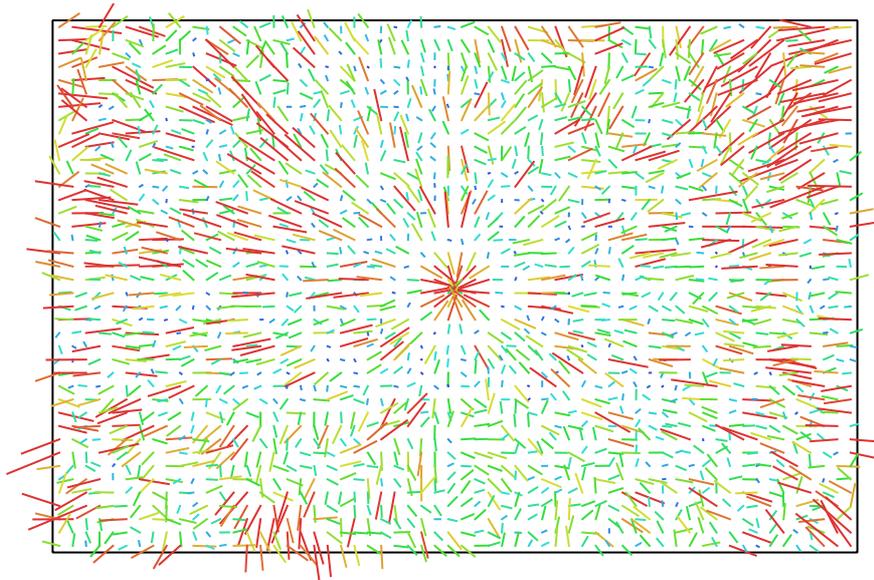
Fig. 2. Image residuals for EP800 (8.8mm).  
1 pix
