# Drone Data Collection 2023: Big Lorraine Technical Report

The Nova Scotia Community College Applied Geomatics Research Group (NSCC-AGR) was contracted by Emera Newfoundland and Labrador to collect airborne imagery using drones to monitor the position of a critical breakwater at the Big Lorraine, NS grounding site. Drone survey data were successfully collected on October 14<sup>th</sup>, 2023. Quality assurance and control measures have validated that the collected data meet or exceed all project specifications and were accurate to +/-5 cm. Survey results were compared against positions collected by NSCC in August of 2022 to confirm that the breakwater position had remained consistent between surveys. A major storm event, hurricane Fiona, occurred between the two survey dates. While no signs of deformation were observed along the crest of the breakwater, large boulders were shifted, and a significant volume of material was deposited inland at the beach located east of the breakwater. It is possible that marine water was routed inside the control structure at the north tip of the east wall. If incursion is to be prevented, it is advised that the eastern breakwater be extended to t

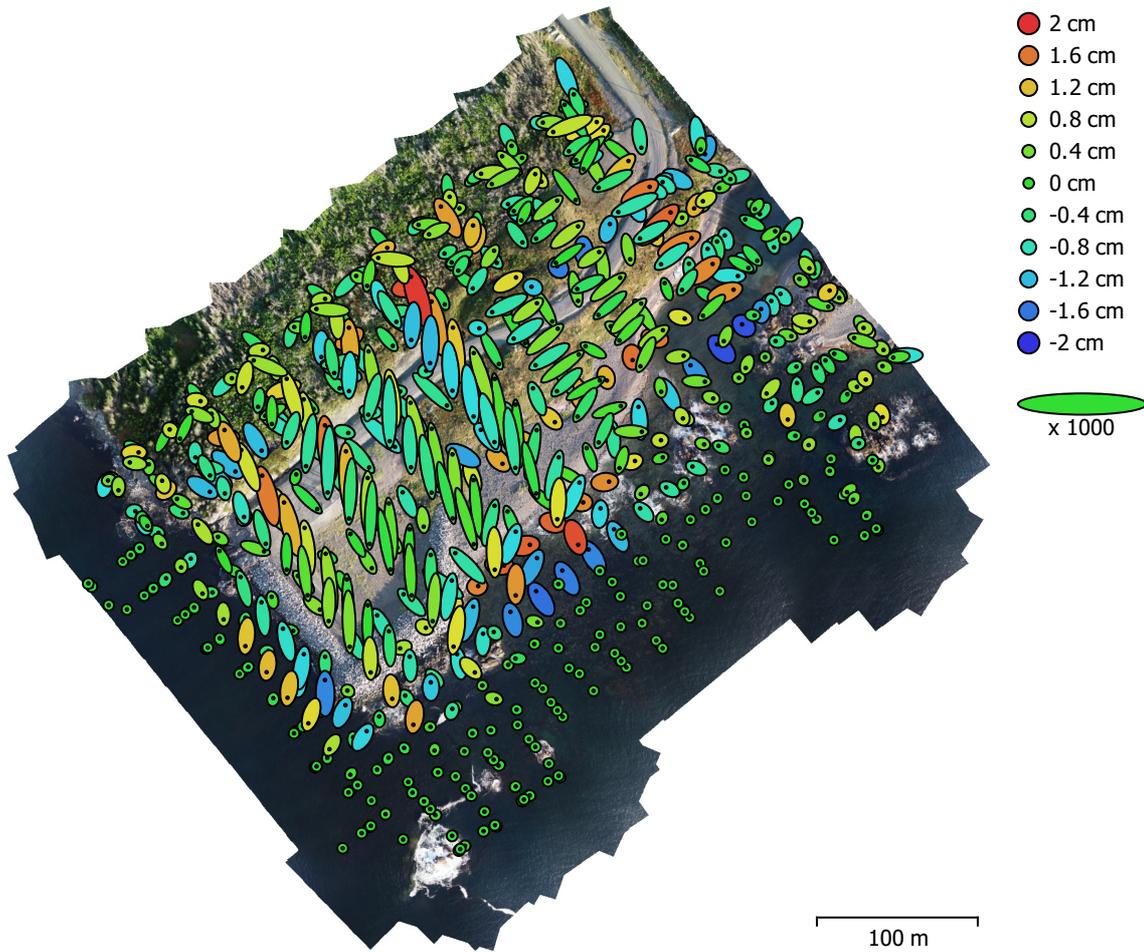
Fig. 3. Camera locations and error estimates.

Z error is represented by ellipse color. X,Y errors are represented by ellipse shape.

Estimated camera locations are marked with a black dot.

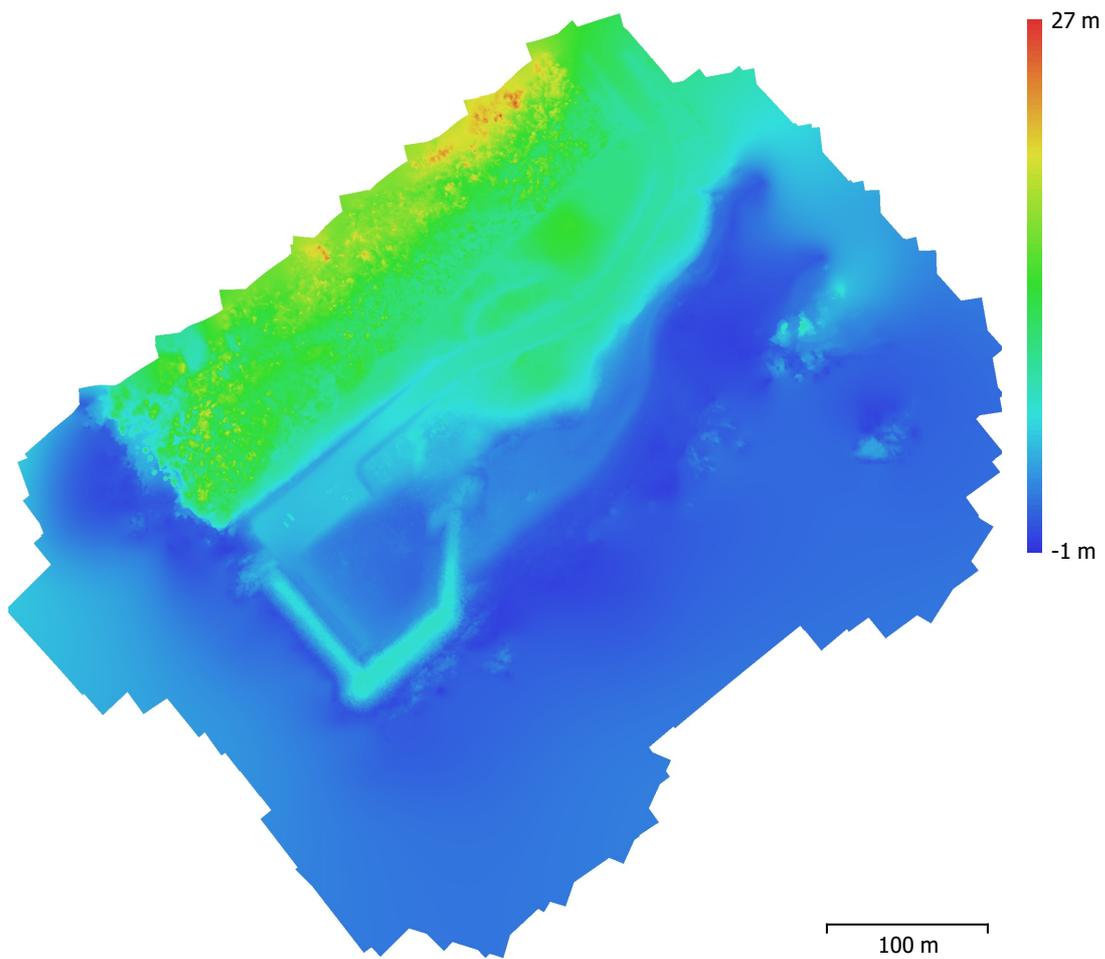
Fig. 4. Reconstructed digital elevation model.

Resolution: 1.83 cm/pix  
Point density: 0.3 points/cm<sup>2</sup>
