# Drone Data Collection 2023: Indian Head Technical Report

The Nova Scotia Community College Applied Geomatics Research Group (NSCC-AGRG) was contracted by Emera Newfoundland & Labrador to collect airborne imagery using drones at the Indian Head, NL grounding site. Survey data were successfully collected on November 6, 2023. Data were required to establish a basis for comparison to historical surveys completed by NSCC-AGRG (longest record 2018) to assess potential deformation of a protective breakwater with a required accuracy of  $\pm 0.30$  m and expected accuracy of  $\pm 0.10$  m. Quality assurance and control measures have validated that the collected data meet or exceed all project specifications with an accuracy of  $\pm 0.05$  m. Comparative analysis has determined that the crest of the breakwater has remained within  $\pm 10$  cm of the 2018 surveyed position. Results showed that no significant loss had occurred in the breakwater crest elevation as of November 2023.

The Nova Scotia Community College – Applied geomatics Research Group (NSCC-AGRG) was contracted to conduct drone survey activities over Emera Newfoundland & Labrador sites including the Indian Head grounding

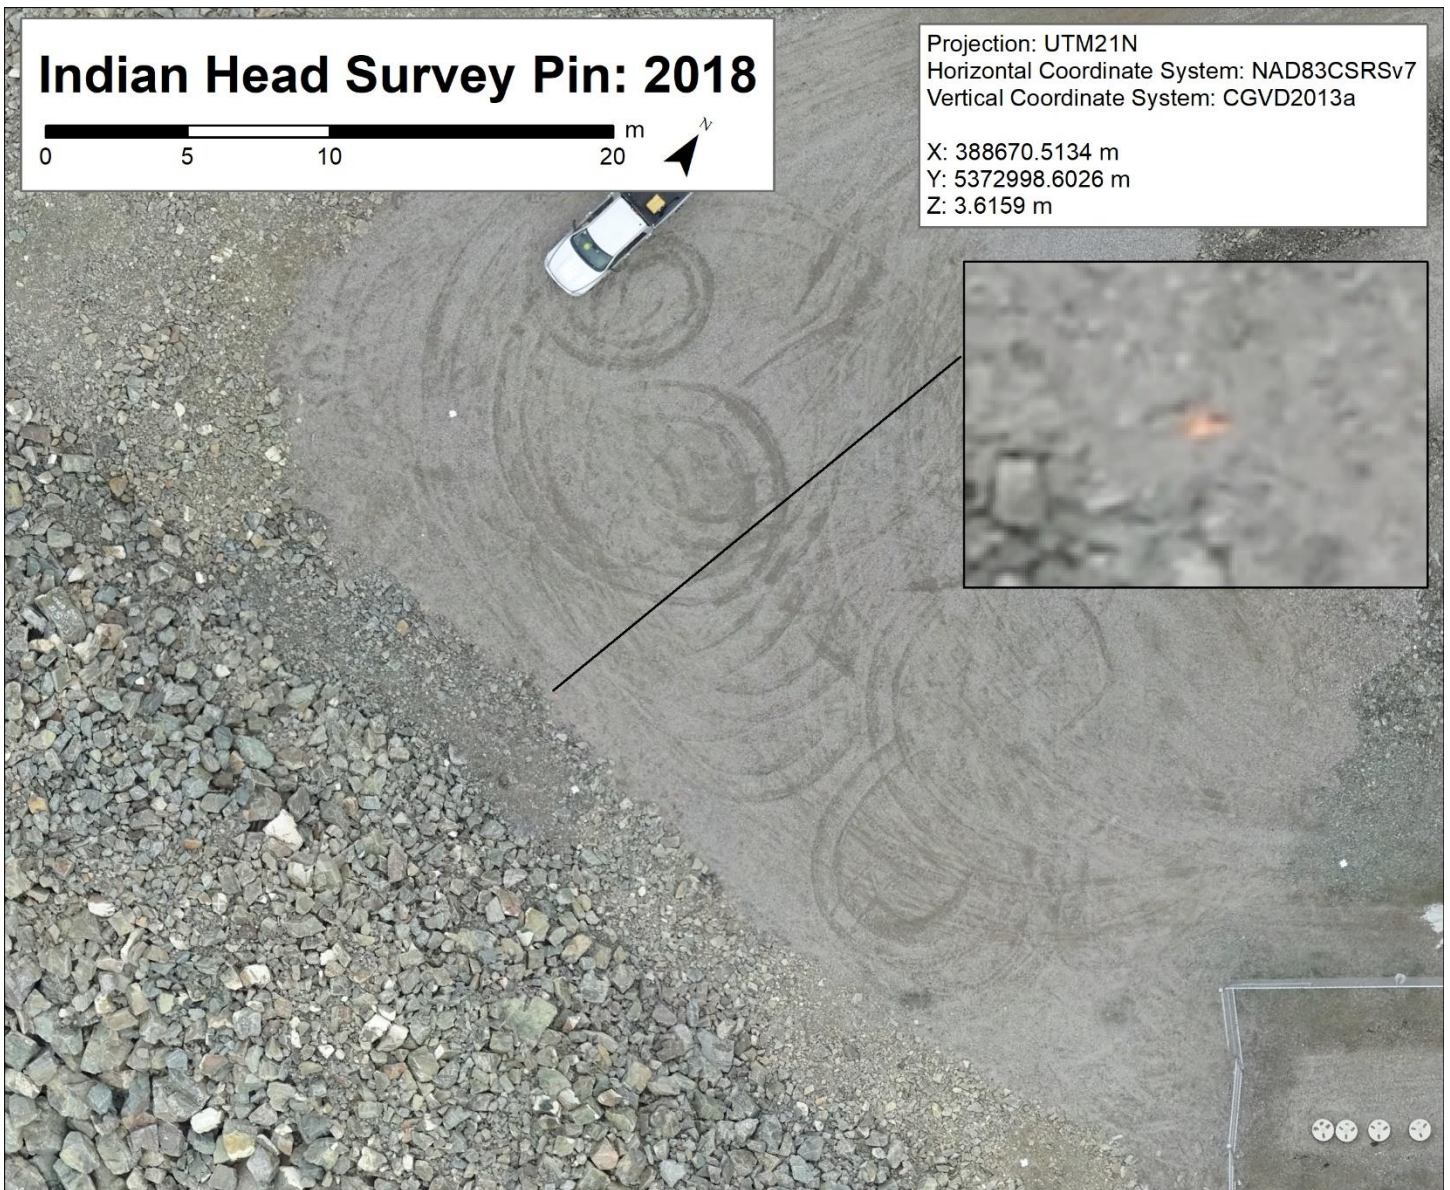
**Figure 1. Indian Head site survey pin observed and positioned in aerial imagery in 2018.**

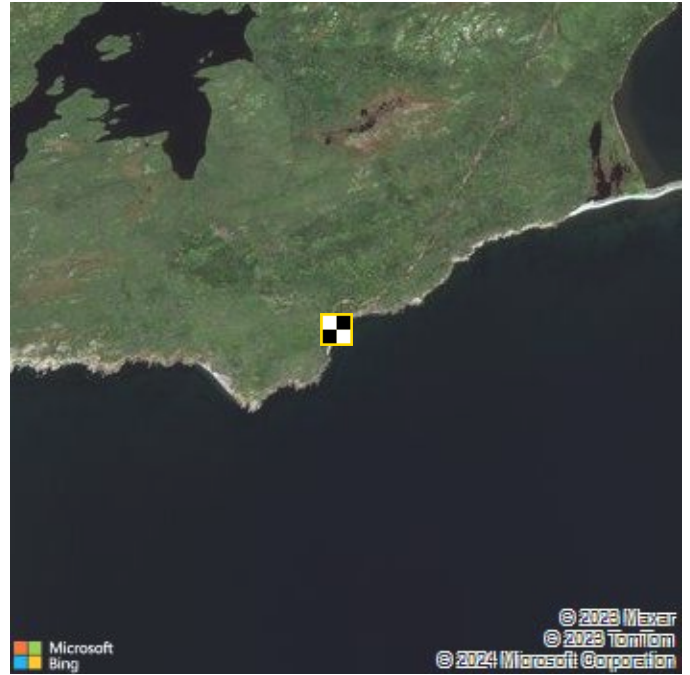
## Point 2

Data points 470  
Points used 452 (96.2%)  
Baseline distance 0.10 km  
Data variance 1.4 mm / 0.7 mm / 2.8 mm

Point Number 2

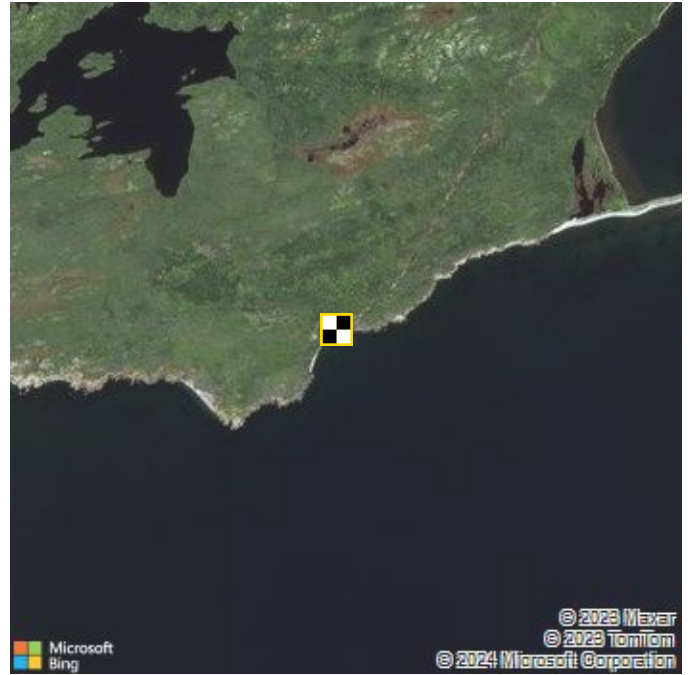
## Point 5

Point Number 5  
Global ID ac2f8e7c49  
AeroPoint ID 07283903

Capture start 06 Nov 2023 10:12 AM NST  
Capture end 06 Nov 2023 11:32 AM NST  
Duration 1:20  
Uploaded 06 Nov 2023 11:48 AM NST

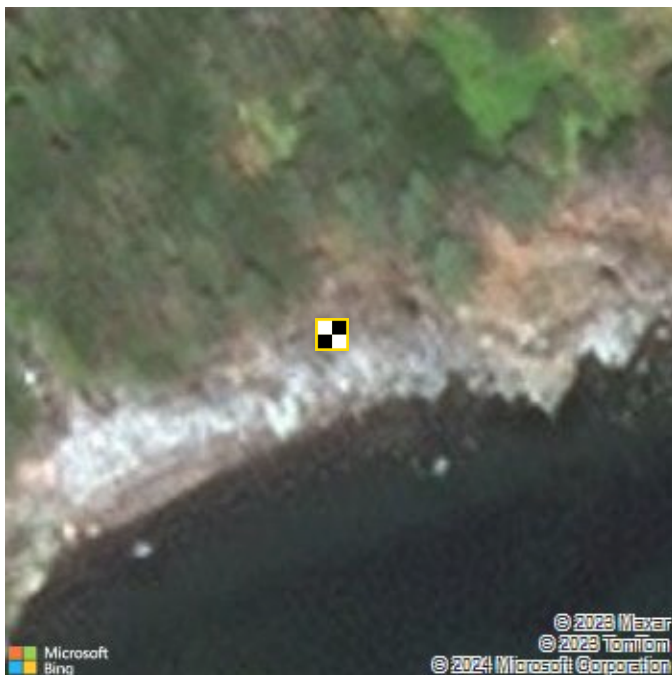
## Point 7

Point Number 7  
Global ID ac69d97fb4  
AeroPoint ID 07284369

Capture start 06 Nov 2023 10:14 AM NST  
Capture end 06 Nov 2023 11:34 AM NST  
Duration 1:20  
Uploaded 06 Nov 2023 11:59 AM NST

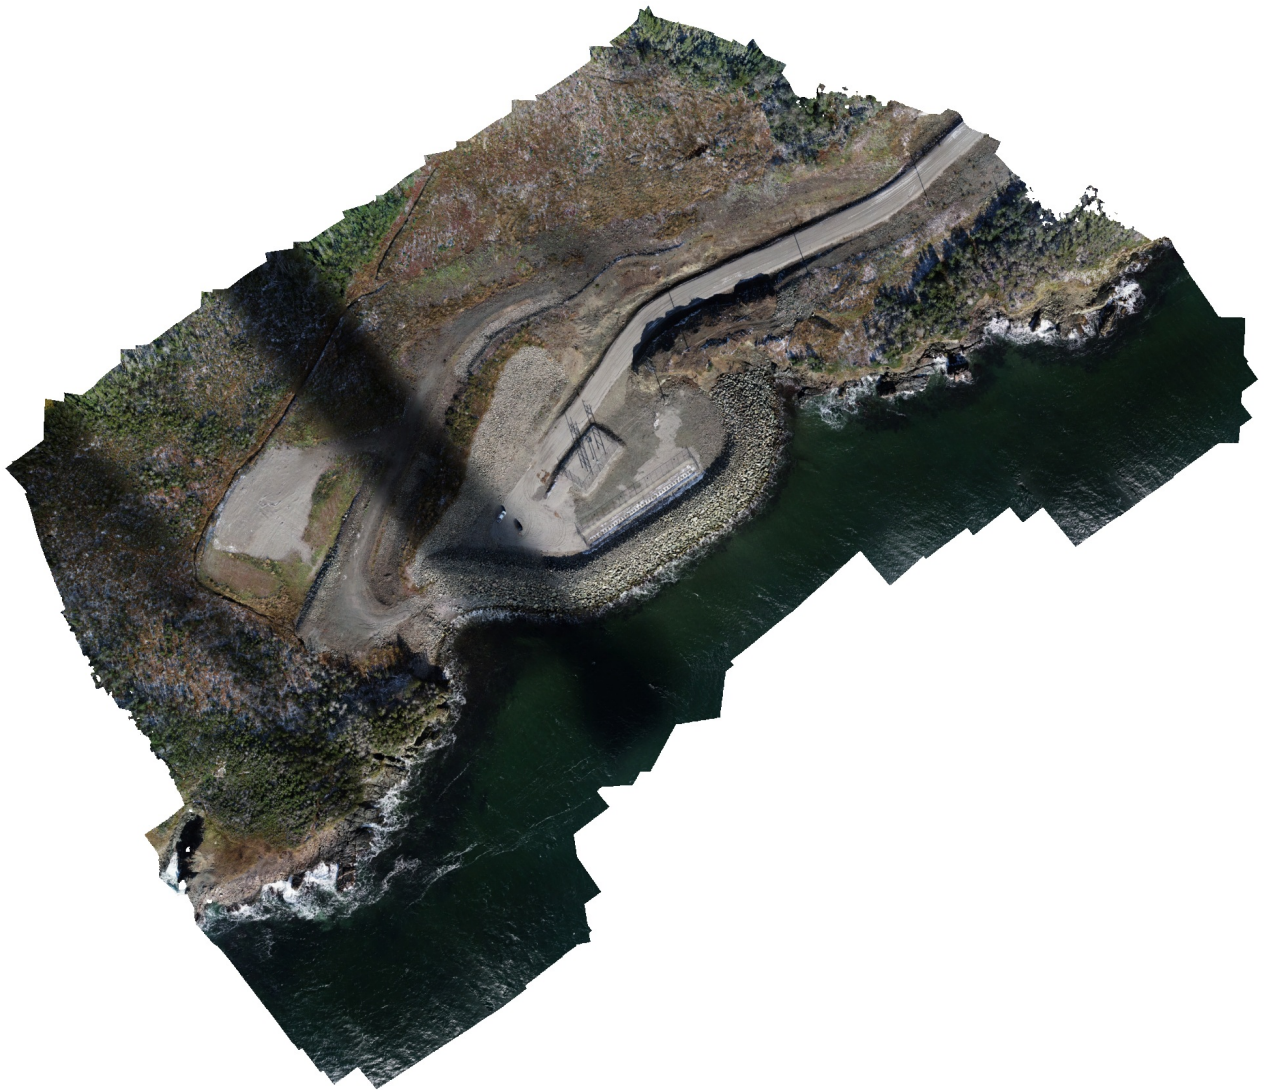
DJI Matrice 300 RTK L1 RGB Processing Report

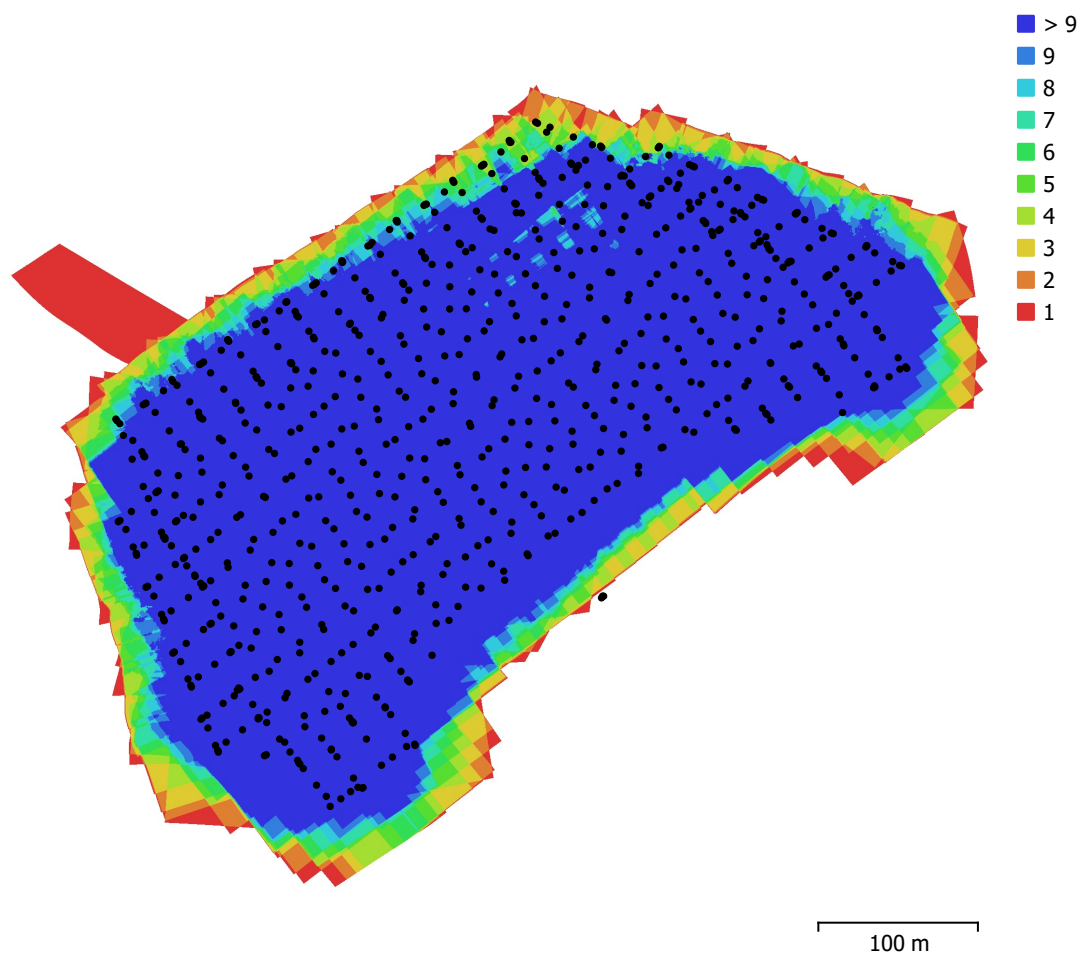
Fig. 1. Camera locations and image overlap.

Number of images:	897	Camera stations:	783
Flying altitude:	48.6 m	Tie points:	3,216,830
Ground resolution:	1.26 cm/pix	Projections:	10,053,944
Coverage area:	0.164 km <sup>2</sup>	Reprojection error:	0.649 pix
