Drone Data Collection 2023: Point Aconi Technical Report

The Nova Scotia Community College Applied Geomatics Research Group (NSCC-AGRG) was contracted by Emera Newfoundland and Labrador to collect airborne imagery using a drone to establish a baseline position of an area of eroding coastline near Point Aconi infrastructure. Data were successfully collected on August 31st of 2022, and on October 14, 2023, using a DJI Matrice 300 RTK drone equipped with an L1 survey grade lidar and camera system. Quality assurance and control measures have validated that the collected image data met or exceeded project specifications and were accurate to +/-5 cm. Survey results were determined to be of high quality and are suitable for use in future monitoring of bank erosion. In 2023, the crest of the eroding bank position remained stable when compared to measurements obtained in 2022. However, a large volume of material was removed from the toe of the bank which resulted in a more vertical face along the elevated areas to the north and east of the HDD pad. It is expected that stability in these areas will fail and result in a slump of the face and setback (estimated at 1.5 m) of the crest toward t

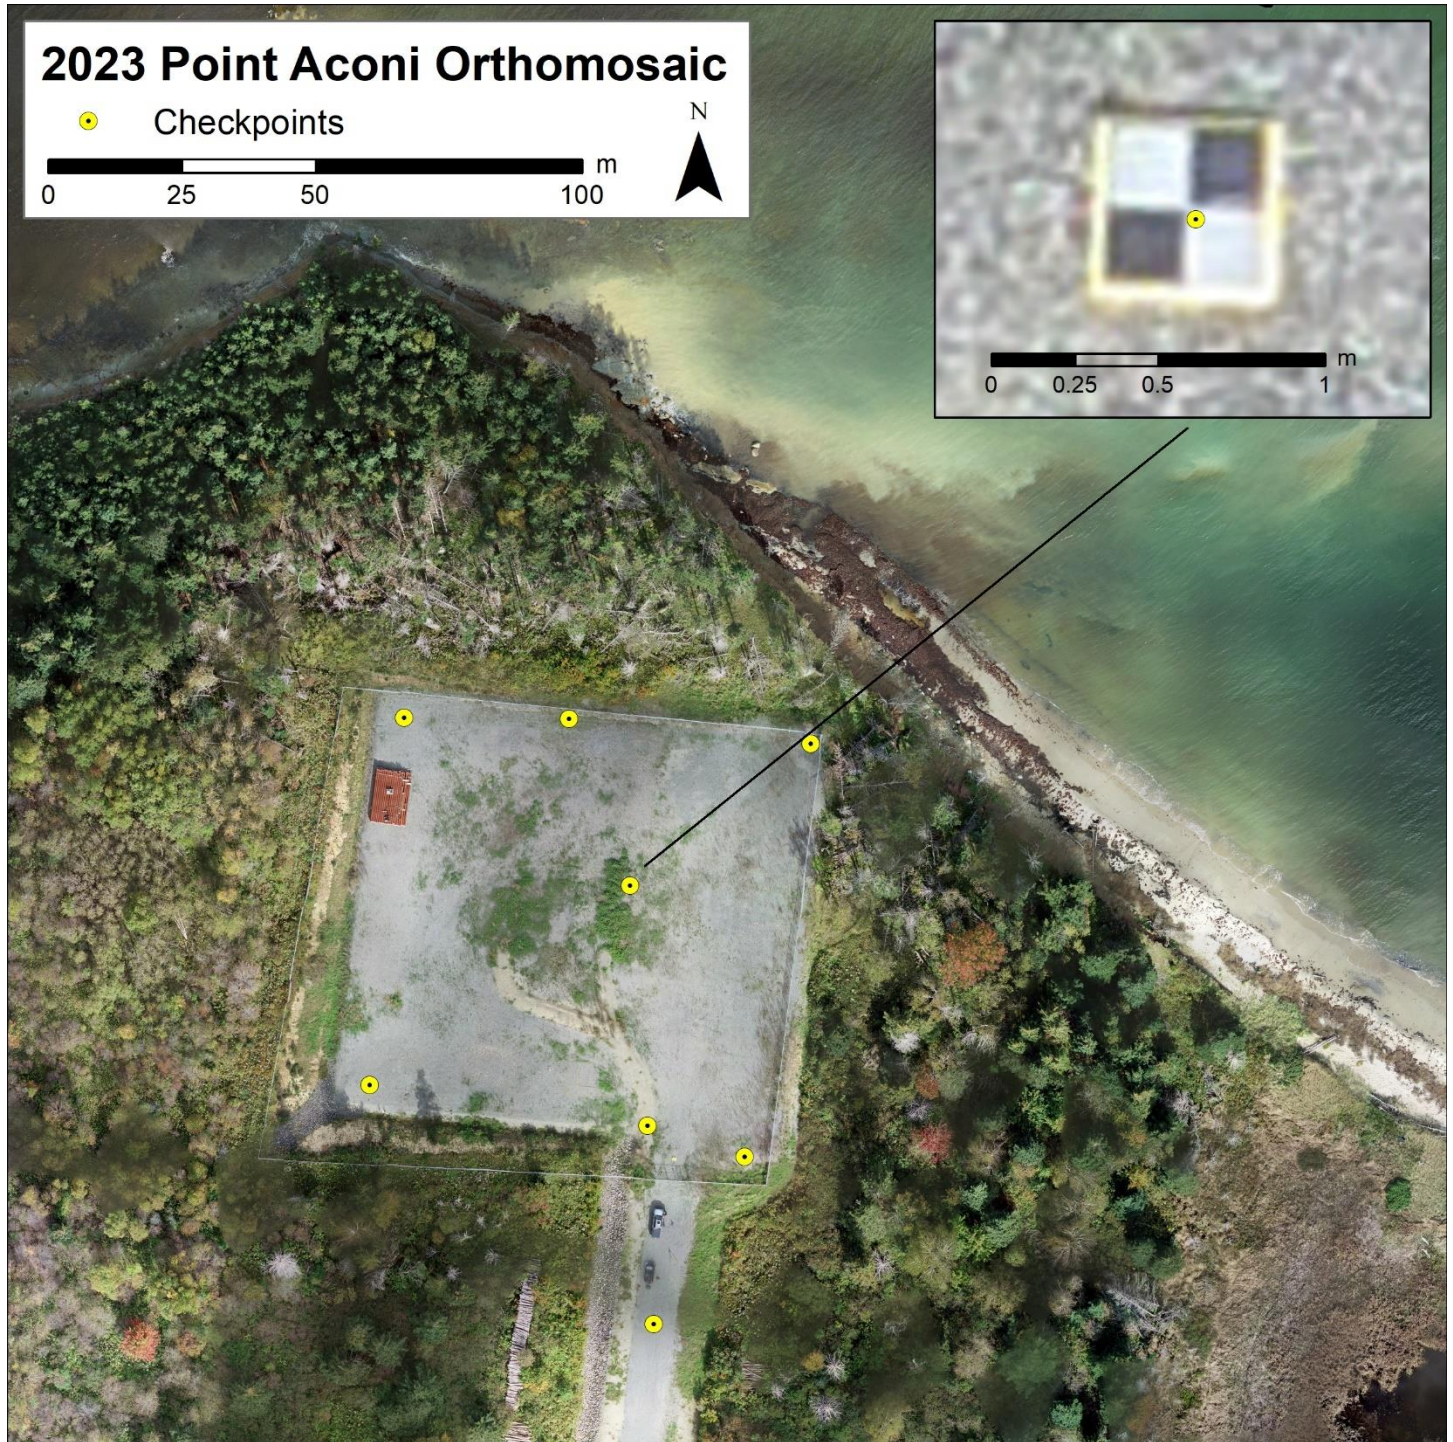
Image mosaics were found to be of high quality due to consistent light levels experienced during the collection period (Figure 1).

Figure 1. Point Aconi site photo mosaic showing good horizontal alignment over checkpoint targets.

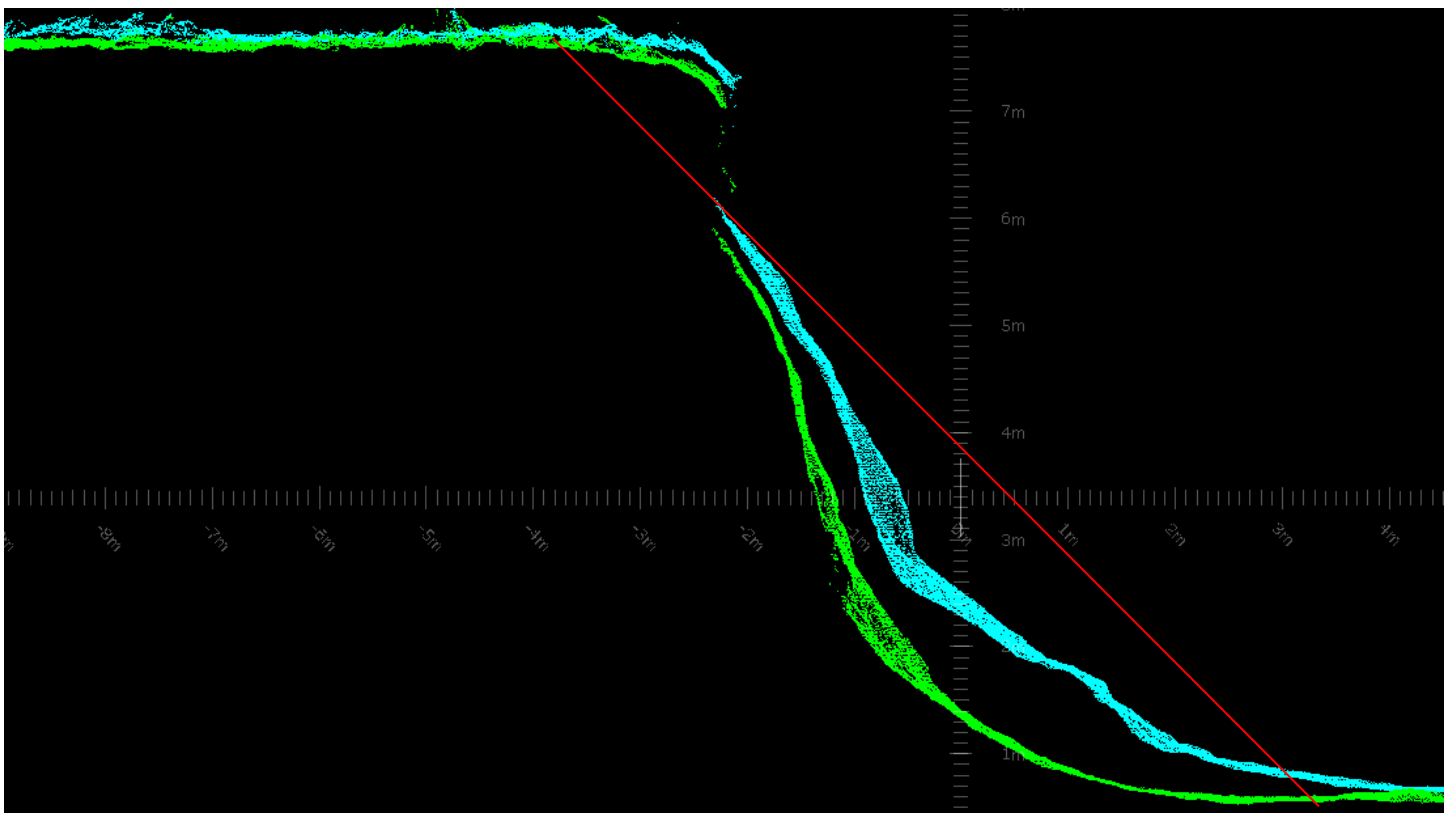
Image point cloud data (pixel matches) were further examined in cross-sections drawn perpendicular to the eroding bank. Closer inspection confirmed trends observed in the top-down elevation model differencing. Between 2022 and 2023 the bank crest remained nearly stationary; however, a large volume of material was removed from the bank toe (Figure 4). This removal of material is consistent with marine erosion in areas exposed to wave action. While the crest of the bank remained stable between 2022 and 2023, the bank material will become less stable as the ocean continues to remove toe material to create a vertical face. The crest will set back at the next slump event when the material fails and re-fills the toe.

Figure 4. Cross-section (1 m width) of image point cloud data drawn perpendicular to the eroding cliff face. A large volume of material was removed from the toe of the bank between the 2022 (blue) and 2023 (green) surveys. 1:1 slope line imposed in red to demonstrate potential setback of 1.5 m.

Cross-section inspection determined that the crest of the eroding bank remained stable when compared to measurements obtained in 2022. However, a large volume of material was removed from the toe of the bank which resulted in a more vertical face along the elevated areas to the north and east of the HDD pad. It is expected that stability in these areas will fail and result in a slump of the face and setback (estimated at 1.5 m) of the crest toward the HDD pad.

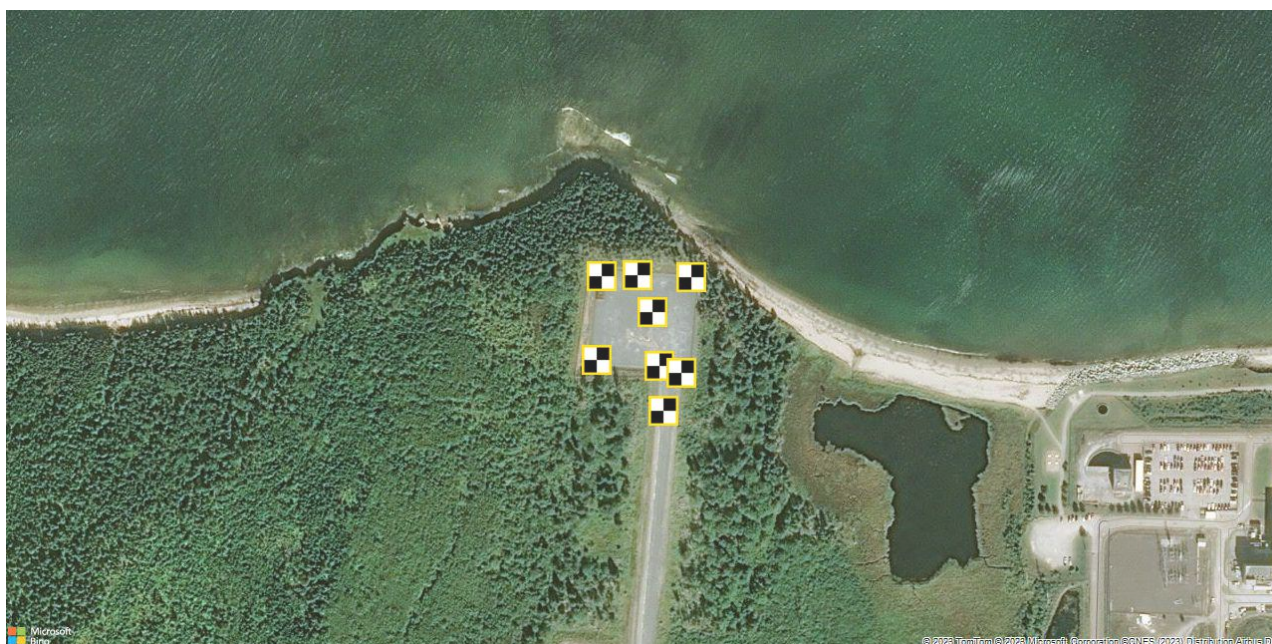
Ground Control Report

Survey ID as096b2f7f
Aeropoint Set
Date captured 14 Oct 2023 11:20 AM ADT
Points captured 8
Processing method Propeller network correction
Document generated 17 Oct 2023 4:34 PM ADT

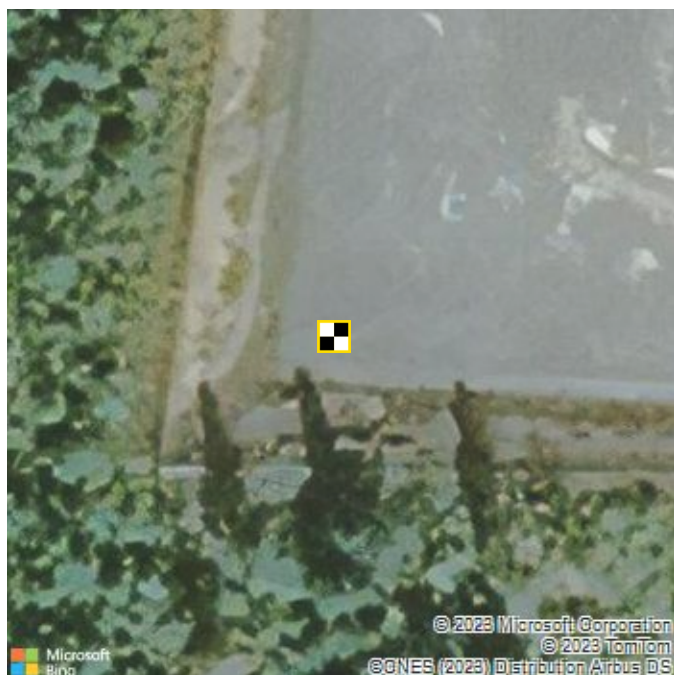
Point 3

Point Number 3
Global ID acd21d667a
AeroPoint ID 7284587

Capture start 14 Oct 2023 11:23 AM ADT
Capture end 14 Oct 2023 12:07 PM ADT
Duration 0:44
Uploaded 14 Oct 2023 12:14 PM ADT

Data points 263
Points used 259 (98.5%)
Baseline distance 0.05 km
Data variance 6.0 mm / 3.5 mm / 2.0 mm

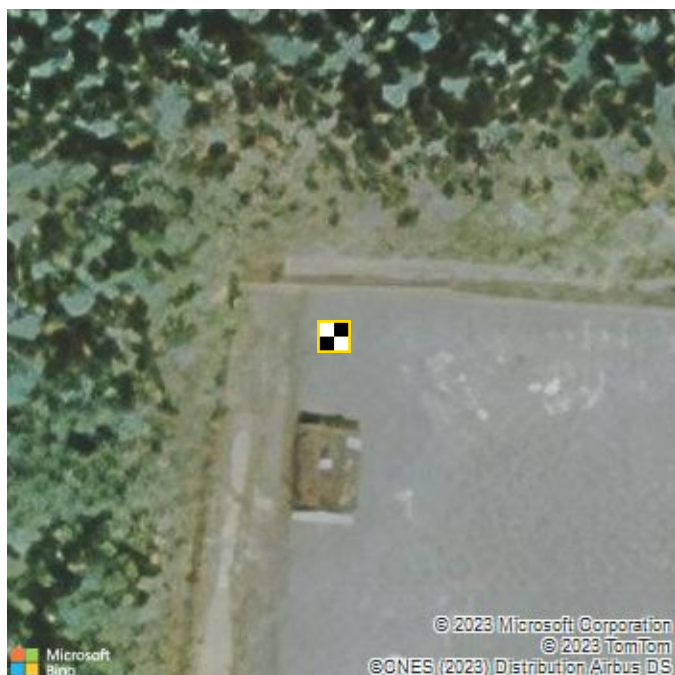
Point 4

Point Number 4

Global ID ac3b923bbe

Data variance 0.8 mm / 0.5 mm / 1.4 mm

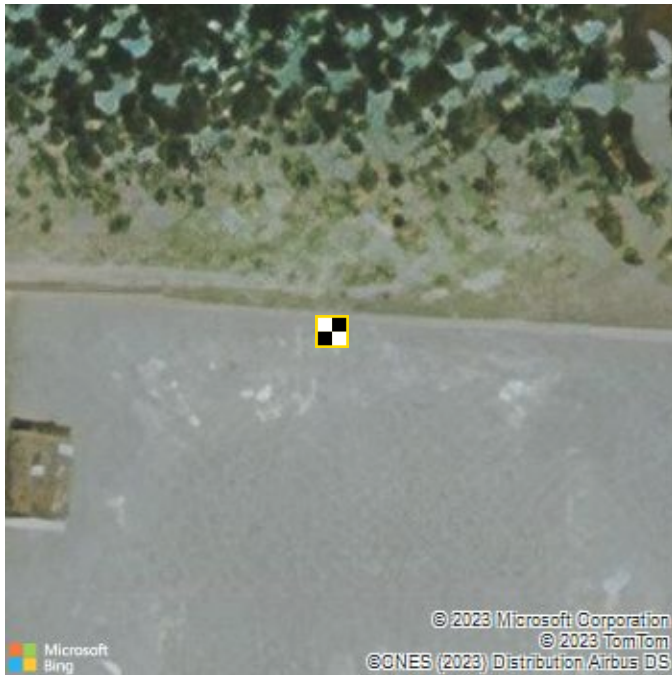
Point 5

Point Number 5
Global ID acd465bdca
AeroPoint ID 7287283

Capture start 14 Oct 2023 11:25 AM ADT
Capture end 14 Oct 2023 12:08 PM ADT
Duration 0:43
Uploaded 14 Oct 2023 12:15 PM ADT

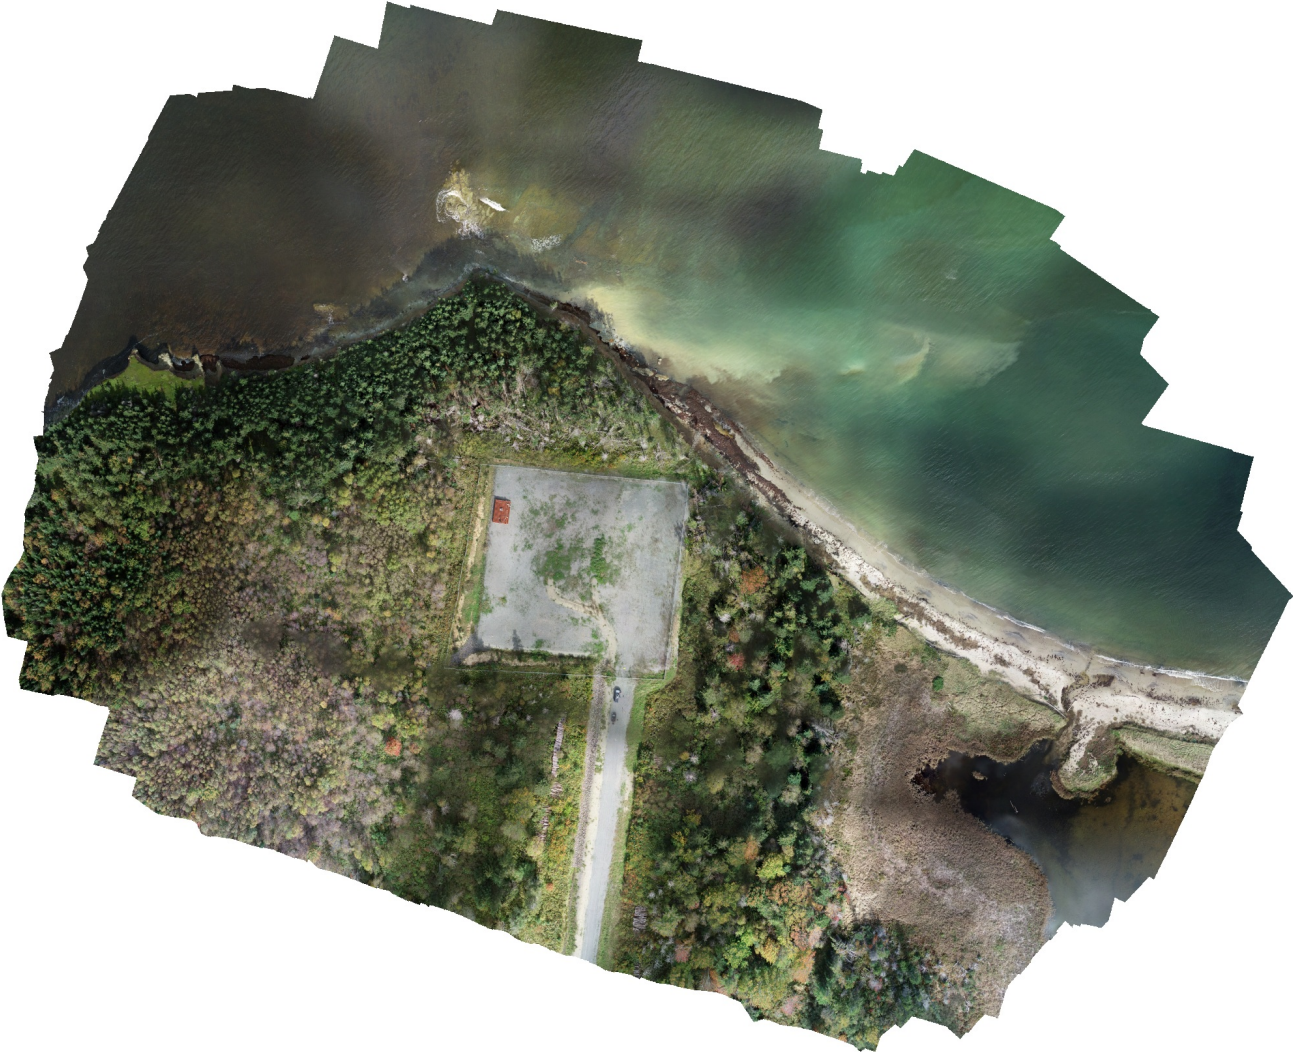
DJI Matrice 300 RTK L1 RGB Processing Report

Survey Data
